DISMANTLING NOW . Minespec Parts Pty Ltd
HITACHI EX3600-5 BACKHOE

REPORT NO: 15-070-01

SUBJECT: The partial inspection of Hitachi Excavator EX3600 Unit No. EX214 as per the Hitachi visual inspection manual. The inspections were carried out to detect any possible cracking.

HITACHI EX3600-5 TRACK ASSESSMENT MINESPEC PARTS PTY LTD

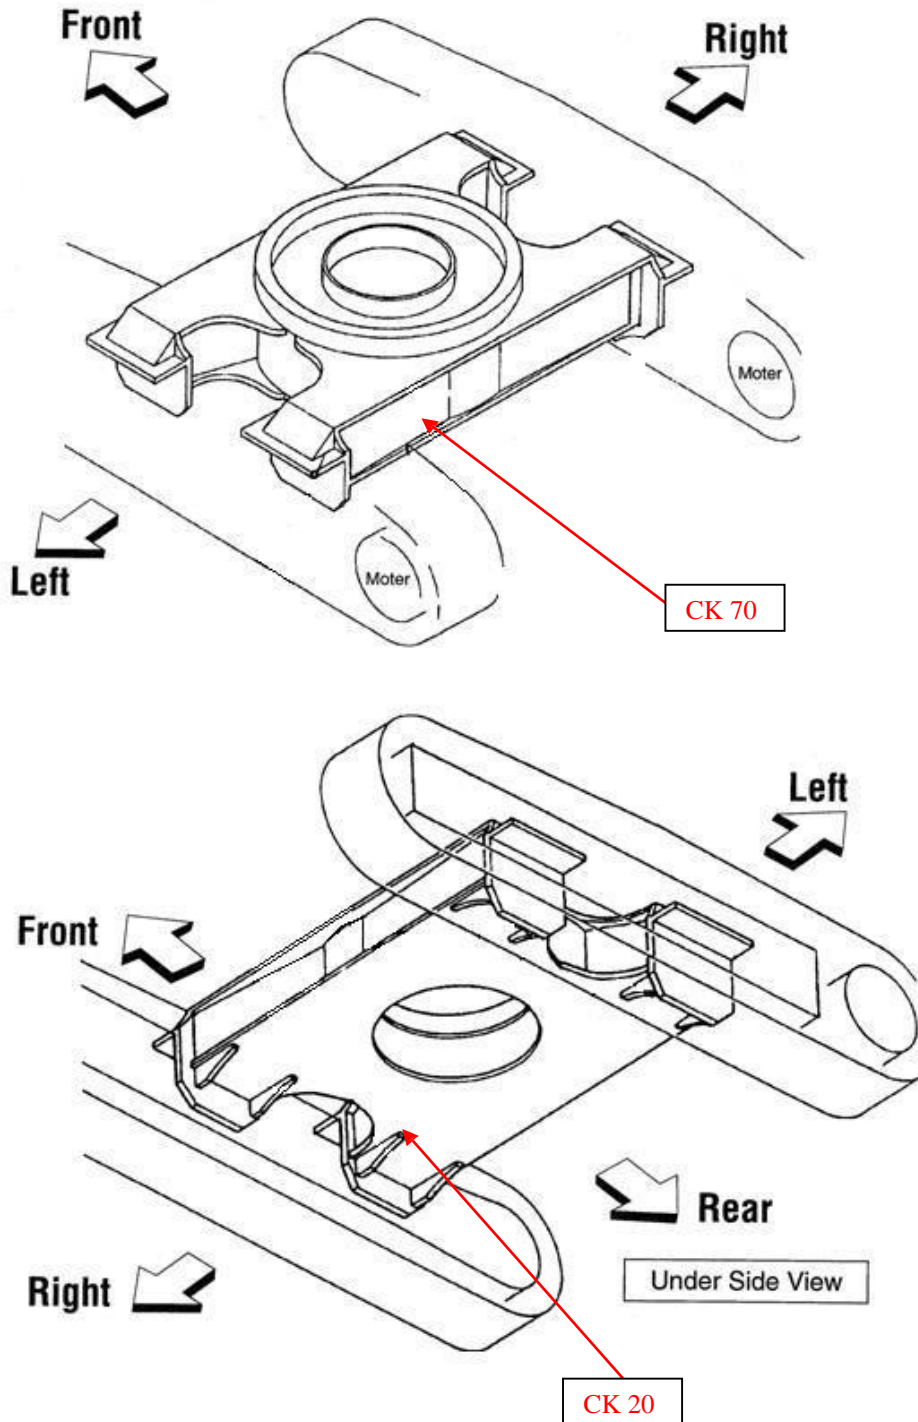
TRACK FRAME

Cracking detected, Refer to the Carbody drawing for details of the cracking

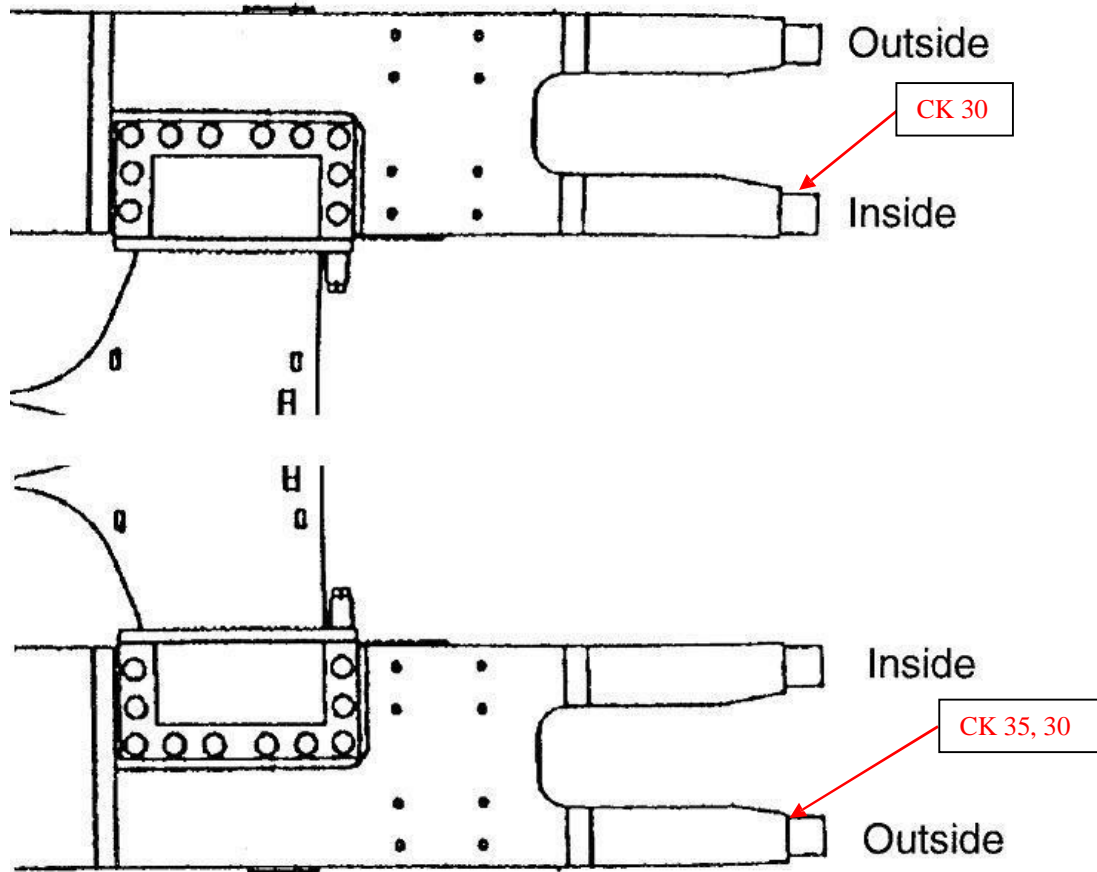
SIDE FRAMES

Cracking detected, Refer to the Side Frame drawing for details of the cracking

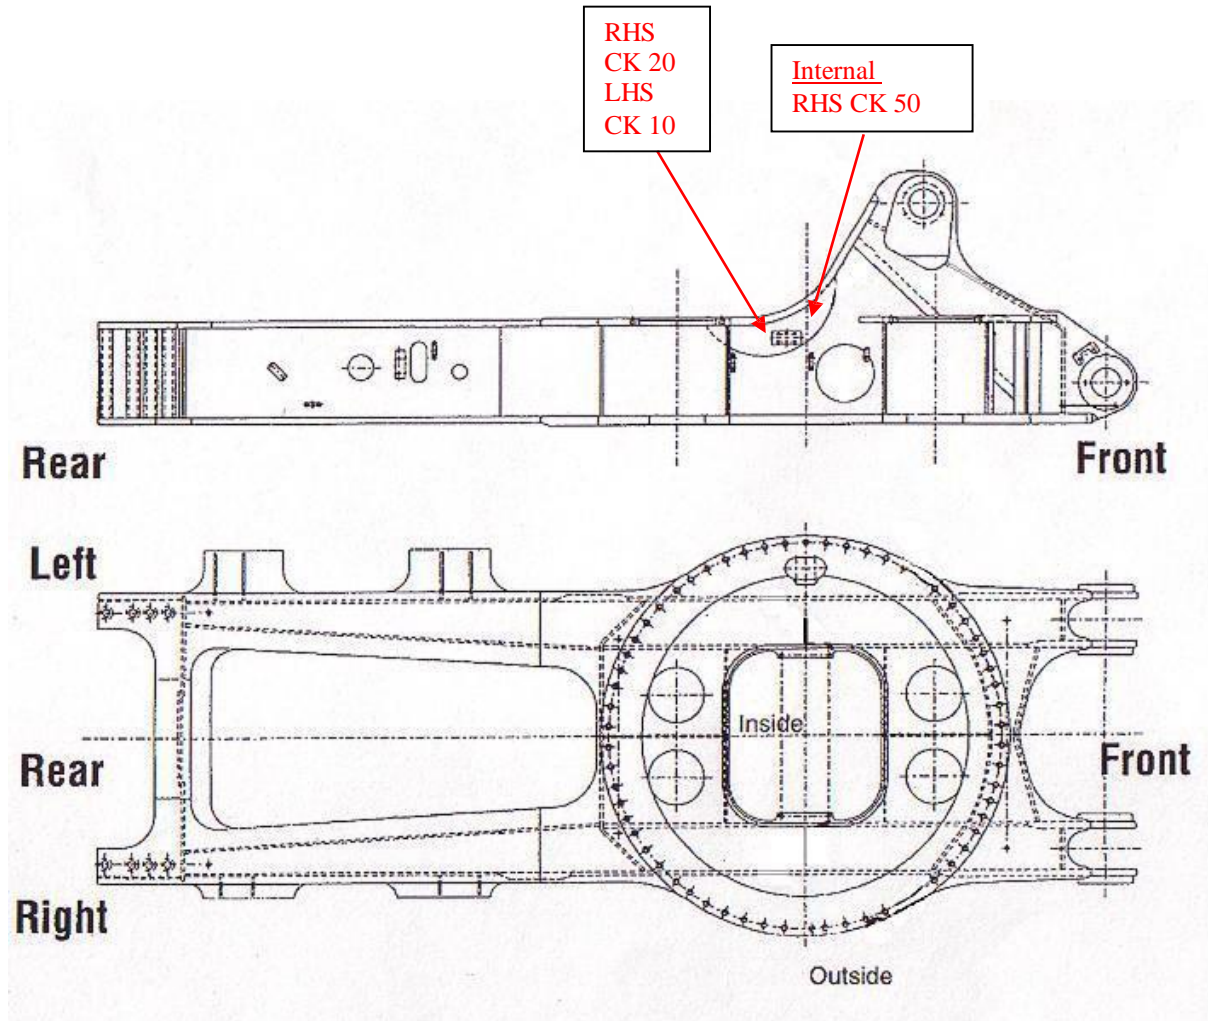
MAIN FRAME

Cracking detected, Refer to the Main Frame drawing for details of the cracking

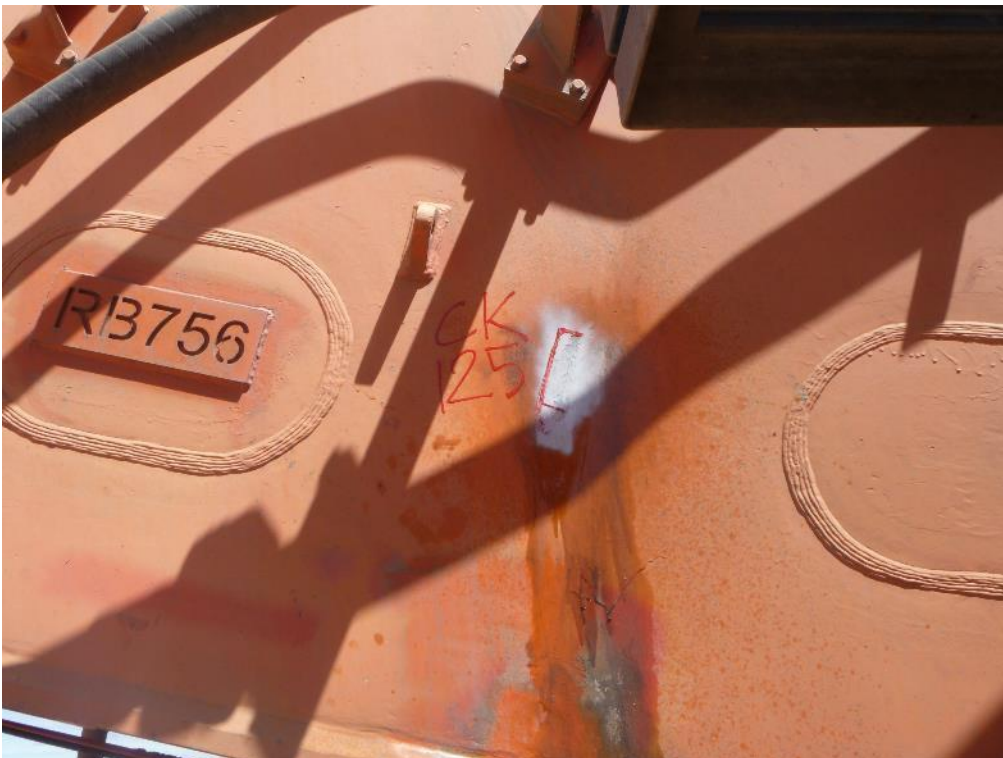
Photograph No. 2

Cracking was detected, Refer to the photograph numbers 1 . 5 for details of the cracking

View of the cracking detected in the Boom

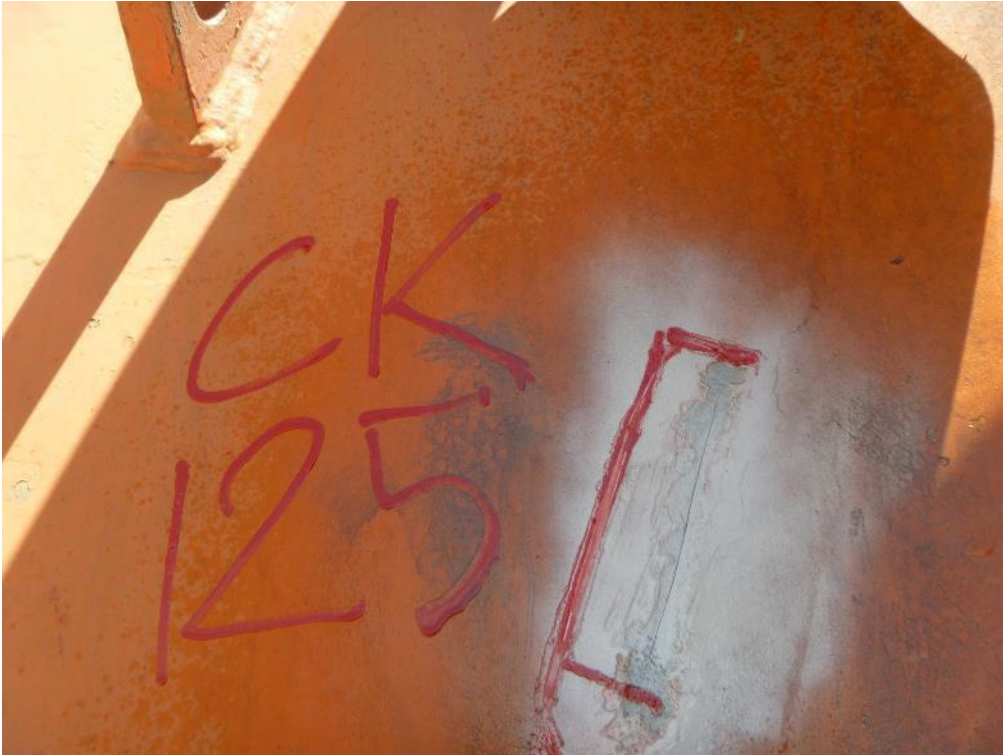
Photograph No. 3

Close up view of the 125mm long crack detected in the Boom

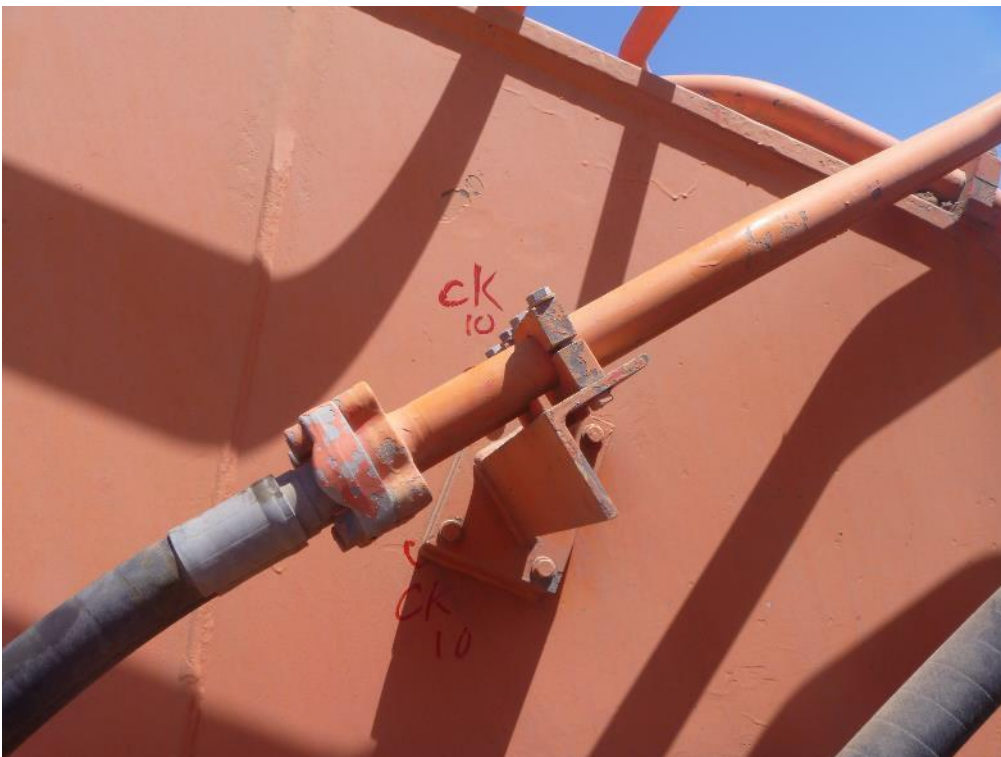
Photograph No. 4

View of cracking detected in a hydraulic line mount

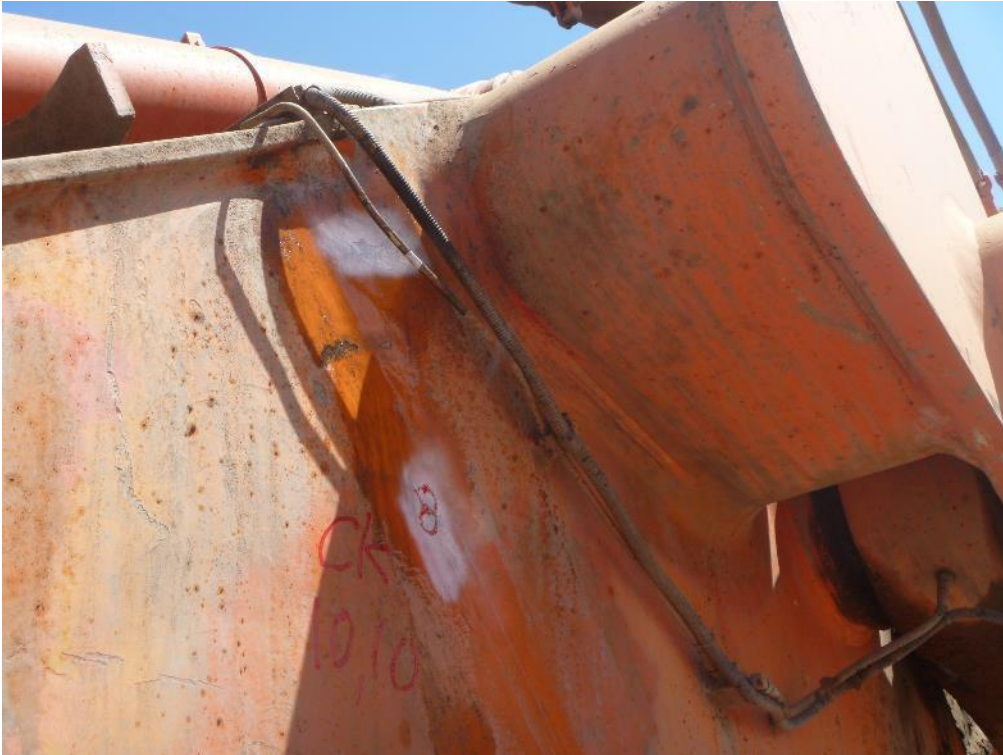
Photograph No. 5

View of cracking detected in the Left hand side of the Boom

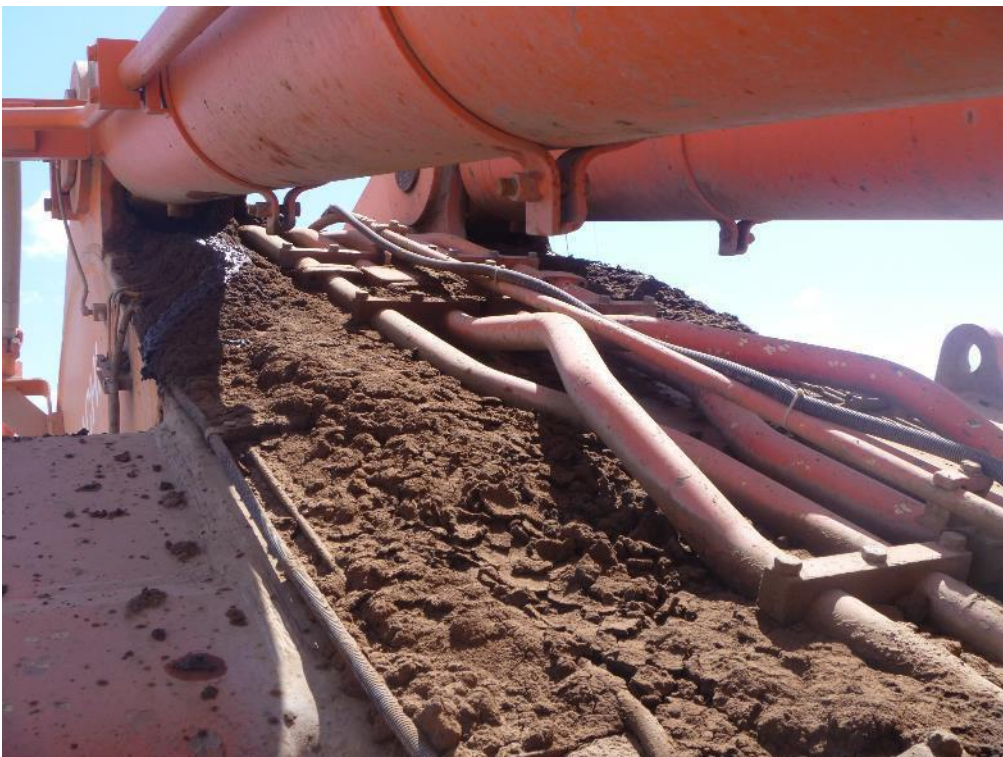
Photograph No. 6

NB. Limited access to the boom during the inspection due to excess grease and dirt build up.

View of the access restrictions on the Boom

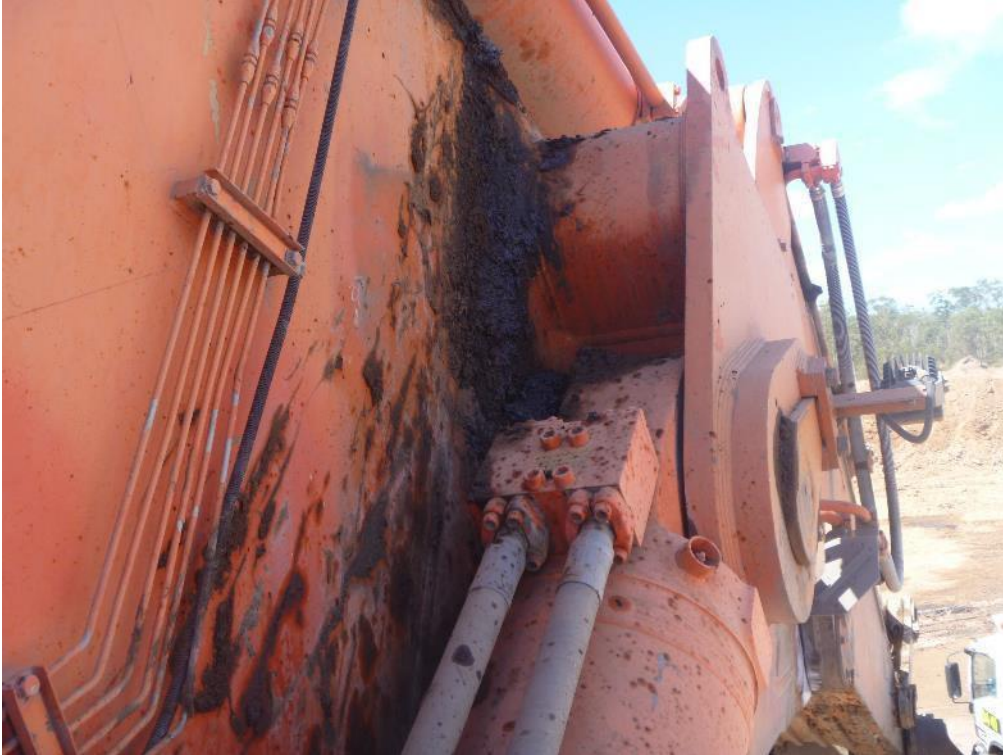
Photograph No. 7

View of the access restrictions on the Boom

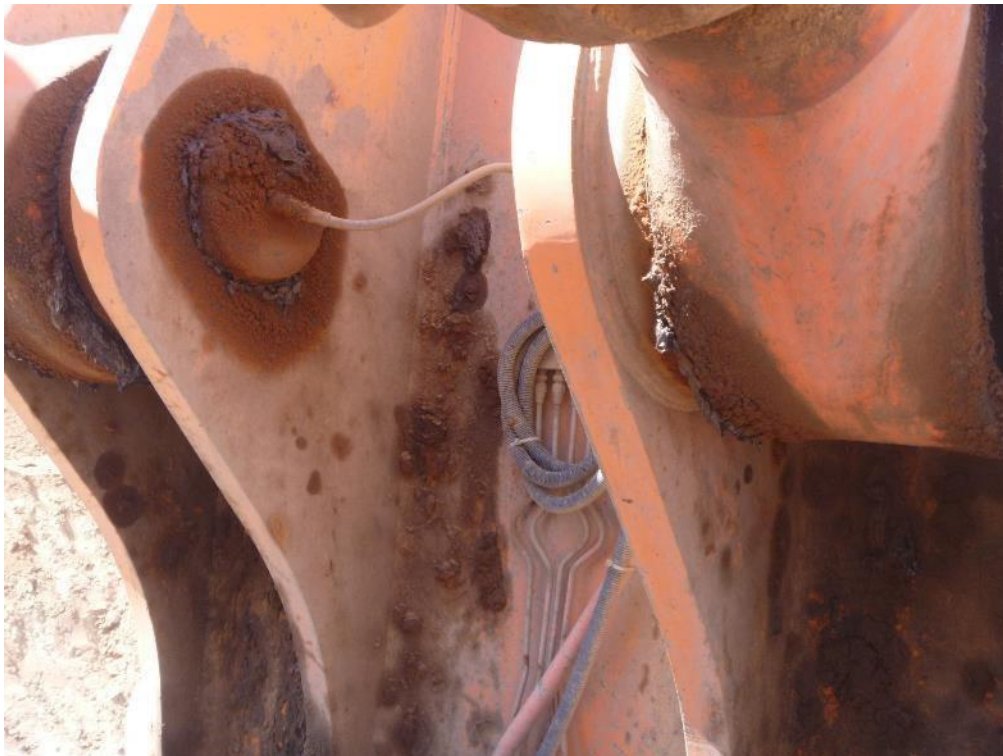
Photograph No. 8

Very limited access to the Stick during the inspection due to time constraints and excess grease and dirt build up.

View of the access restrictions on the Stick

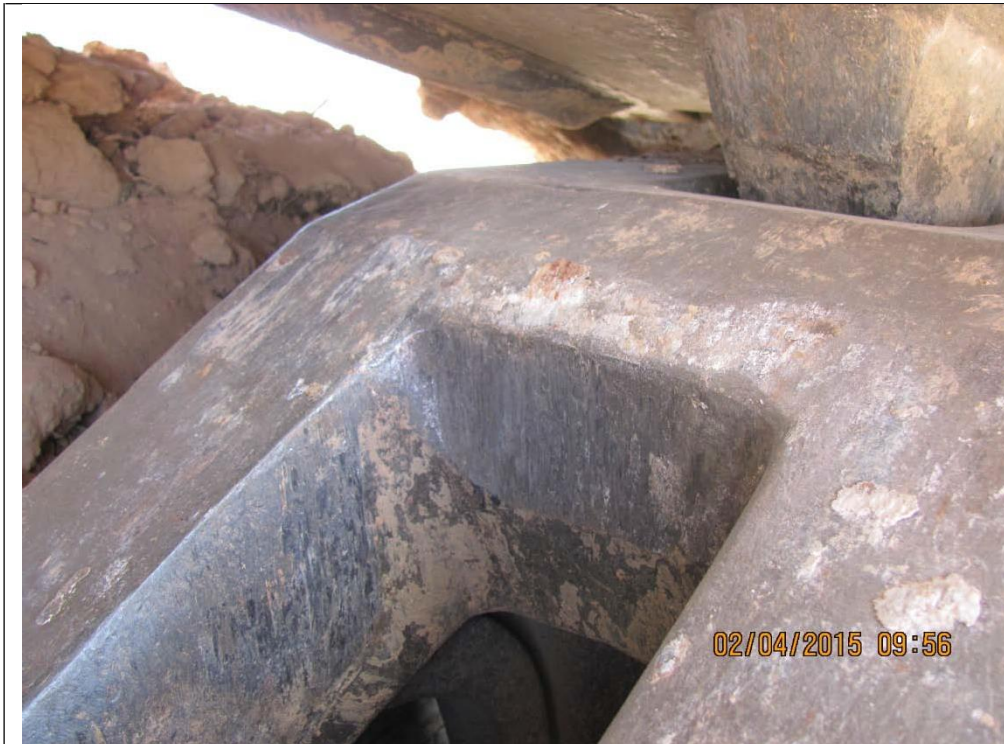
LH Aftermarket Drive Tumbler. Teeth are oversized and cannot be measured accurately as the gauge does not fit correctly on the tooth.

Drive Tumbler		
Mud Pack	181 No	<input type="checkbox"/> Yes
Comments RH aftermarket tumbler is too narrow. LH aftermarket Tumbler teeth are oversized and cannot be accurately measured

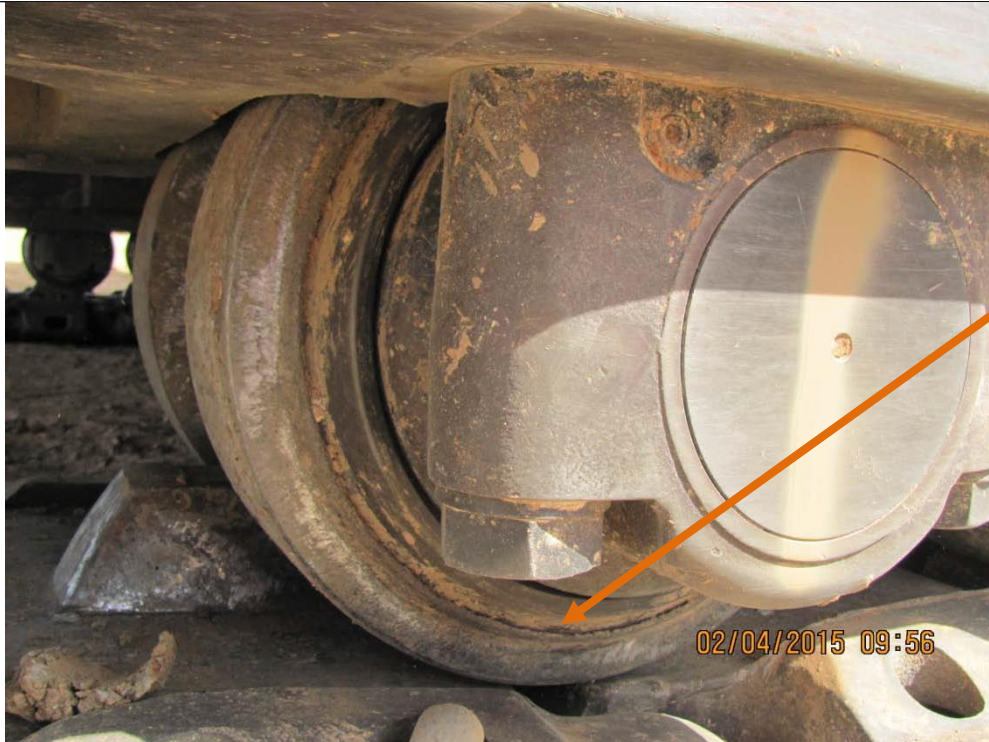
LH Lower Roller 1-
outer surface has
rolled edges

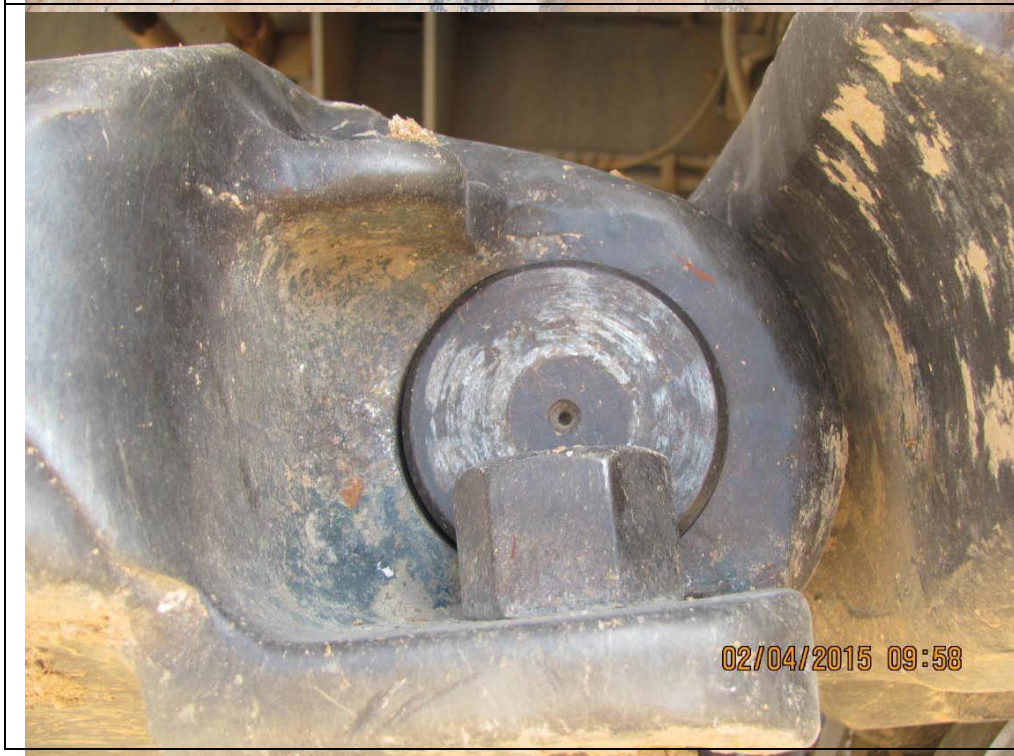
Minimal pin wear on the LH tracks.

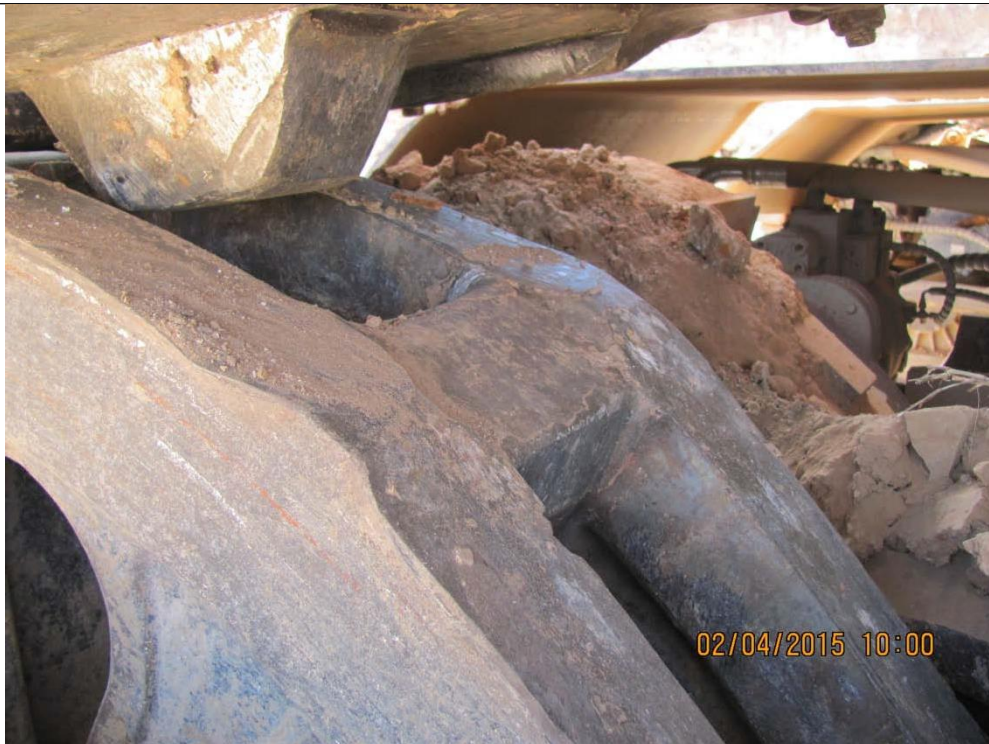
RH Aftermarket Drive
Tumbler Profile-
Worn outer surface.

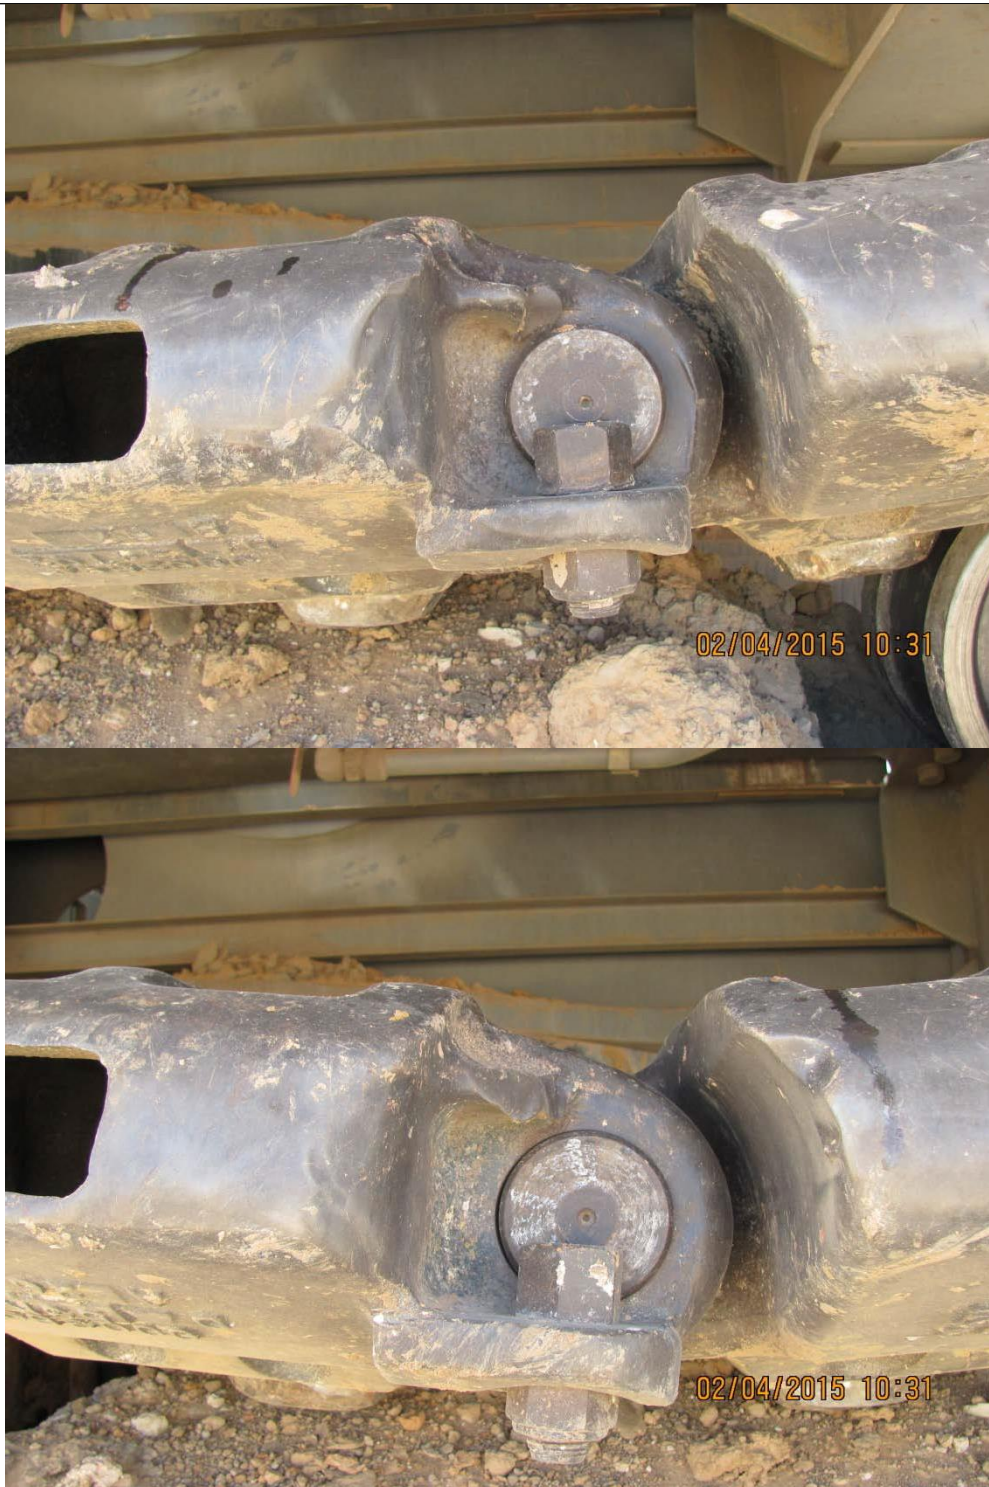
Minimal Pin Wear on the RH tracks
