UNIT 390 HITACHI EX5500 LOADER

Walkthrough inspections

Job Number: 2687871-1

VISUAL INSPECTION TEST REPORT

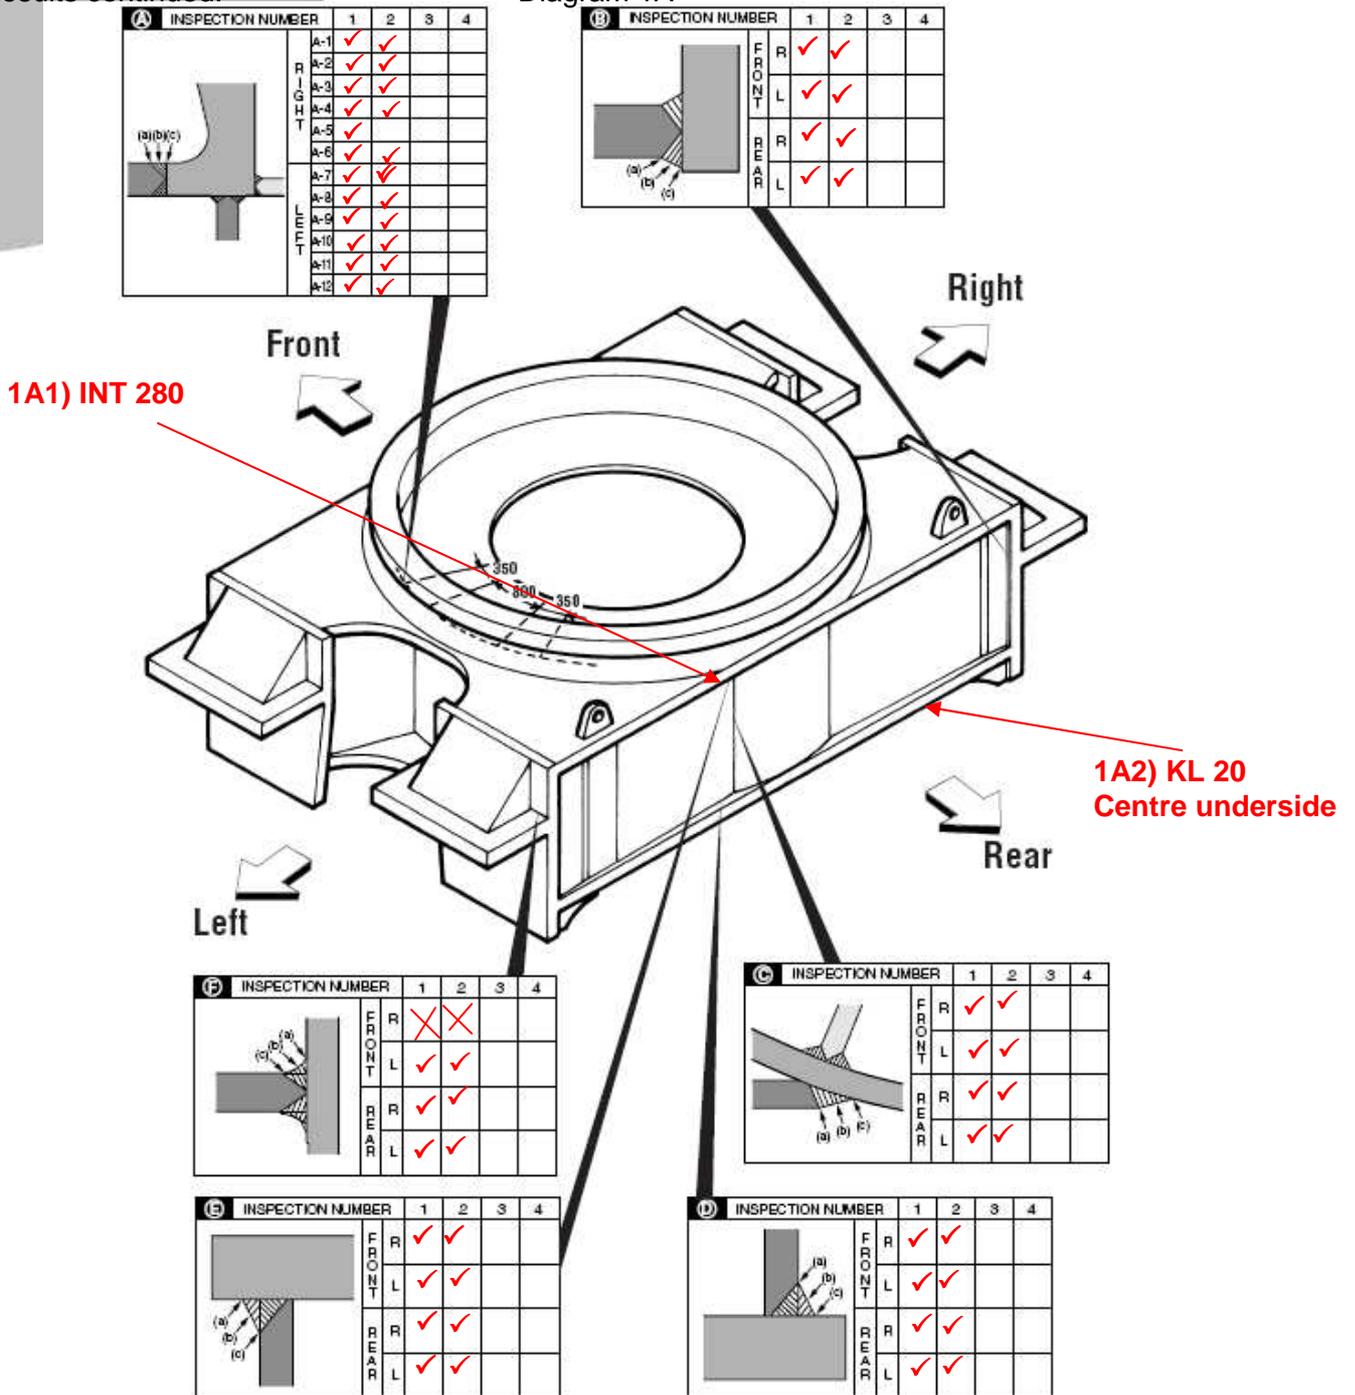
Diagram 1A

Crack I.D.	Details	Severity	Date	Work order	notification	Comments
1A1	INT 280	Moderate				80mm growth
1A2	KL 20	Moderate				NEW

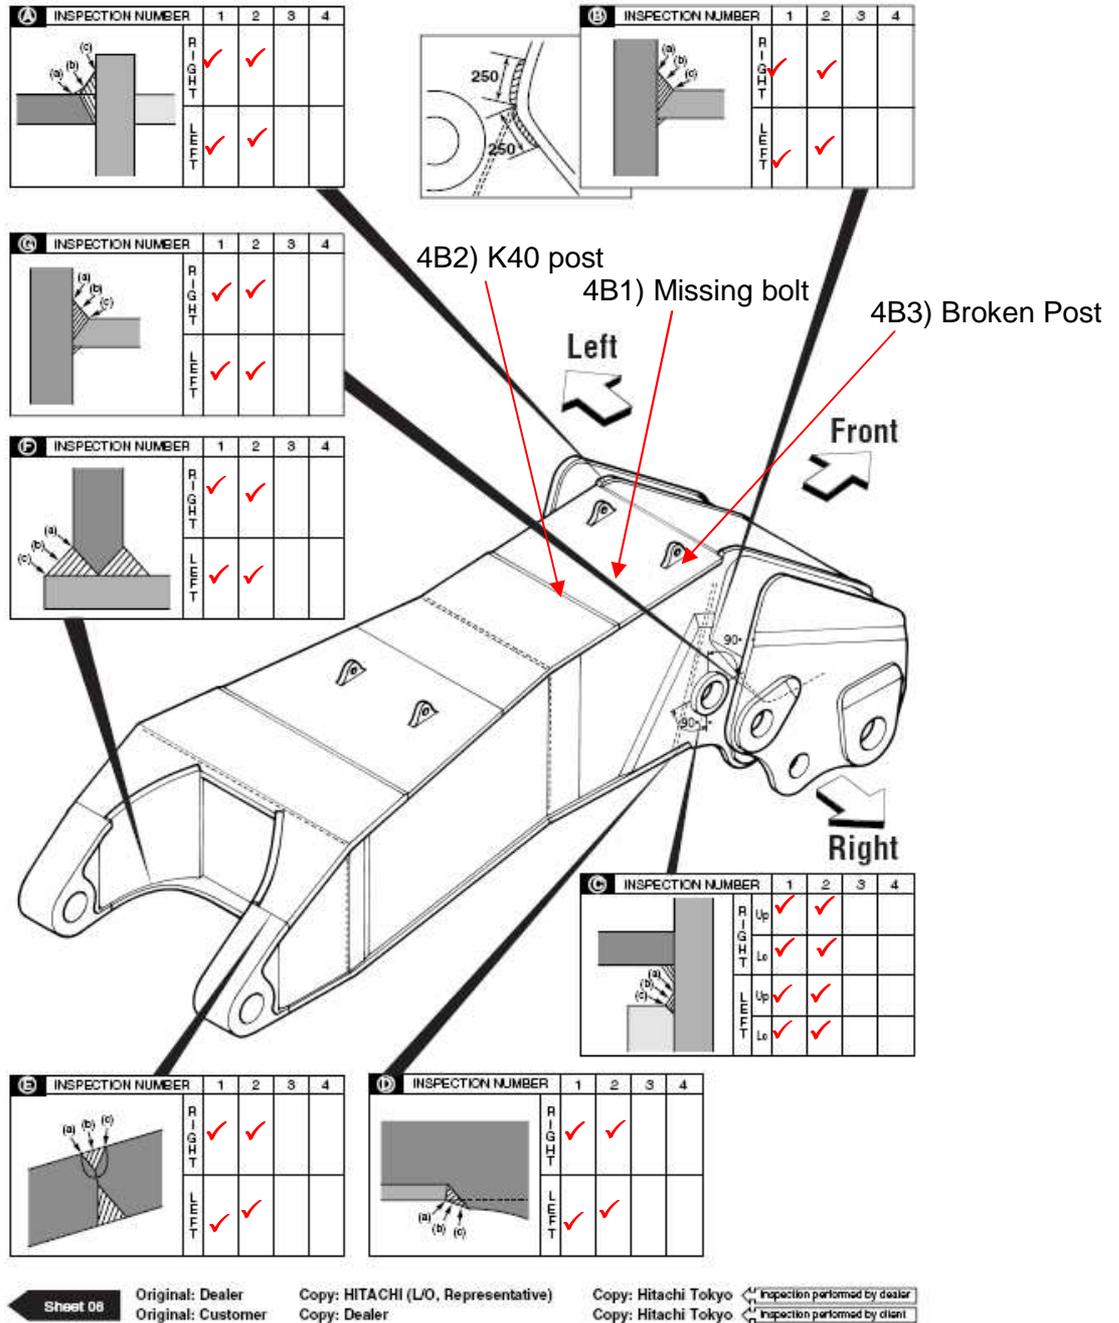
Diagram 4B

Crack I.D.	Details	Severity	Date	Work order	notification	Comments
4B1	Missing bolt	Moderate				
4B2	K 40 post	Moderate				
4B3	Broken post	Severe

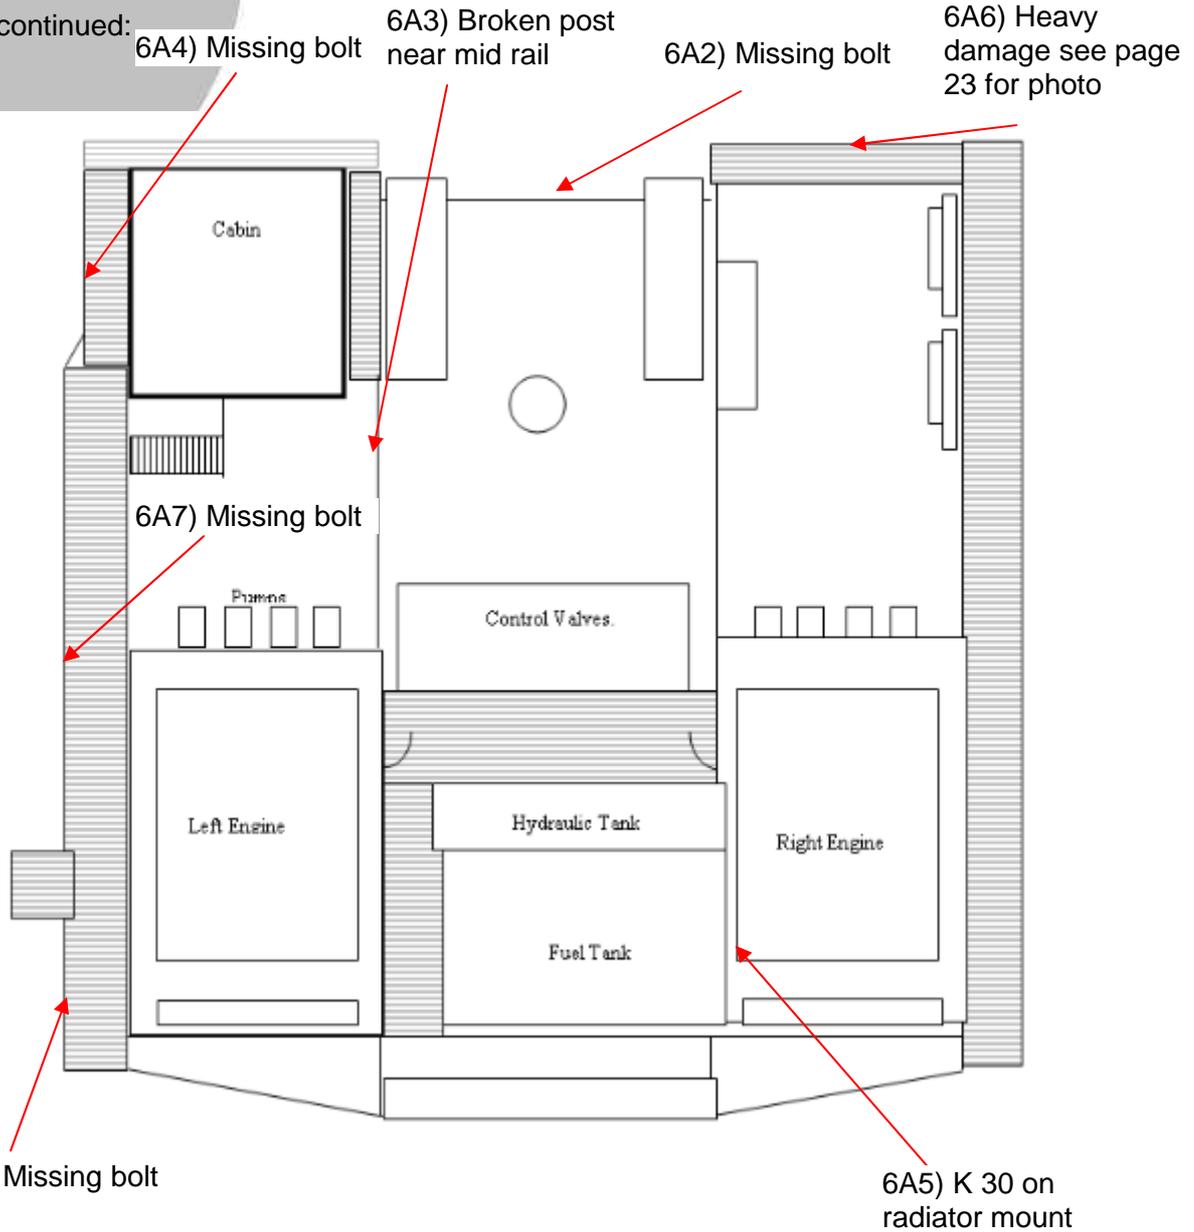
6A) Walkways

Crack I.D.	Details	Severity	Date	Work order	notification	Comments
6A1	Missing bolt	Moderate				
6A2	Missing bolt	Moderate				
6A3	Repaired					
6A4	Missing bolt on escape shoot	Moderate				
6A5	K 30 on mount	Moderate				
6A6	Heavy damage	Severe				Repair handrails
6A7	Missing bolt	Moderate

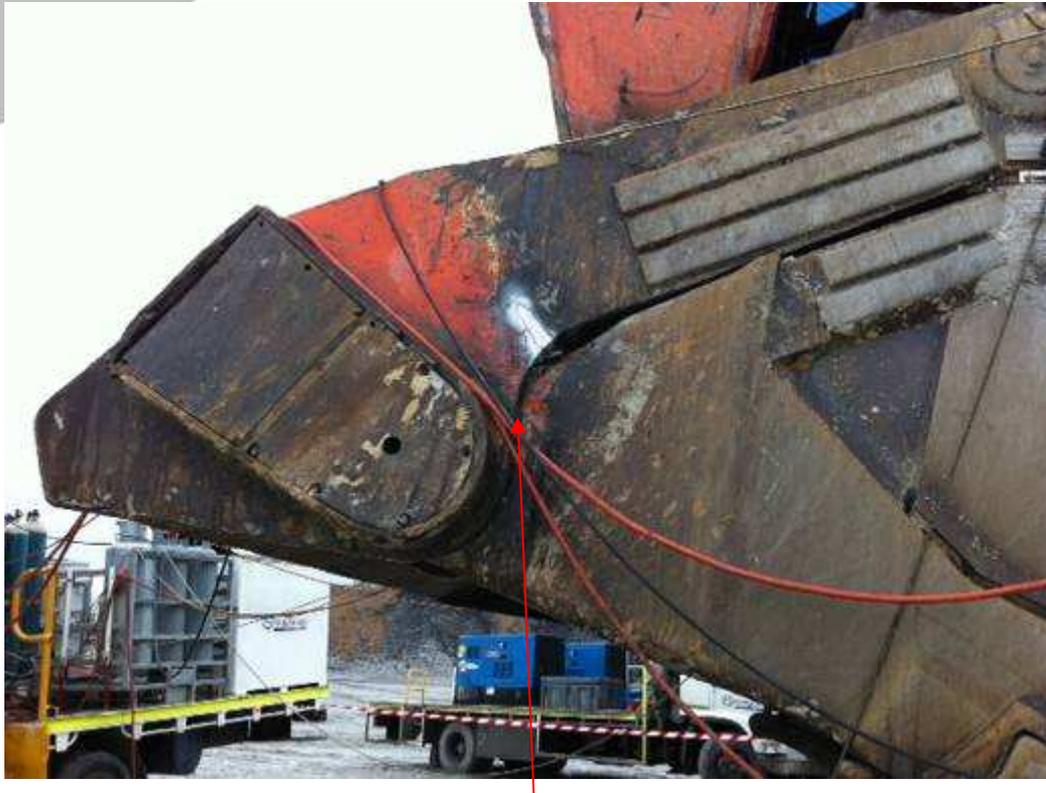
Photo of area (Repaired) (Crack 1 on bucket)

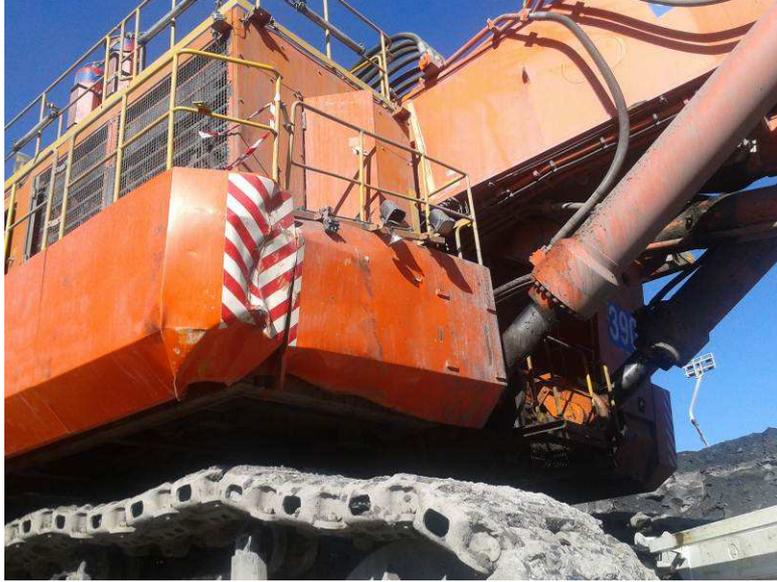
Photo shows damage evident on the RHS front walkway

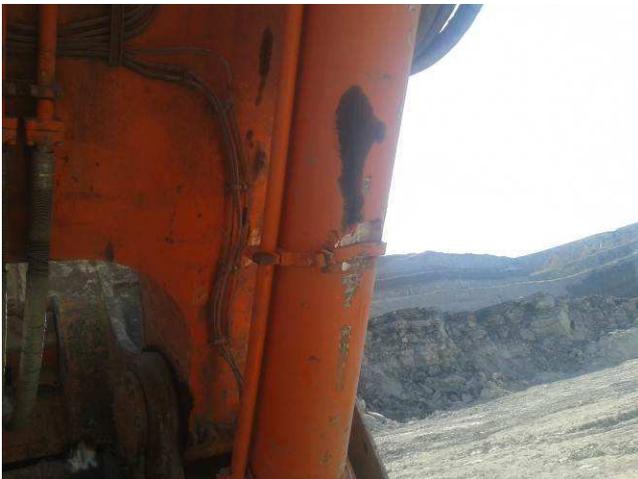
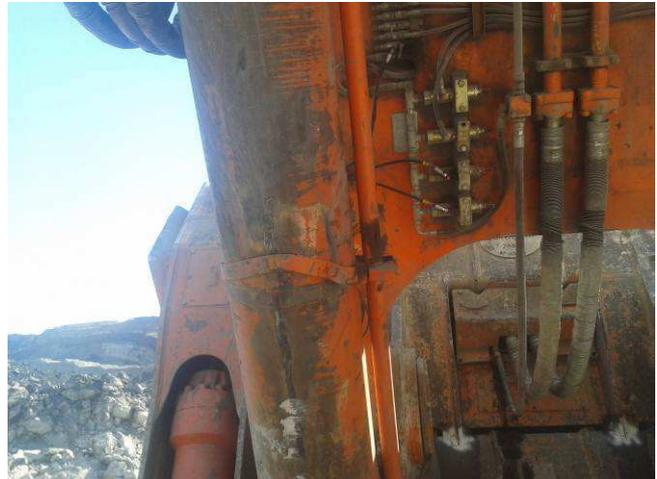
- **Track frame –** **Cracking detected**, See diagram 1A
- **Side Frames –** **No cracking detected**, See diagram 2A
- **Mainframe –** **No Cracking detected**, See diagram 3A-C
- **Boom –** **No cracking detected**, See diagram 4A-E
(Rams have damage see page 23 for details)
- **Stick –** **No cracking detected**, See diagram 5A-D

Photos above are of damage on two rams behind the bucket

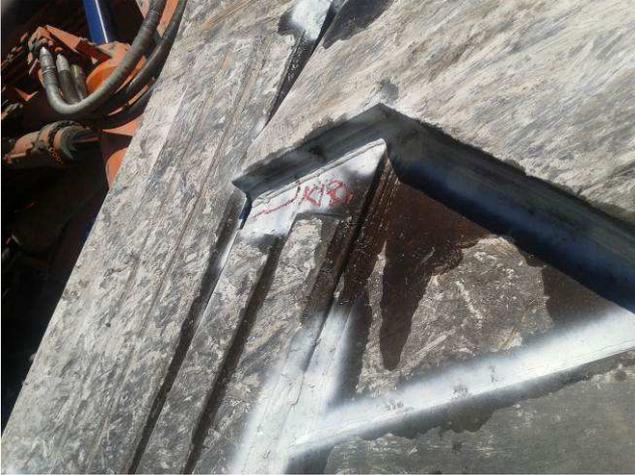
**Cracking evident on RHS top area near door
Crack 2) KL 130**

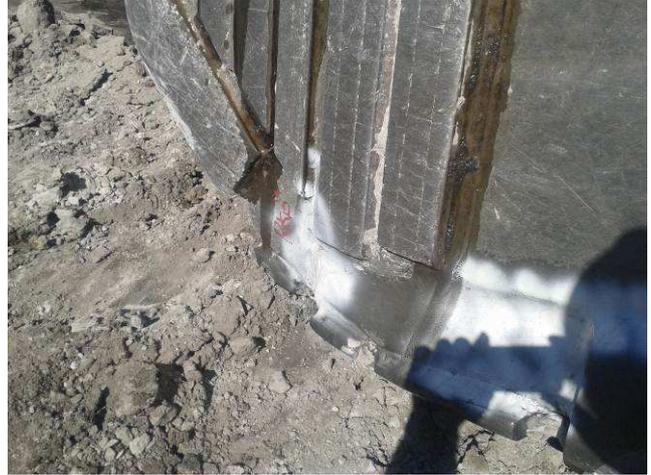
**Cracking evident in floor outboard near door
Crack 3) KL 50+**

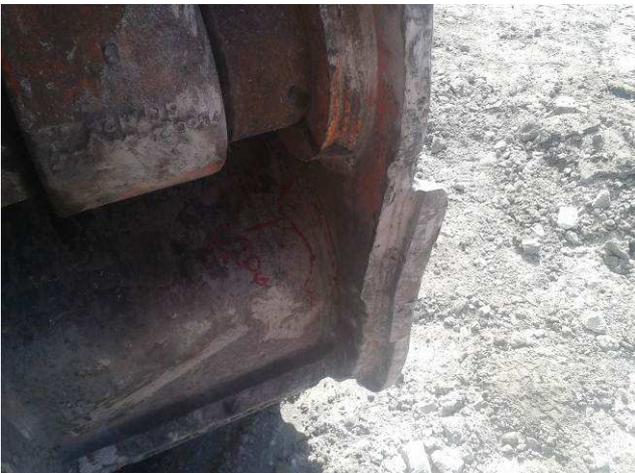
Cracking in back side of door Crack 4) KL 200

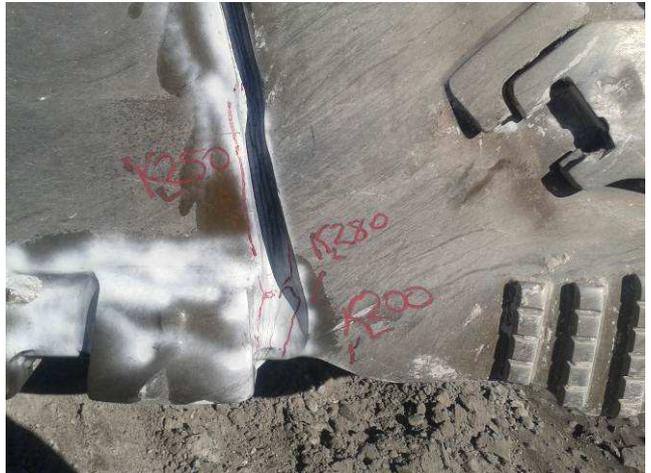
**Cracking evident in lip welds RHS outboard
Crack 5) KL 250, Crack 6) KL 280
Crack 7) KL 200 underside.**

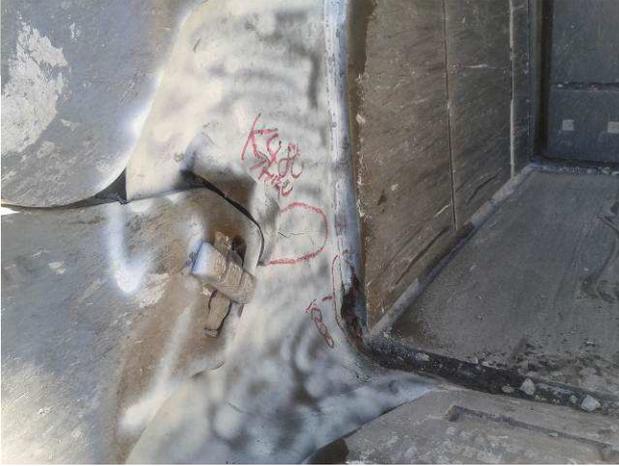
Photo shows major crack 8) KT 480 in LIP
Crack 9) KL 200 in wear plate

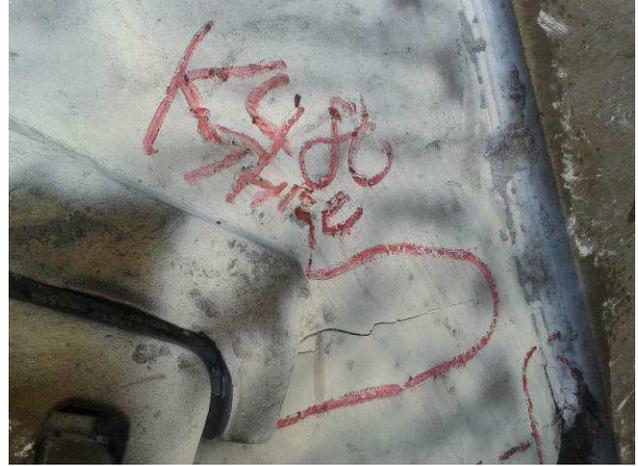
Photo shows major crack 8) KT 480 in LIP

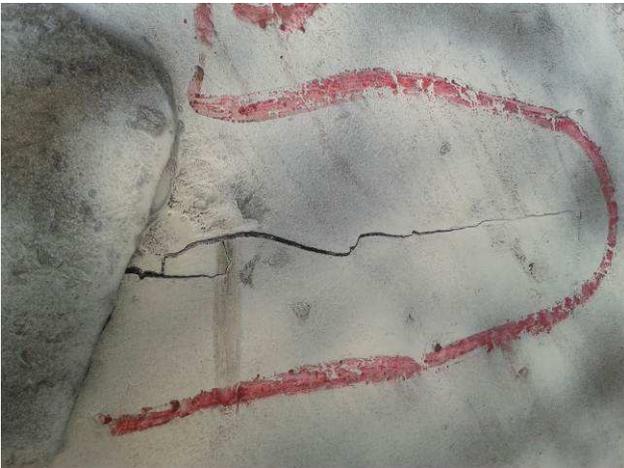
Photo shows major crack 8) KT 480 in LIP
Close up detail inboard side

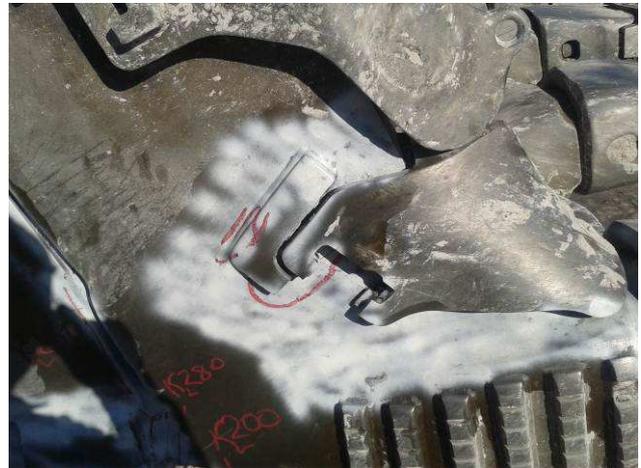
Photo shows major crack 8) KT 480 in LIP
outboard side and crack 10) INT 70 adaptor

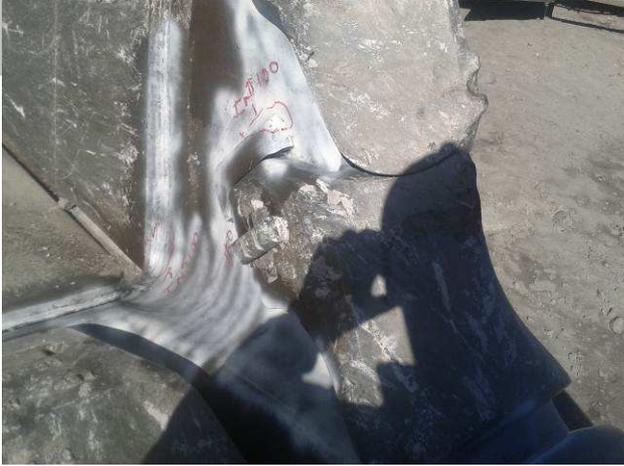
Photo shows crack 11) INT 100 Adaptor
Crack 12) INT 100 evident in wear plate weld
Inboard

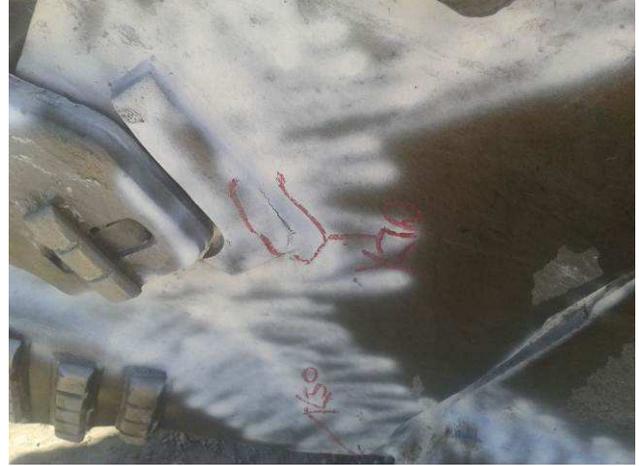
Photo shows crack 13) KL 70 Adaptor
Crack 14) KL 50 in lip weld underside
outboard

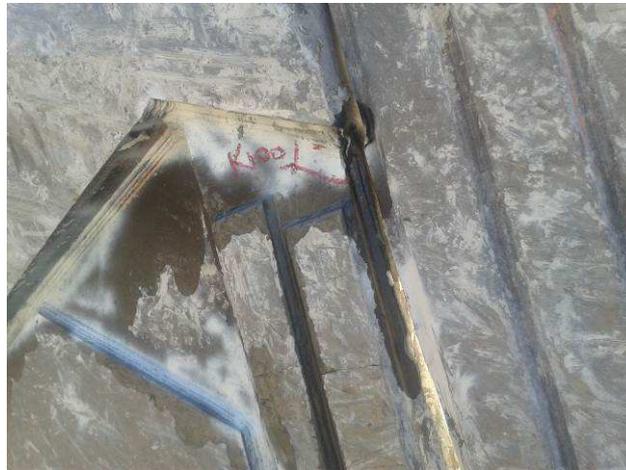
Cracking evident on LHS top area near door
Crack 15) KL 100

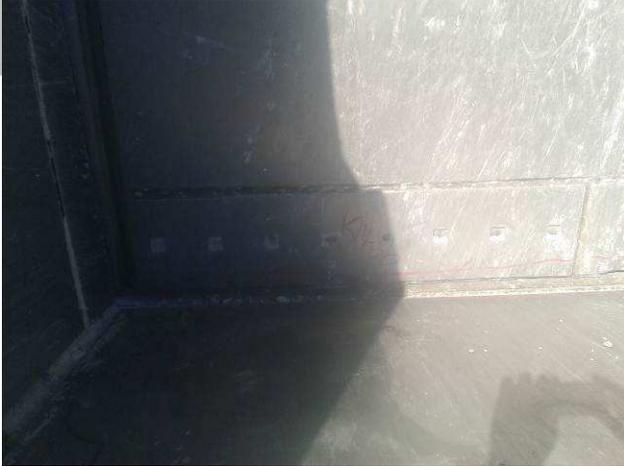
Cracking evident in the door jam area under wear plate Crack 16) KL 1400 Inboard

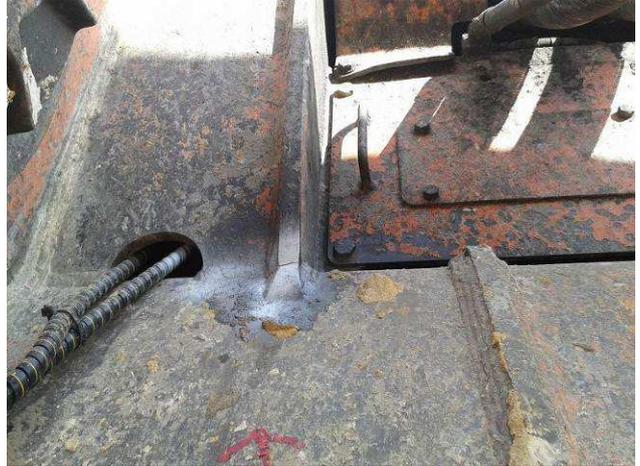
Cracking evident in the door jam area under Crack 17) KL 180 LHS top

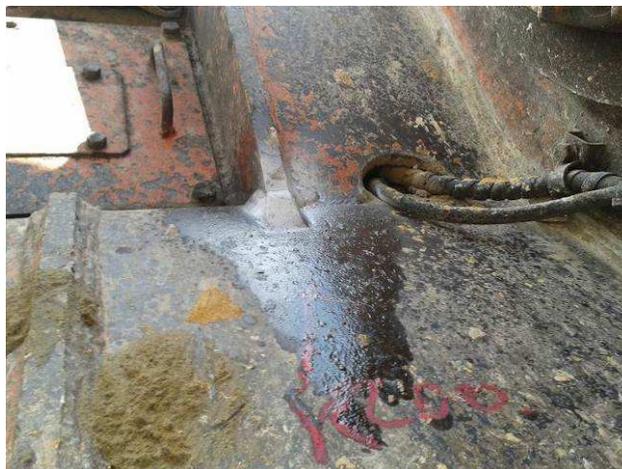
Cracking evident in the door rear side Crack 18) KL 180 RHS top
