**Report No:** M16-1337  
**Date:** 21<sup>st</sup> and 25<sup>th</sup> July 2016  
**Client:** Minespec Parts Pty Ltd  
**Contact:** Ian Roduner  
**Subject:** The Magnetic Particle, Ultrasonic and Visual examination of nominated areas about one [1] EX5500 Boom.  
**Test Location:** Austin Engineering, 56 Len Shield Street, Paget QLD 4740.  
**Order No:** P0216  
**Client Job No:** TBA  
**Technician:** Paul McNeill and Donald O'Hare

The Magnetic Particle, Ultrasonic and Visual examination of nominated areas about one [1] EX5500 Boom.

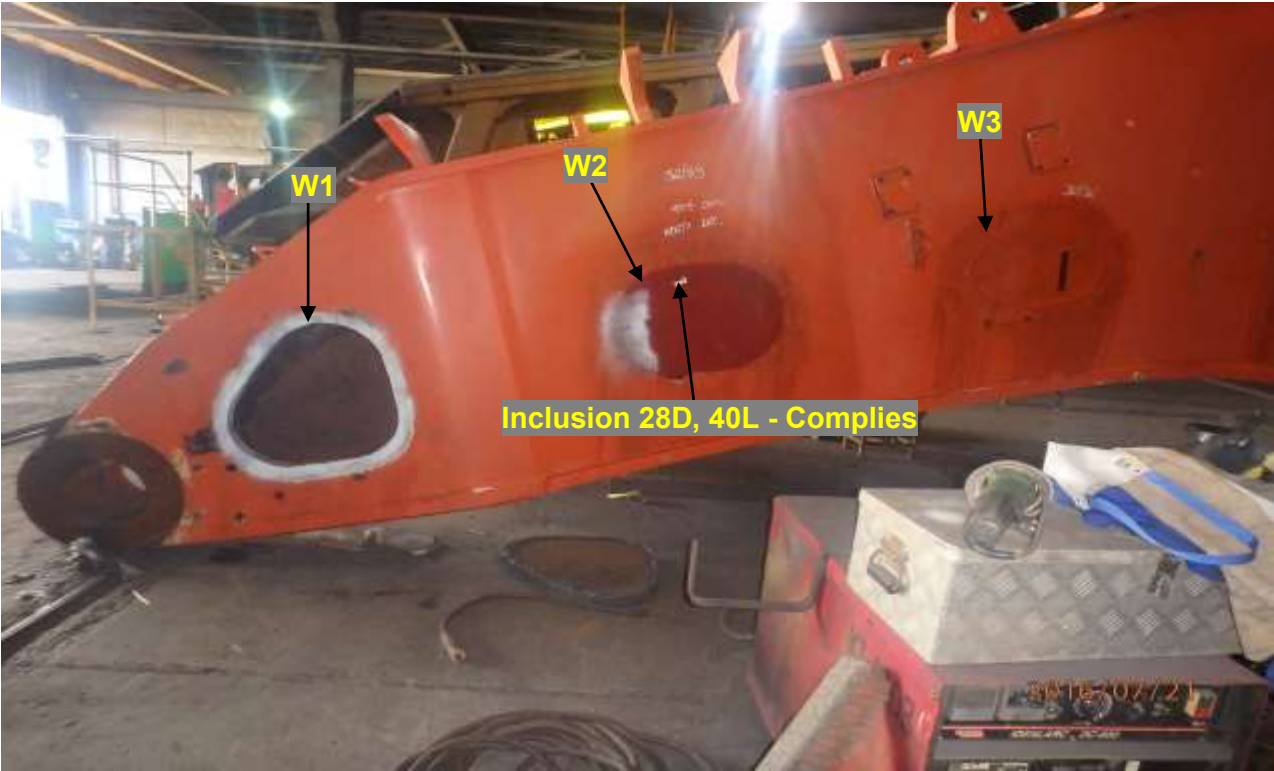
<b><u>Examined</u></b>	<b><u>Interpretation</u></b>	<b><u>Quality</u></b>
1.1 <b>RHS W1 Internal Welds and Transitions</b> Visual Supp MPI	No cracking detected	
1.2 <b>RHS W4 Welds</b> Visual Supp MPI	Cracking detected – <i>refer to photograph 1.2.</i>	
1.3 <b>RHS W7 Welds</b> Visual Supp MPI	Cracking detected – <i>refer to photograph 1.3.</i>	
1.4 <b>RHS Boom Foot Welds</b> Visual Supp MPI	Cross failure through casting – <i>refer to photograph</i>	
<b><i>Window numbers are from Boom Foot to Stick End</i></b>		
1.5 <b>LHS W1 Welds</b> UT	No recordable discontinuities detected	Complies
1.6 <b>RHS W1 Welds</b> UT	Window removed at time of inspection	
1.7 <b>LHS W2 Welds</b> UT	No recordable discontinuities detected	Complies
1.8 <b>RHS W2 Welds</b> UT	Inclusion detected – 28mm Deep, 40mm Long <i>Refer to photograph 1.1.</i>	Complies

**Photograph 1.1.**  
General view of areas examined and inclusions detected about EX5500 Boom.

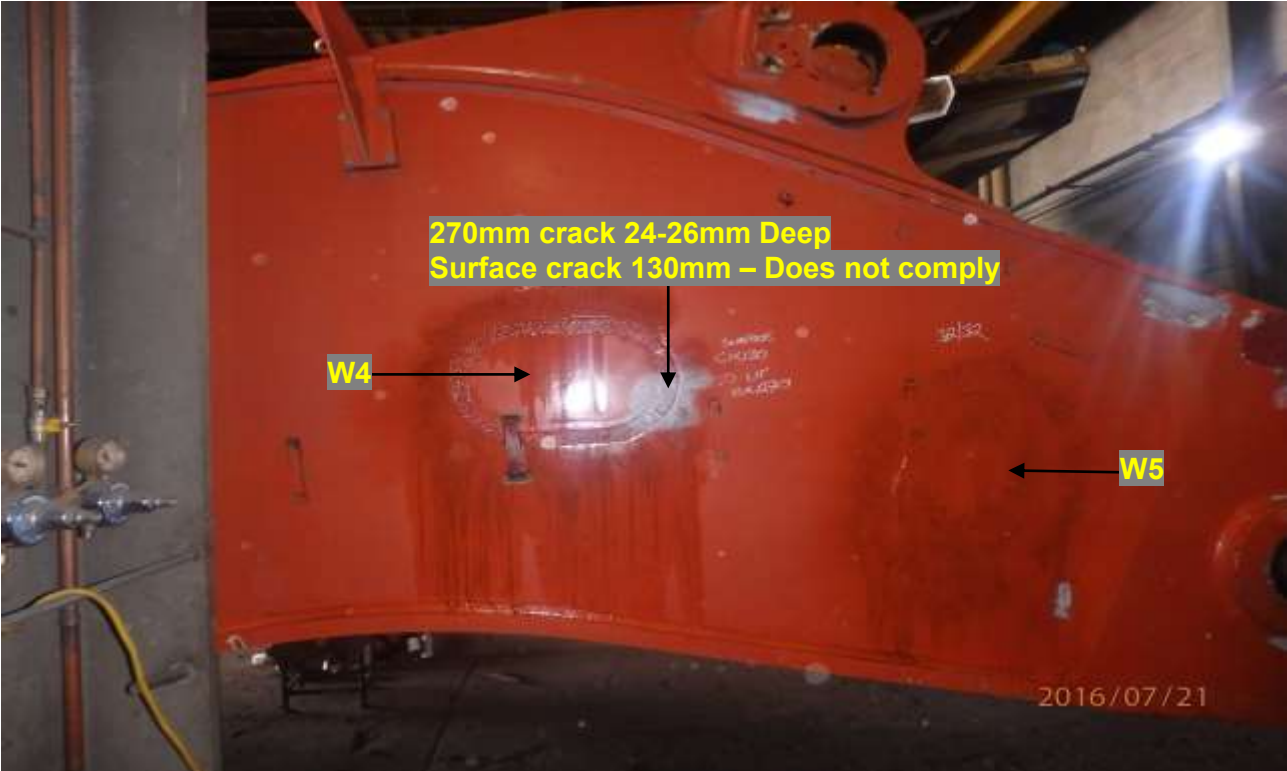
**Photograph 1.2.**  
General view of areas examined and discontinuities detected about EX5500 Boom.

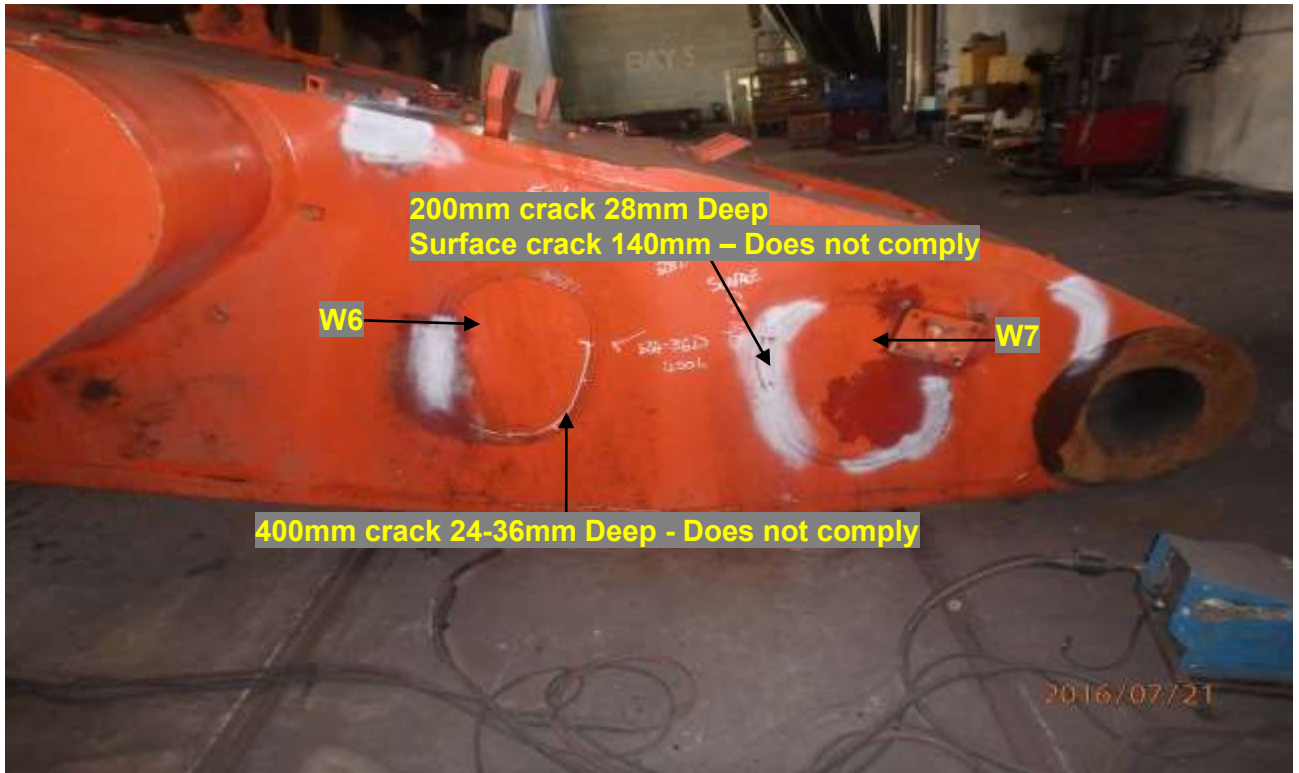
<b><u>Examined</u></b>	<b><u>Interpretation</u></b>	<b><u>Quality</u></b>
1.9 LHS W3 Welds UT	No recordable discontinuities detected	Complies
1.10 RHS W3 Welds UT	No recordable discontinuities detected	Complies
1.11 LHS W4 Welds UT	No recordable discontinuities detected	Complies
1.12 RHS W4 Welds UT	Discontinuities detected: - Crack 270mm Long, 24-26mm Deep, surface breaking 130mm x 1 <i>Refer to photograph 1.2.</i>	Does not comply
1.13 LHS W5 Welds UT	No recordable discontinuities detected	Complies
1.14 RHS W5 Welds UT	No recordable discontinuities detected	Complies
1.15 LHS W6 Welds UT	No recordable discontinuities detected	Complies
1.16 RHS W6 Welds UT	Discontinuities detected: - Crack 400mm Long, 24-36mm Deep <i>Refer to photograph 1.3.</i>	Does not comply

<b><u>Examined</u></b>	<b><u>Interpretation</u></b>	<b><u>Quality</u></b>
1.17 LHS W7 Welds UT	No recordable discontinuities detected	Complies
1.18 RHS W7 Welds UT	Discontinuities detected: - Crack 200mm Long, 28mm Deep, surface breaking 140mm <i>Refer to photograph 1.3.</i>	Does not comply

**Photograph 1.3.**  
General view of areas examined and discontinuities detected about EX5500 Boom.
