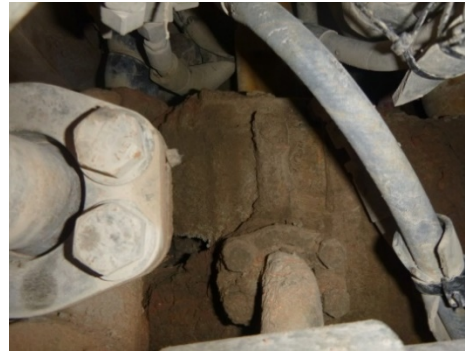
Picture 10

Defect observed	Photo Ref	Material Equipment Defect (Yes/No)	Defect (Yes/No)
Control valve leaks requires dozer to be stood down and valve replaced	10	No	Yes
Main pump leaks require dozer to be stood down and pump replaced	11	No	Yes
Equalizer bar leaking and centre pin & bush movement requires dozer to be stood down and equalizer bar resealed and centre pin & bush and bearings replaced	12	No	Yes
Cannons leaking both sides requires dozer to be stood down and cannons seals replaced	13-14	No	Yes
Draft arm left side damaged	15	No	Yes
Track frame right side damaged	16	No	Yes
Stabilizer bar trunnion worn requires dozer to be stood down and trunnion replaced	17	No	Yes
Stabilizer bar bent	18	No	No
Engine grill damaged	19	No	No
Belly guards damaged	20	No	No
Cabin pillar crack repaired	21	No	No
Bogie pad left side deteriorating requires dozer to be stood down and bogie pads replaced	22	No	Yes
Oil samples show prior B samples hydraulic system, Rear left final drive and transmission engine		No	Yes
