INSPECTION REPORT

UNDERCARRIAGE WEAR

| Site Visit / Machine Summary | |
|---|---|
| Machine ID | 5491 |
| Machine Model | EX5500 |

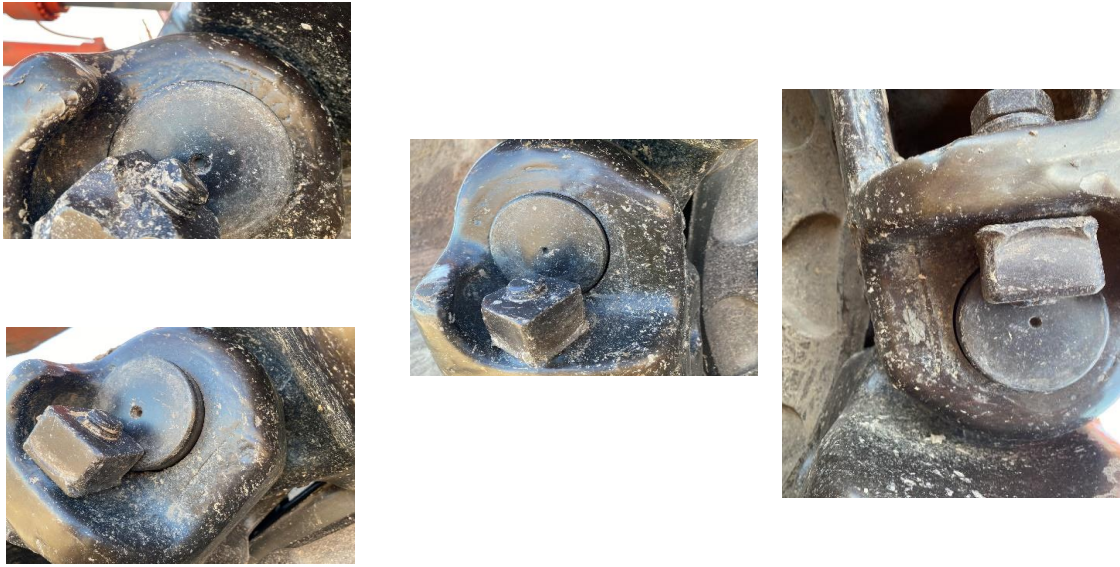
Figure 1 - Typical pin, bore, and retaining hardware condition

| Shoes | <p>Crawler shoe pitch extension was measured at 75%LHS and 83% RHS. The pins, bores, and retaining hardware were all in good condition at this stage of undercarriage life as shown in Figure 1.</p> <p>Crawler shoe roller path wear was measured at 40%LHS and 45% RHS. roller paths were in good condition.</p> <p>Crawler shoe drive lugs were in Good condition with no major defects found at the time of inspection. The condition is shown in Figure 3.</p> |

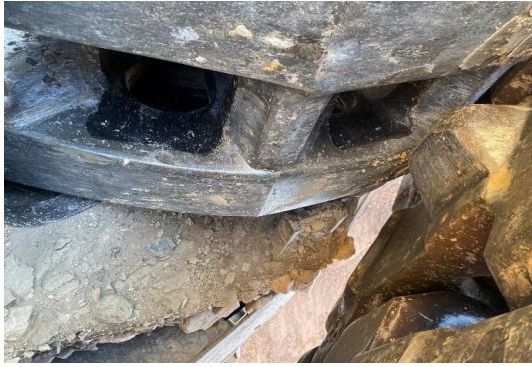
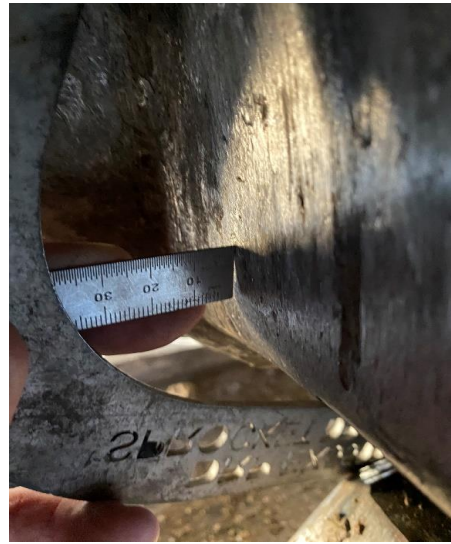
Figure 4 - Sprocket drive lug condition

| Tumblers | <p>With 76% LH and 82% RH of drive face wear on the Tumblers they appear in reasonable condition, Roll path on Tumblers was measured at 67% LHS and 73% RHS indicating they are through the hardened surface and wear may increase at a more rapid pace., As wear progresses much more quickly through the softer parent material of the tumbler. The tumbler drive lug condition should be monitored to ensure replacement is appropriately scheduled as the tumbler lugs are reaching end of life.</p> |

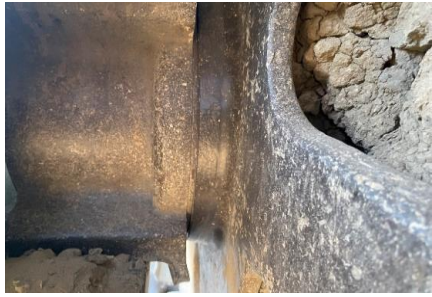
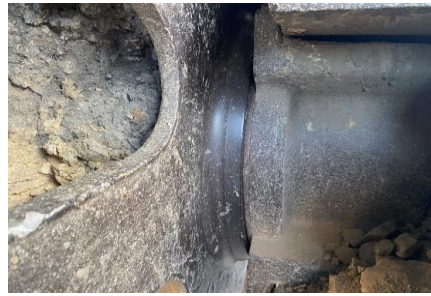
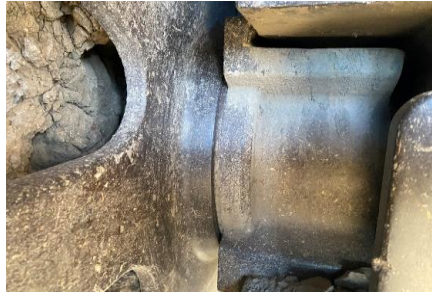
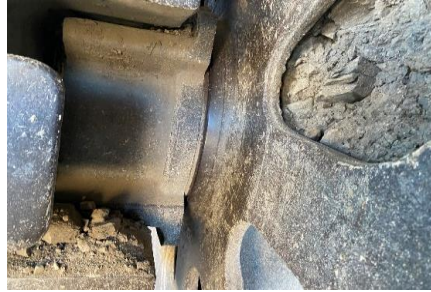
Figure 5 - Front idler condition LHS (left above) and RHS (right above)

| Front Idlers | <p>Both front idlers appeared to be in serviceable condition following the visual inspection. The roller paths were in good condition and there was no evidence of lubricant leakage. The alignment between the idler wheel and the end blocks was suitable, indicating good condition of the axle and bushes. Side frame clearances were appropriate. Figure 5 shows their condition.</p> |

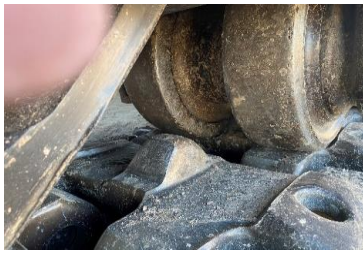
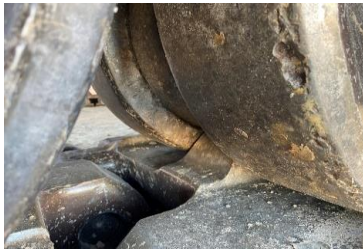
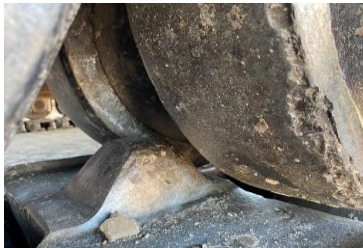
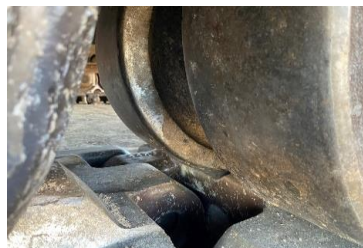
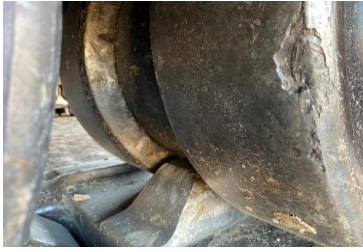
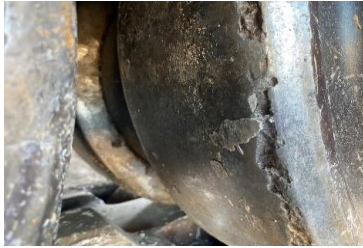
Figure 6 - LHS & RHS Rollers

| Load Rollers | <p>Load rollers were in a serviceable condition but have shards of steel missing from both sides of the roller indicating the hardened steel surface is starting to wear through and this will increase the wear rate moving forward an increased inspection should be scheduled.</p> |
