## **INSPECTION REPORT NO. M23-8959**

**MACHINE IDENTIFICATION:** **Hitachi EX3600 Excavator EX0043**

**SUBJECT:** Inspection and non-destructive testing of Hitachi EX3600 excavator EX0043 at Broadlea Coal Mine.

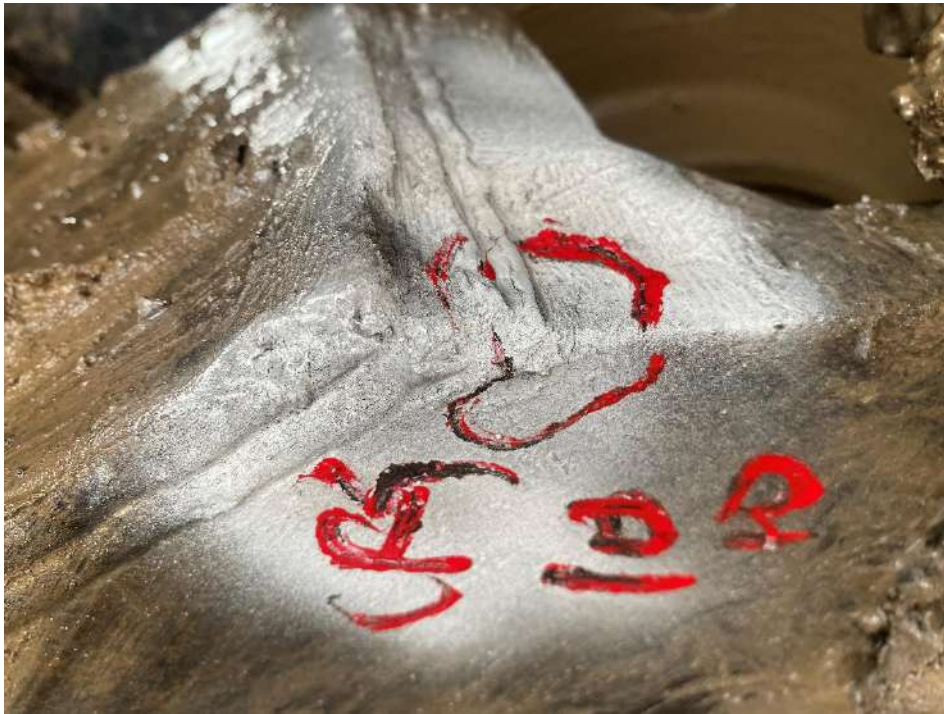
DEFECT NO. A7

Defect No.	Location	Defect Details		Figure No.	Previous Length (M22-830)
		Type	Length (Mm) / Description		
A7	Side Frame - Left Hand Side	Crack	10 & 10	A1	10 & 10
A8	Side Frame - Left Hand Side	Cracks	Repaired	A1	35
A9	Side Frame - Left Hand Side	Cracks	Repaired	A1	40
B1	Slew Internal	Crack	Repaired	B1	50
B2	Slew Internal	Crack	10	B1	-
B3	Slew Internal	Crack	420	B1	-
B4	Slew Internal	Crack	40+	B1	-
B8	Track Frame	Crack	20	B1	30 & 80
B9	Track Frame Slew	Crack	Not Inspected	B1	42, 5, 5 & 10
B11	Track Frame Slew	Crack	Repaired	B1	10, 10 & 10
B12	Track Frame Slew	Crack	Not Inspected	B1	20 & 22
B15	Track Frame	Cracks	Repaired	B1	35 & 130
B19	Slew Internal	Crack	Repaired	B1	170
B20	Track Frame	Crack	Repaired	B1	195
B21	Track Frame	Crack	Repaired	B1	200
B22	Track Frame	Crack	Repaired	B1	20
B23	Track Frame	Missing Bolt	Repaired	B1	-
B24	Track Frame	Missing Bolt	Repaired	B1	-
B25	Slew Internal	Crack	Repaired	B1	-

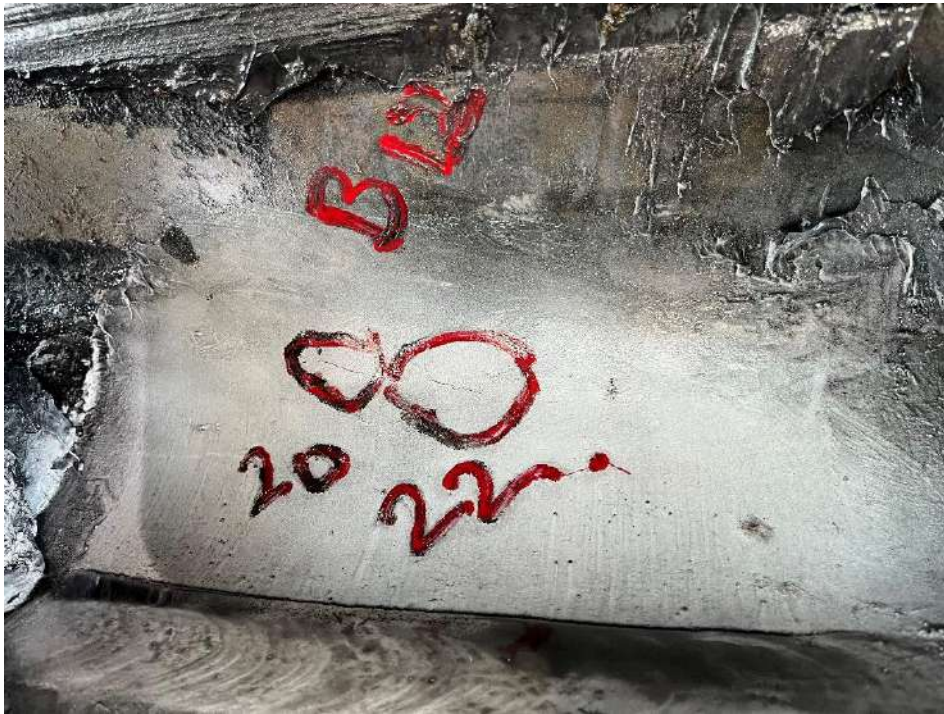
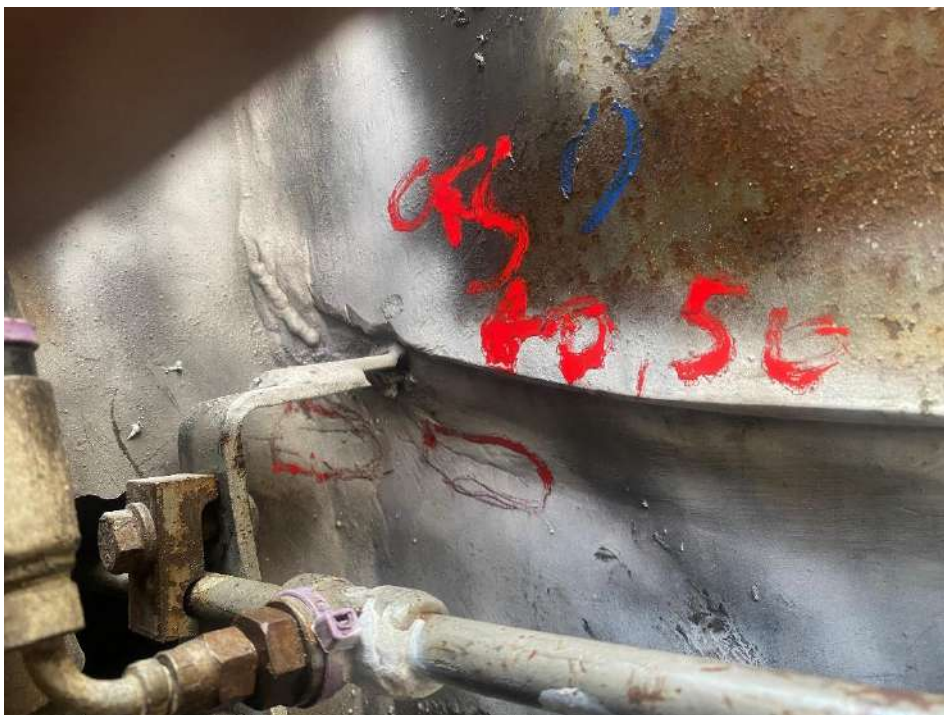
DEFECT NO. C1

Defect No.	Location	Defect Details		Figure No.	Previous Length (M23-8300)
		Type	Length (mm) / Description		
C1	Left Hand Side Inboard	Cracks	20 & 50	C1	85
C2	Hydraulic Bracket	Crack	60	C1	15+
C3	External Left Hand Outboard Side	Crack & Missing Bolts	20	C1	20
C4	External Right Hand Outboard Side	Crack	45	C1	45
C6	Main Frame Right Hand Outboard Side	Crack	40	C2	80
C7	Main Frame Right Hand Outboard Side	Crack	Repaired	C2	90
C8	Main Frame Left Hand Inboard Side	Cracks	Repaired	C1	380
C9	Main Frame Right Hand Outboard Side	Crack	20	C2	100
C10	Main Frame Right Hand Outboard Side	Crack	520	C1	520
C11	Front Middle Outboard	Crack	Not Inspected	C1	25
C12	External Left Hand Outboard Side	Cracks	15 & 20	C1	-
C13	Center of Main Frame	Crack	30	C2	-
C14	Main Frame Right Hand Outboard Side	Crack	30	C2	-
C15	Main Frame Right Hand Outboard Side	Crack	10	C2	-
D2	Boom - Left Hand Side	Cracks	Not Inspected	D1	15 & 30
D3	Boom - Left Hand Side Outboard	Crack	30	D1	-

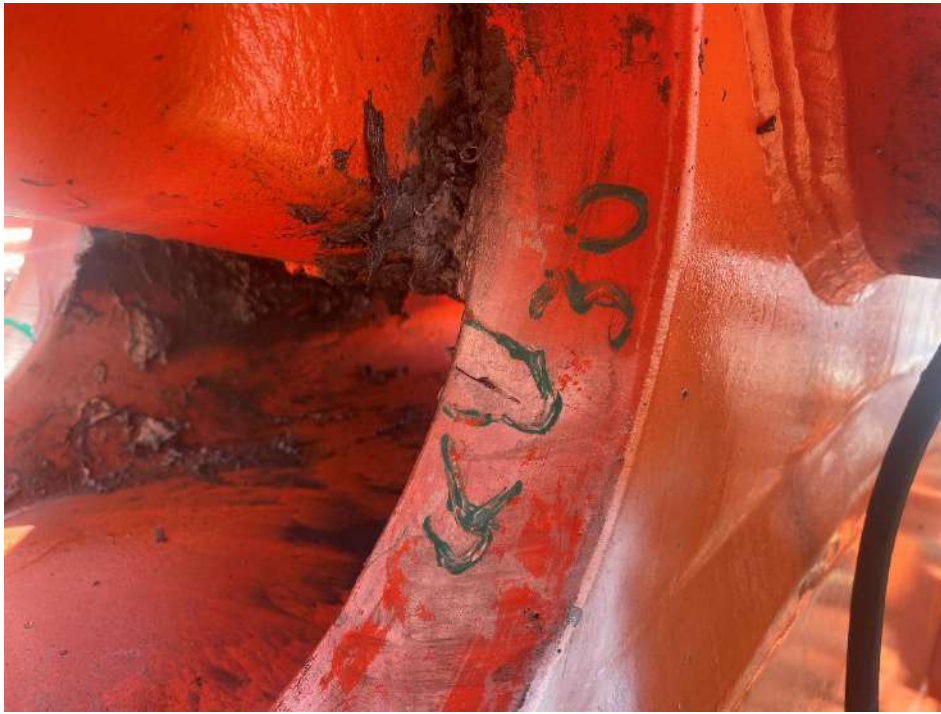
DEFECT NO. D4

D4	Boom - Left Hand Side Inboard	Crack	70+	D1	-
D5	Boom - Right Hand Side	Missing Clamp & Cracks	Repaired	D2	120 & 140
D6	Boom - Right Hand Side	Crack	Repaired	D2	85
D7	Boom - Left Hand Side Outboard	Crack	15	D2	-
D8	Boom - Left Hand Side Inboard	Crack	70	D2	-
D9	Boom - Left Hand Side	Missing / Loose Bolt	-	D1	-
D10	Boom - Left Hand Side	Broken	-	D1	-
D11	Boom - Left Hand Side	Cylinder Wearing on Boom	-	D1	-

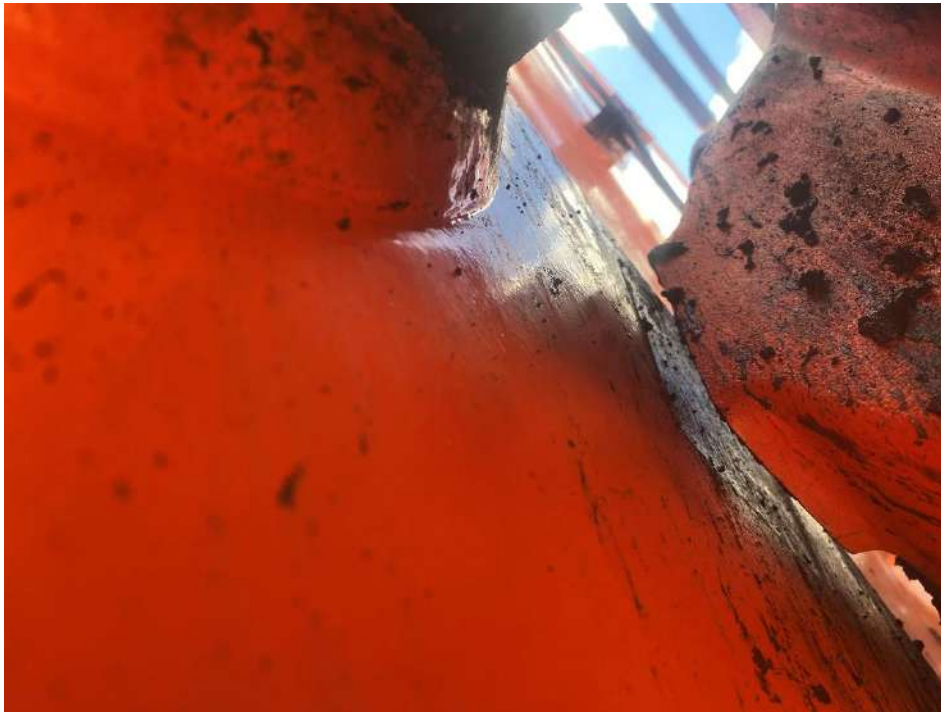
DEFECT NO. F2

Defect No.	Location	Defect Details		Figure No.	Previous Length (M22-8300)
		Type	Length (mm) / Description		
E1	Boom Left Hand Side - Internal	Crack	Not Inspected	D1	25mm Deep 100mm Long
F2	Stick	Cracks	50 & 55	F1	Repaired
F16	Stick - Left Hand Side - External	Crack	Repaired	F1	-
G1	Stick - Right Hand Side - Internal	Crack	Not Inspected	F1	150mm long 25mm deep
G2	Stick - Right Hand Side - Internal	Crack	Not Inspected	F1	50mm long 34mm deep
G3	Stick - Right Hand Side - Internal	Crack	Not Inspected	F1	80mm long 35mm deep
H1	Bucket - Outboard Right Hand Side	Cracks	Not Inspected	H4	10, 10 & 35
H2	Bucket - Outboard Left Hand Side	Crack	Not Inspected	H4	10 & 10
H3	Bucket - Front plate	Cracks	Not Inspected	H4	Repaired
H4	Bucket - Underside Right Hand Side	Crack	Not Inspected	H1	60
H5	Bucket - Underside Left Hand Side	Crack	Not Inspected	H1	110
H6	Bucket - Underside Left Hand Side	Crack	Not Inspected	H1	100
H7	Bucket - Inboard Right Hand Side	Crack	Not Inspected	H3	80

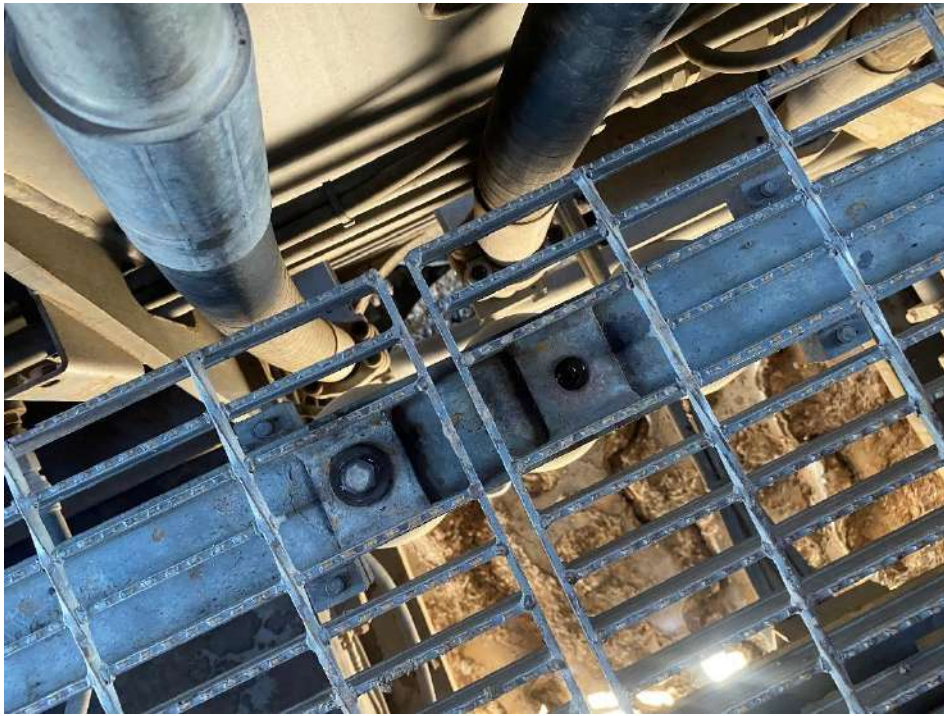
DEFECT NO. J5

Defect No.	Location	Defect Details		Figure No.	Previous Length (M22-8300)
		Type	Length (mm) / Description		
H18	Bucket - Underside Floor	Crack	Not Inspected	H4	300
H19	Bucket - Lip	Cracks	Not Inspected	H2	30 & 20
H20	Bucket - Lip	Crack	Not Inspected	H2	20
H21	Bucket - Lip	Cracks	Not Inspected	H2	35 & 35
H22	Bucket - Lip	Cracks	Not Inspected	H2	10 & 10
H23	Bucket - Underside Floor	Cracks	Not Inspected	H4	10 & 20
H24	Bucket - Right Hand Inboard Side	Cracks	Not Inspected	H2	100 & 90
H25	Bucket - Left Hand Inboard Side	Cracks	Not Inspected	H2	50, 65, 20 & 45
H26	Bucket - Rear	Crack	Not Inspected	H1	32
I1	Bucket Link - Left Hand Side	Cracks	Not Inspected	I1	5, 5 & 5
J1	Engine House - Left Hand Side External	Mechanical Damage & Missing Bolt	-	-	-
J2	Engine House - Rear External	Corrosion	-	-	-
J3	Engine House - Rear External	Missing Bolt	-	-	-
J4	Engine House - Center Walkway	Missing Bolt	-	-	-
J5	Right Hand Side Walkway - Operators Cab	Missing Bolt	-	-	-

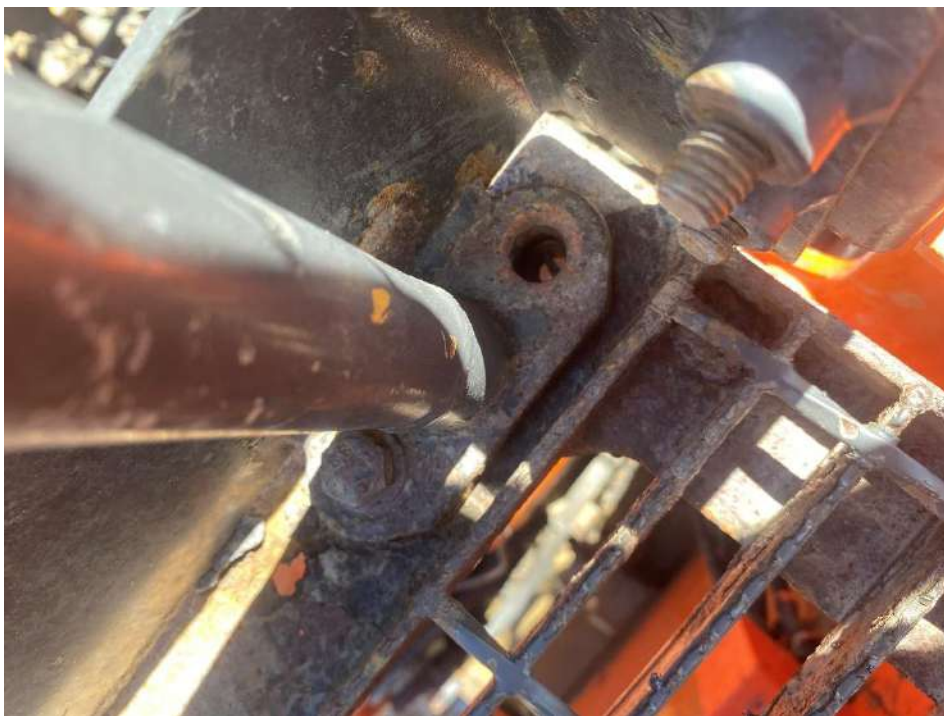
DEFECT NO. J6

J6	Fan House Roof	Crack	60	-	-
