INSPECTION REPORT NO. M23-9255

MACHINE IDENTIFICATION: **Hitachi EX3600 Excavator EX0043**

SUBJECT: Inspection and non-destructive testing of Hitachi EX3600 excavator EX0043 boom and stick at Broadlea Coal Mine.

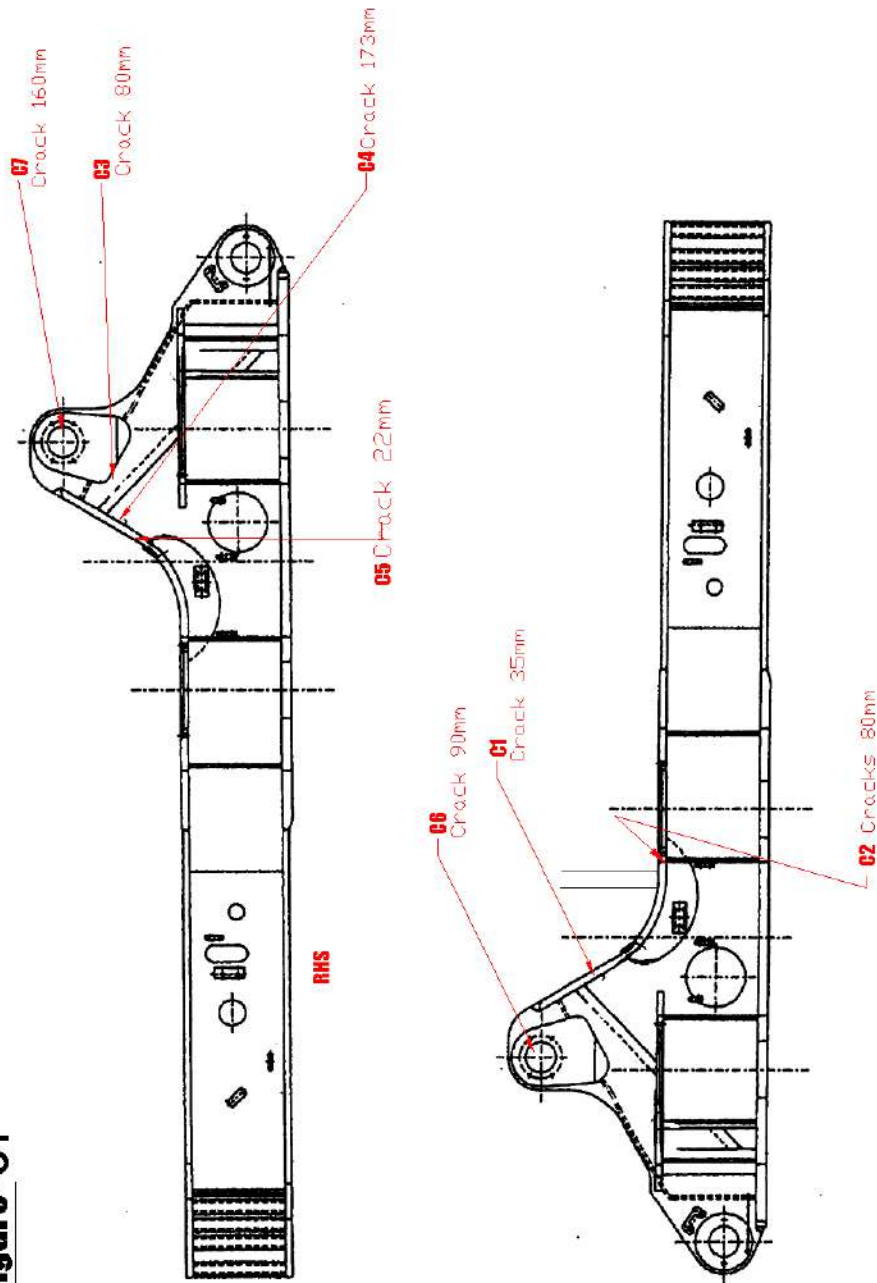
Figure-C1

Cracks detected. Refer to Defect Table for locations and lengths.

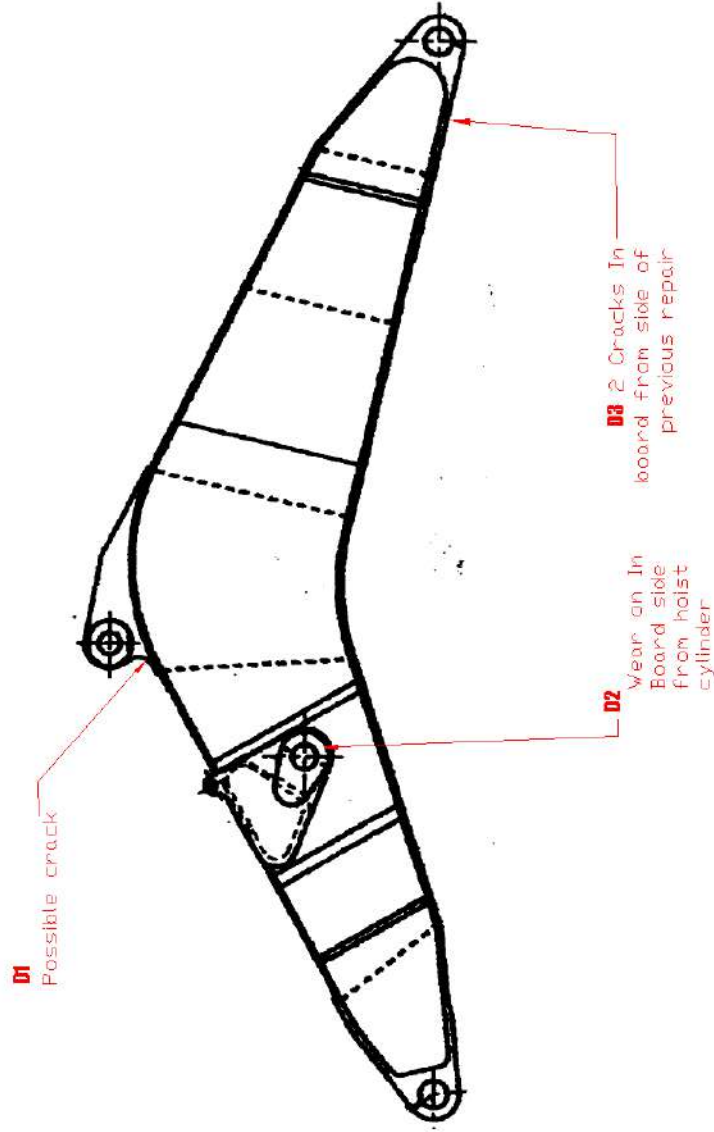
Figure- D1

Cracks detected. Refer to Defect Table for locations and lengths.

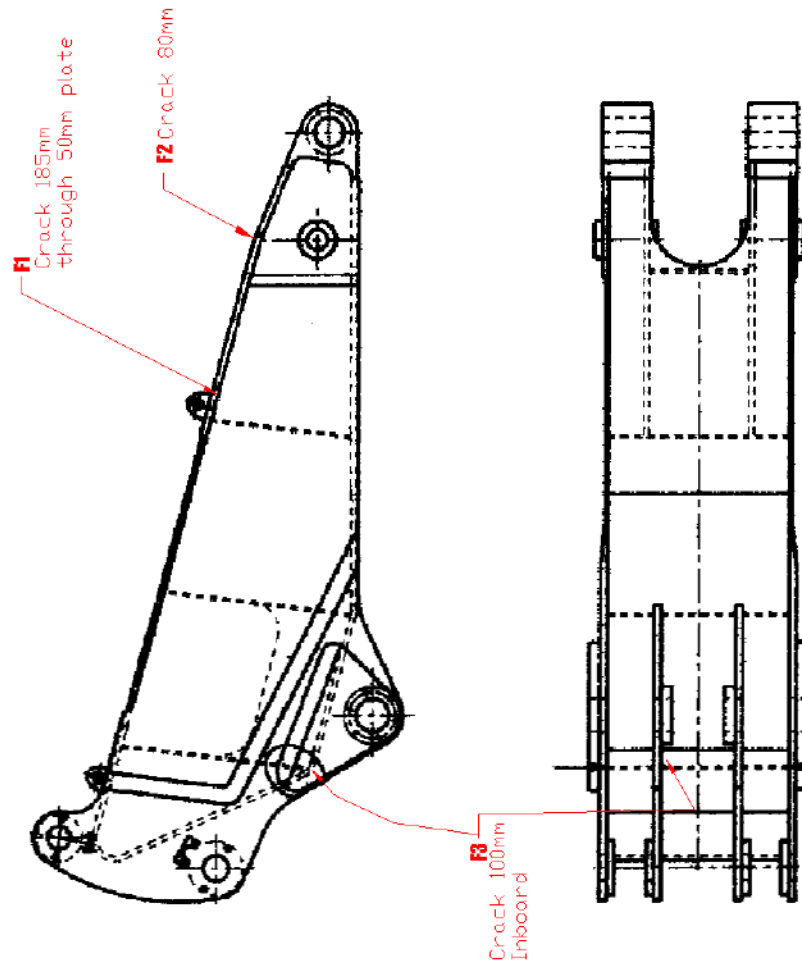
Figure- F1

Cracks detected. Refer to Defect Table for locations and lengths.
