Undercarriage Condition Report

Customer:	Minespec Parts
Site:	Nebo Yard
Machine ID:

Carried Out By:	S. Berge
Inspection Date:	18/09/2023
Issued To:	S. Ross

Make:	Hitachi
Model:	EX3600
Serial #:

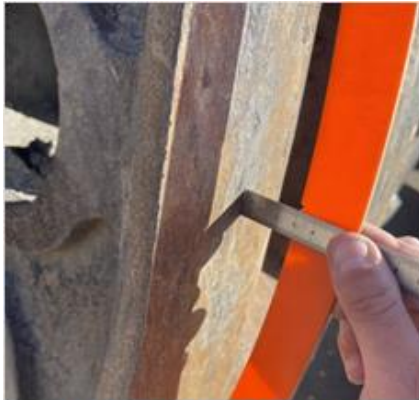
Left sprocket roller-path

- Left side sprocket roller paths are in reasonable condition at 56% worn.
- Left side sprocket drive lugs are in reasonable condition at 75% worn. These will be the limiting factor.

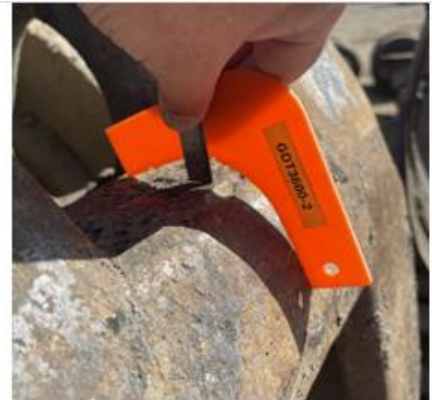
Right sprocket drive lug (driven)

- Right side sprocket roller paths are in good condition at 39% worn.
- Right side sprocket drive lugs are in good condition at 38% worn. These are expected to match the life of the roller paths.

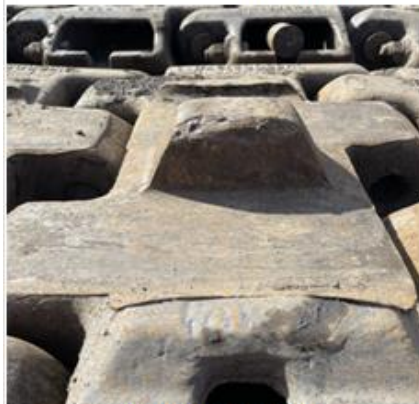
Shoe roller-path

- Track shoes are Bradken units.
- There is visible pin bore wear on the tracks. Measurements indicated these are at 46% worn, although when properly tensioned this measurement is expected to be higher. This is the likely limiting factor of shoe life.
- Track shoe roller paths are in good condition at 44% worn.
- Track shoe drive lugs are in good condition at 28% worn.
