# REPAIRER'S DATA REPORT

**JOB NUMBER: 27861**

**Description: REFURB EX5600 BOOM**

## STRUCTURAL INTEGRITY SURVEY REPORT FOR THE STRUCTURE REPORT NUMBER HMI 23-033.7

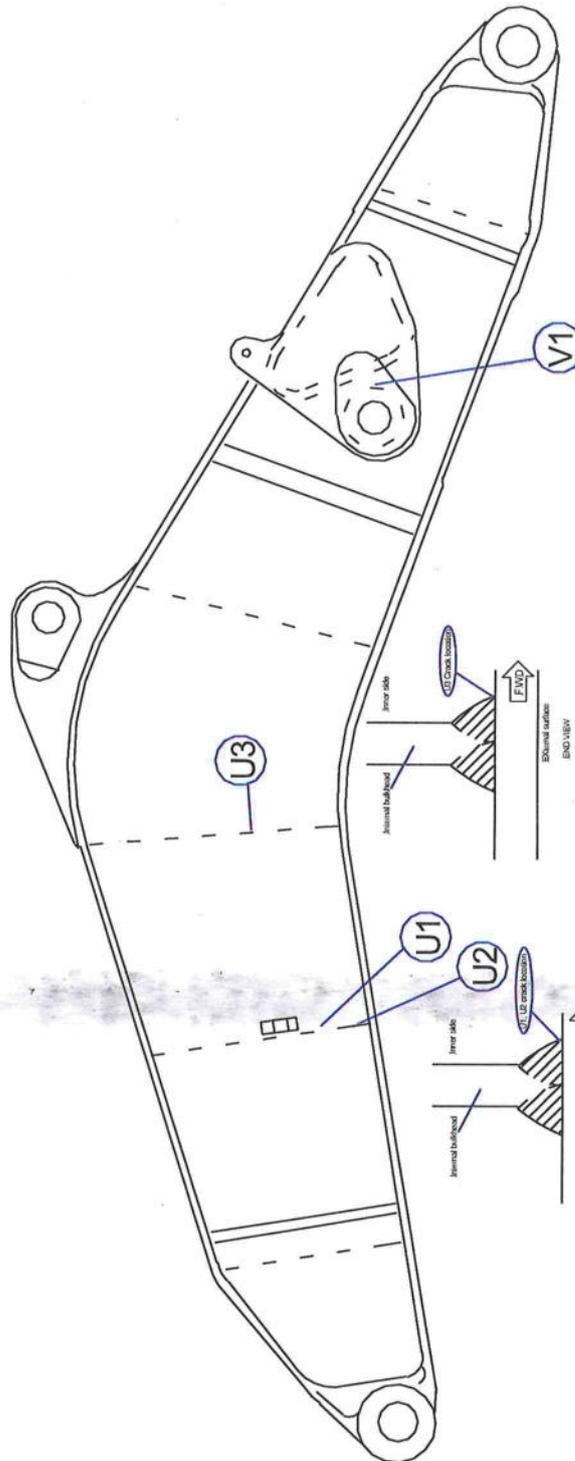
**Diagram 1**  
Schematic indicating crack locations in the right side of the boom

The survey identified four internal cracks by the ultrasonic method. Refer Results Table and Diagrams 1 and 2.

The survey identified six visual cracks by the visual and magnetic particle examination methods. Refer Diagrams 1, 2 and 3 and Images 1, 2, 3, 4, 5, 6 and 7.

BOOM ULTRASONIC EXAMINATION		
Crack	Details	Cat.
U1	60mm long starting at 415mm up from the underside- right side	1
U2	75mm long starting at 240mm up from the underside- right side	1
U3	450mm long starting at 350mm up from underside- right side	1
U4	1040mm long starting at 395mm up from underside- left side (refer V3)	3
BOOM VISUAL EXAMINATION		
Crack	Details	Cat.
V1	180mm long at forward side of lift mount pin boss- right side	1
V2	65mm long at lower corner weld- left side	1
V3	165mm long behind grease lines associated with U4- left side	3
V4	60mm long at rear of the access window weld- left side	1
V5	305mm long on left front extending down at front edge on left side- upper side	5
V6	230mm long on right front end- upper side	3
STICK ULTRASONIC EXAMINATION		
Crack	Details	Cat.
U5	60mm long starting at 400mm down from upper side- right side	1
U6	65mm long starting at 560mm up from underside surface- left side	1

The internal/visual crack, U4/V3 should be monitored continuously. Category 3. Criticality is high due to the internal length.

The internal cracks (U1, U2, U3, U5, U6 and U7 should be monitored. Category 1.

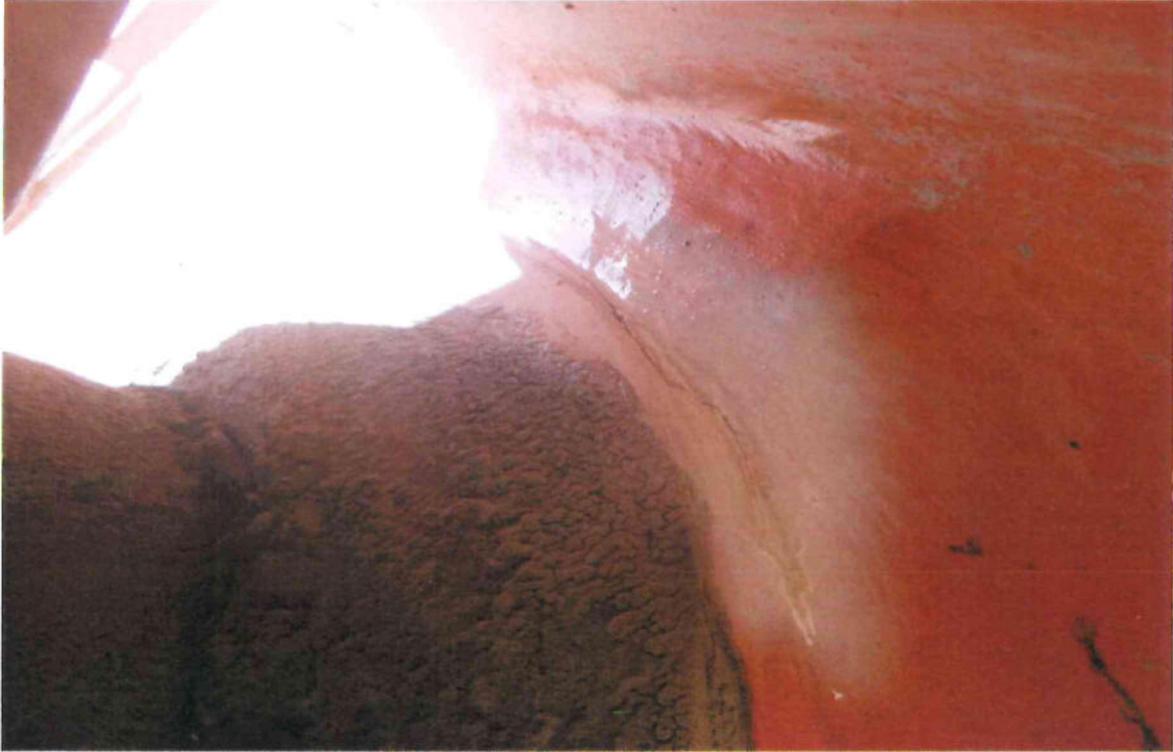
**Image 1**

Cracks V1, V2 and V4 could be repaired in the long term as they were considered as subcritical. Category 1.

View of crack V1 in right side in the pin boss weld at lift cylinder mount

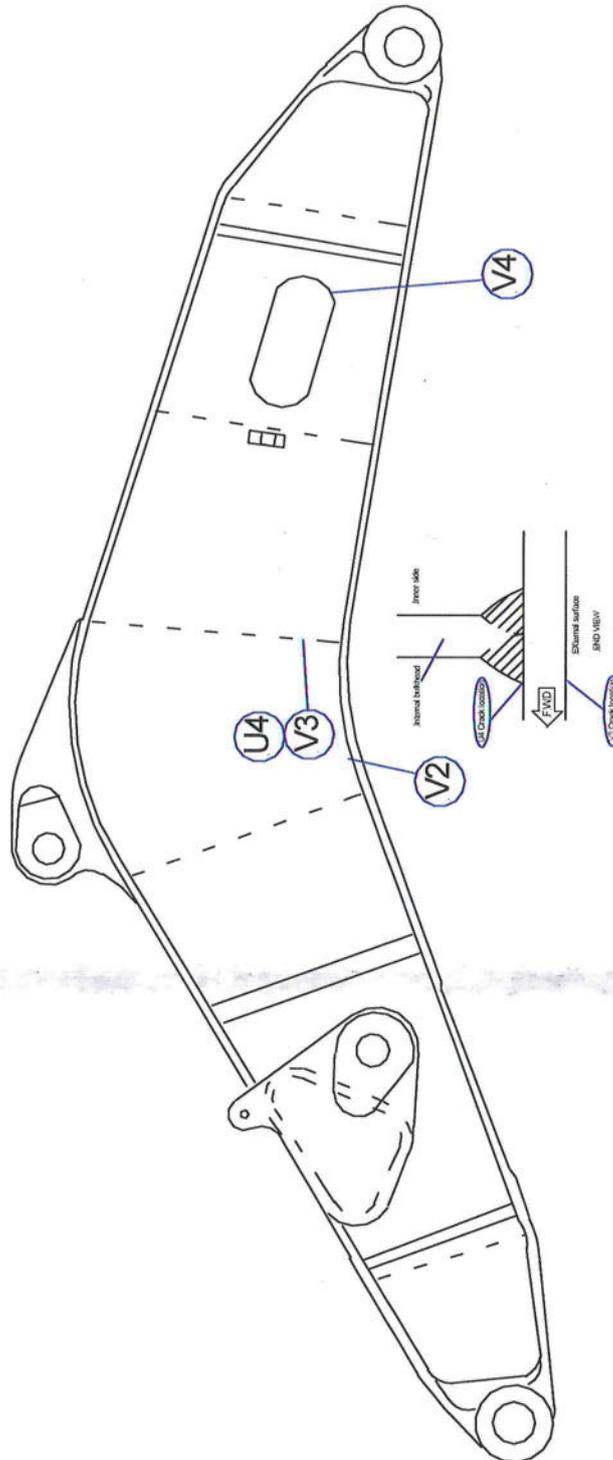
**Diagram 2**

Schematic indicating crack locations in the left side of the boom

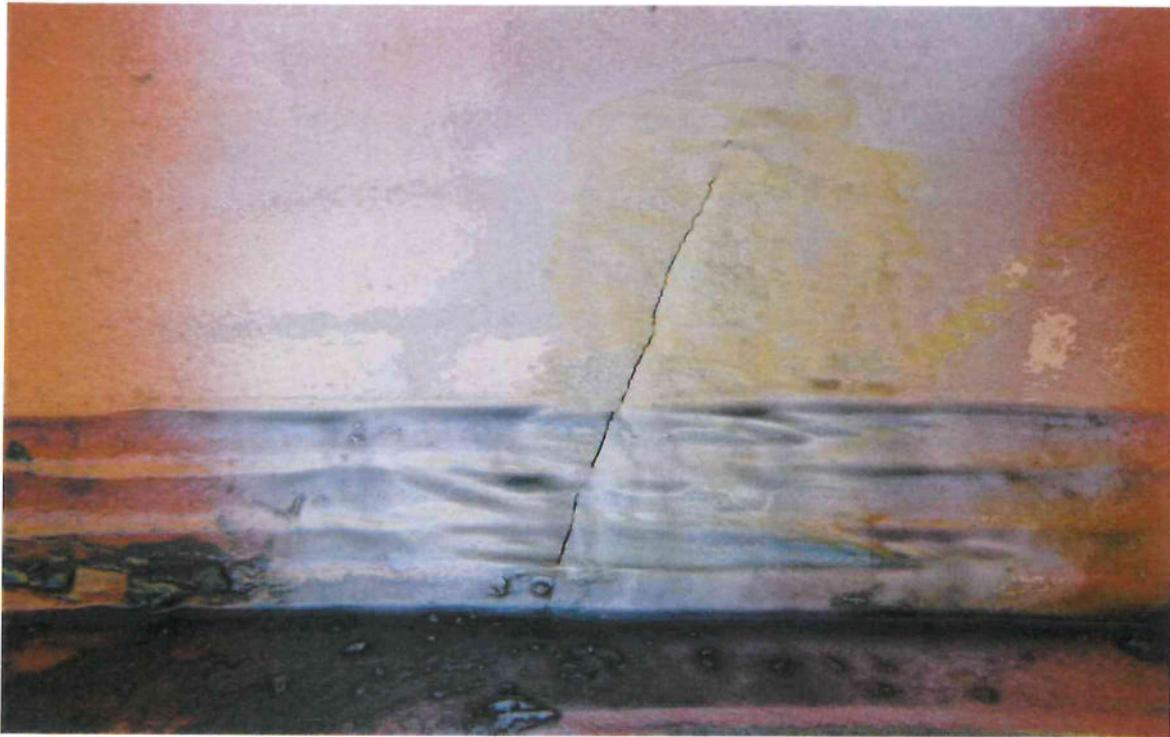
**Image 2**  
View of crack V2 in left side at the lower edge weld

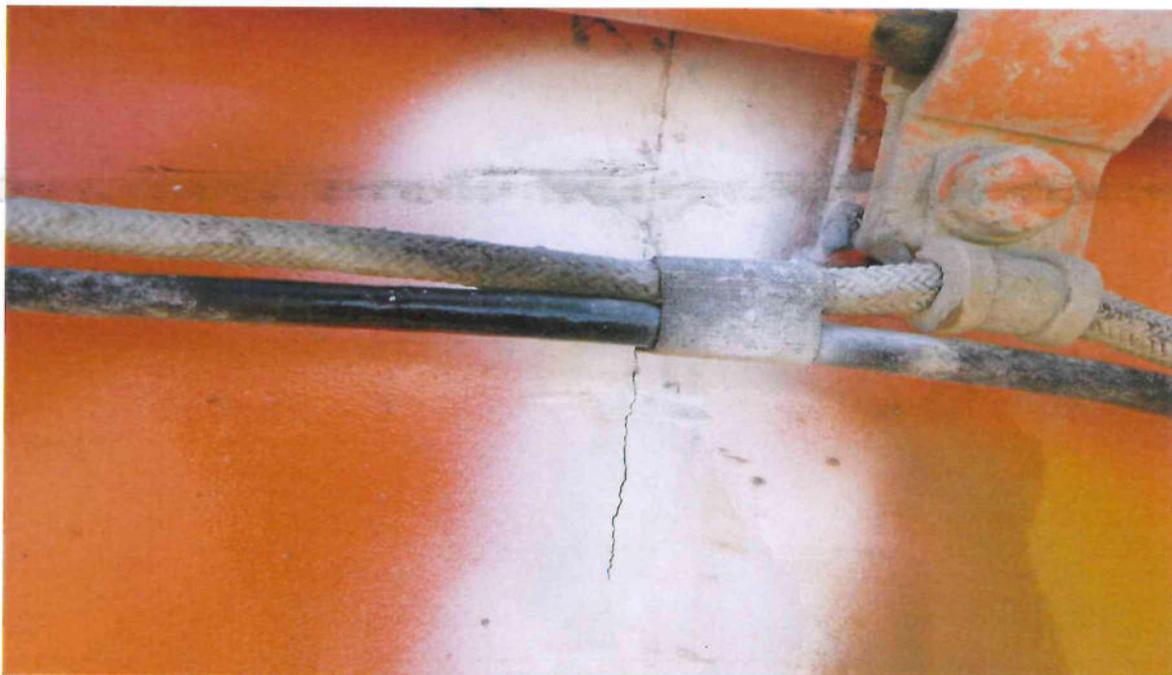
**Image 3**  
View of crack V3 in left side associated with the internal bulkhead at this location

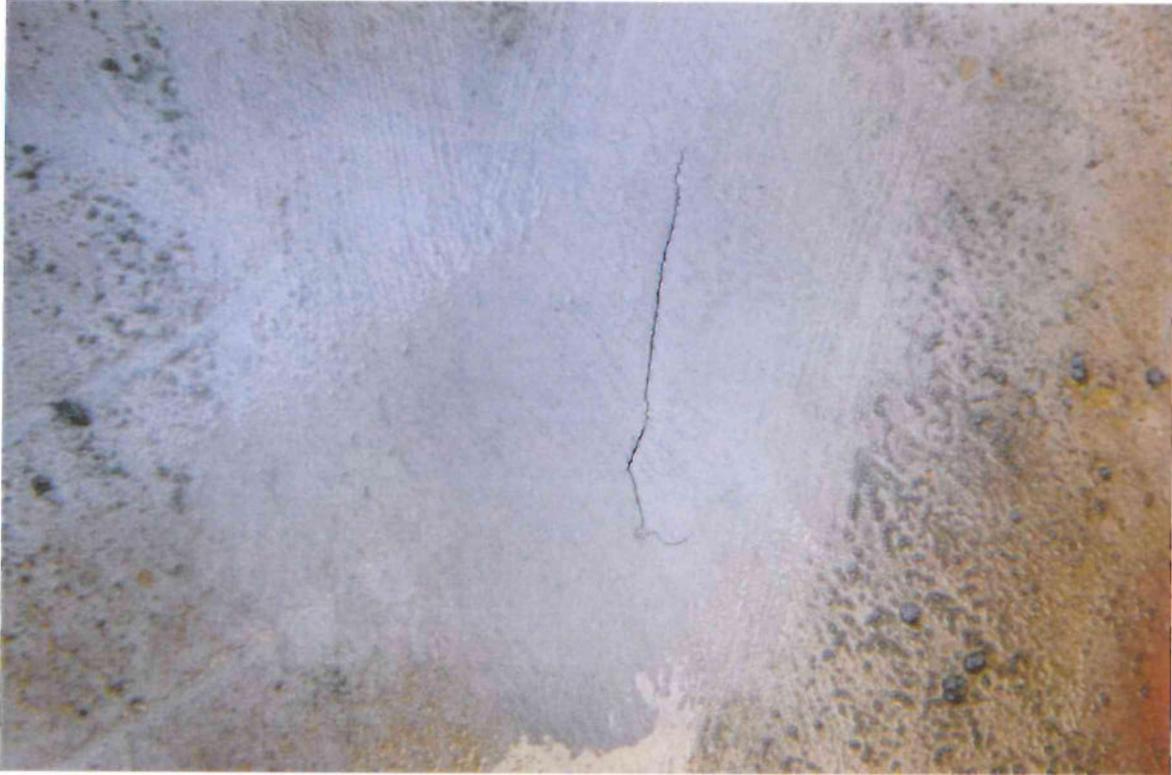
**Image 4**

View of crack V4 in left side associated with the access window weld adjacent to the operators' cabin

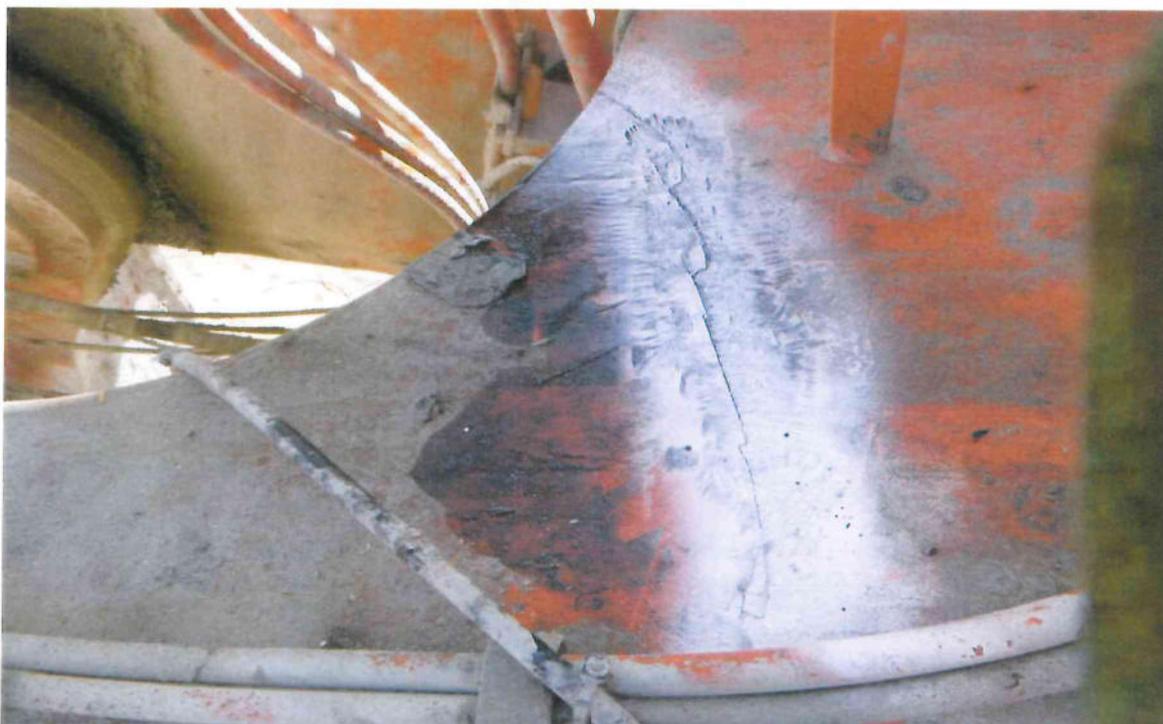
Crack V5 was categorised as 5 due to the extent of cracking.

**Image 5**  
View of crack V5 in upper left side at the front of the boom

Cracks V5 and V6 were repaired as a result of this inspection.

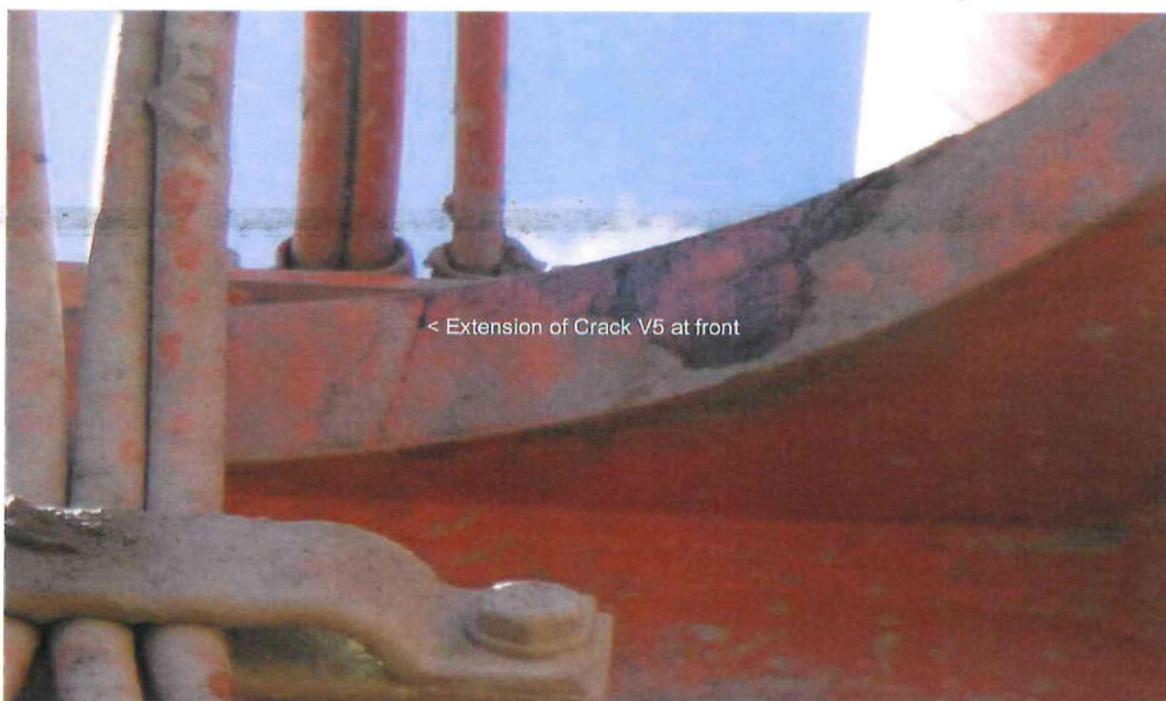
**Image 6**  
View of the extension of crack V5 in upper left side at the front of the boom

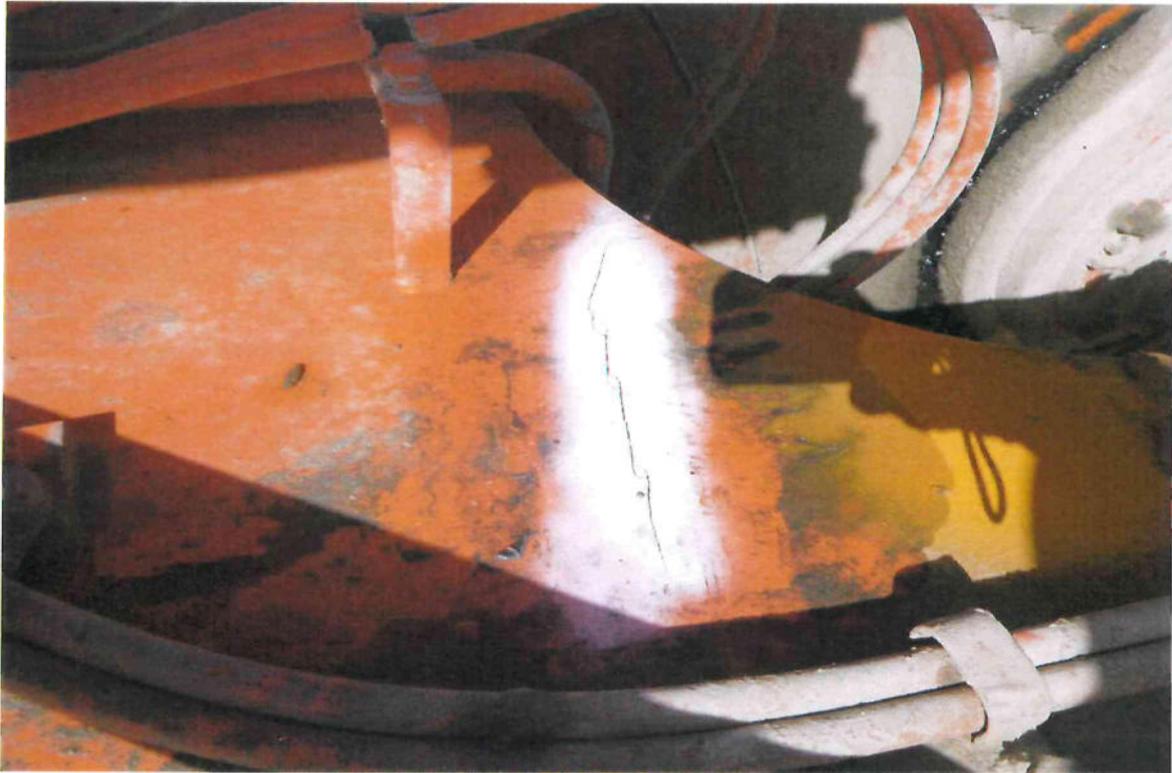
Crack V6 was categorised as 3 due to the extent of cracking.

**Image 7**  
View of crack V6 in upper right side at the front of the boom

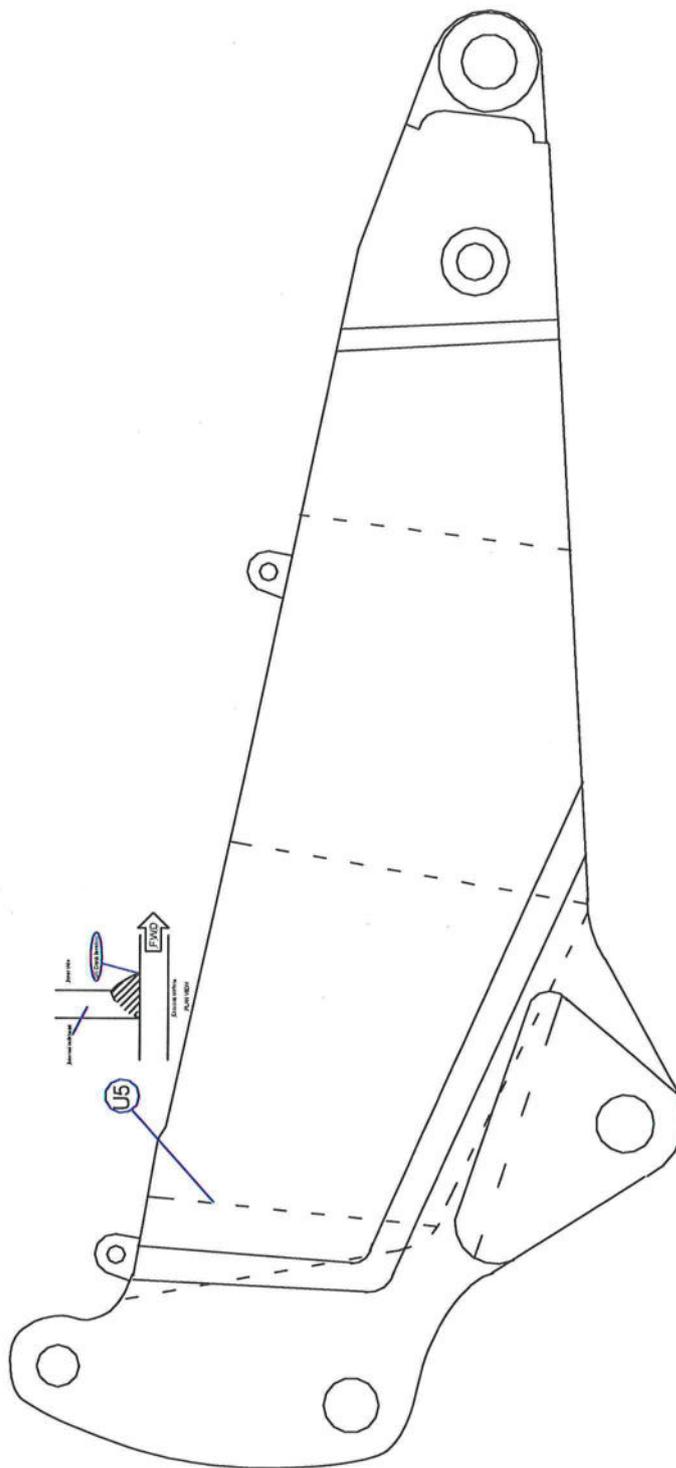
The survey identified three internal cracks by the ultrasonic method. Refer Results Table and Diagrams 4, 5 and 6.

**Diagram 4**  
Schematic indicating crack location in the right side of the stick

The internal cracks identified within the machine structure should be monitored. Category 1.

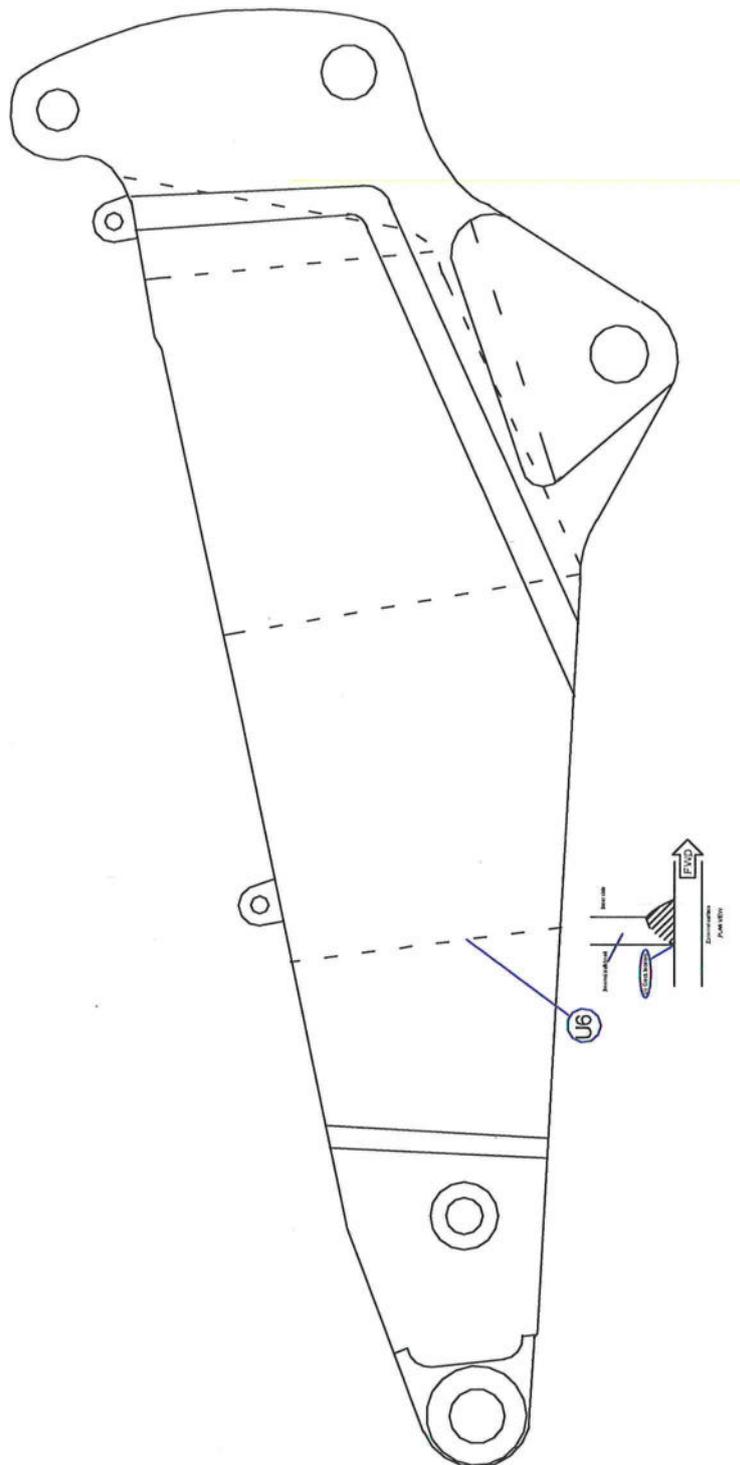
**Diagram 5**  
Schematic indicating crack location in the left side of the stick

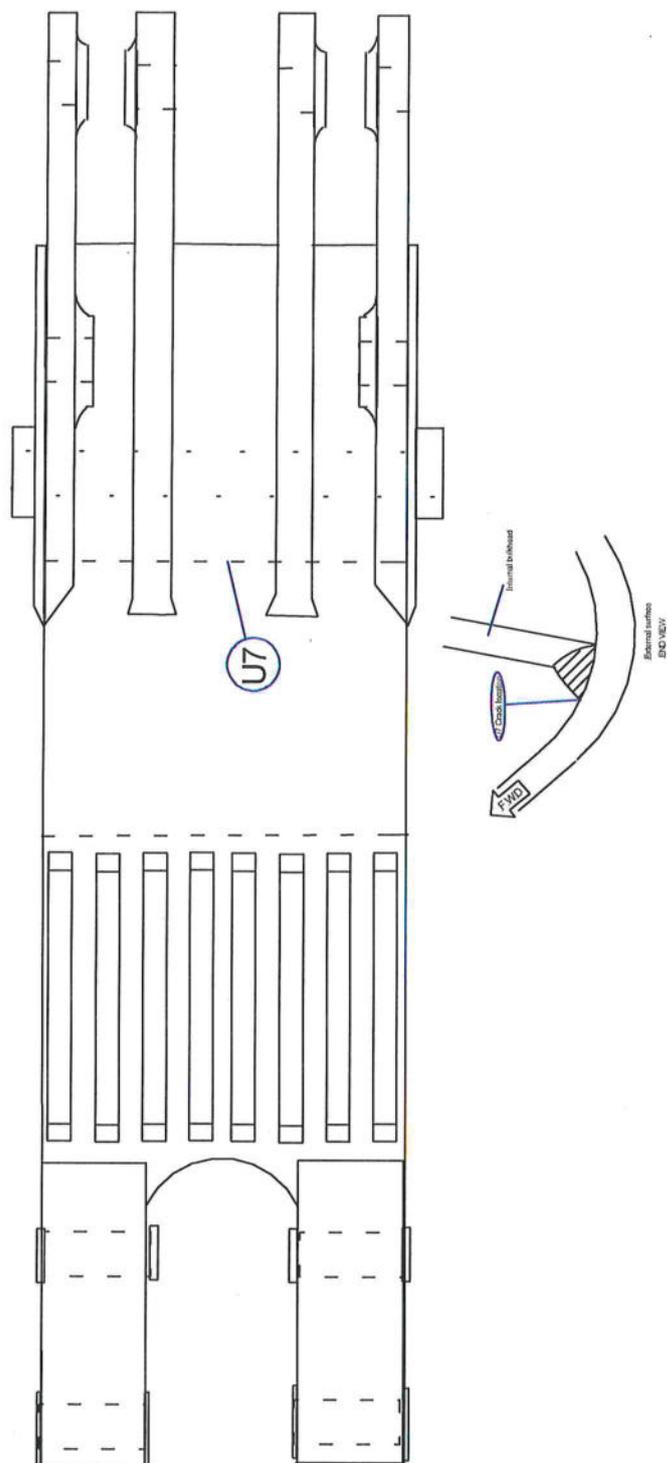
**Diagram 6**  
Schematic indicating crack location in the underside of the stick

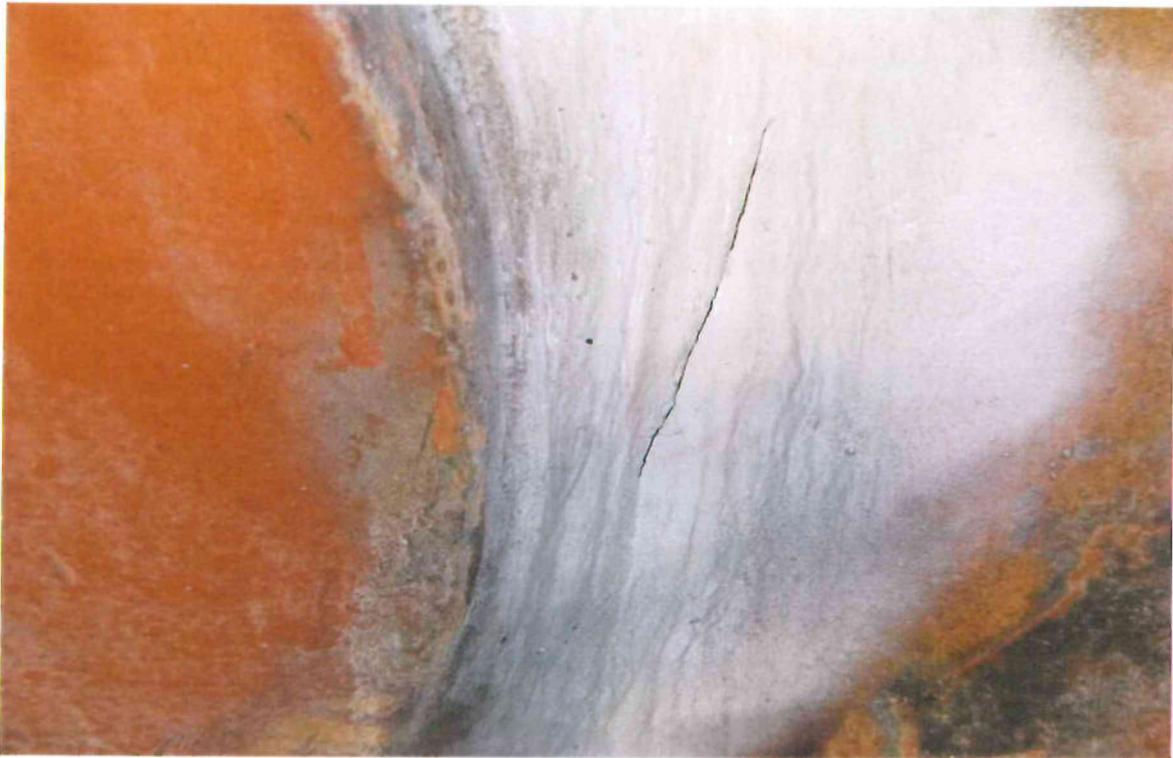
**Image 8**

The survey identified one visual crack, V7, by the visual and magnetic particle examination method. Refer Diagram 7 and Image 8.

View of crack V7 in right side at the main frame at the rear of the boom foot pin

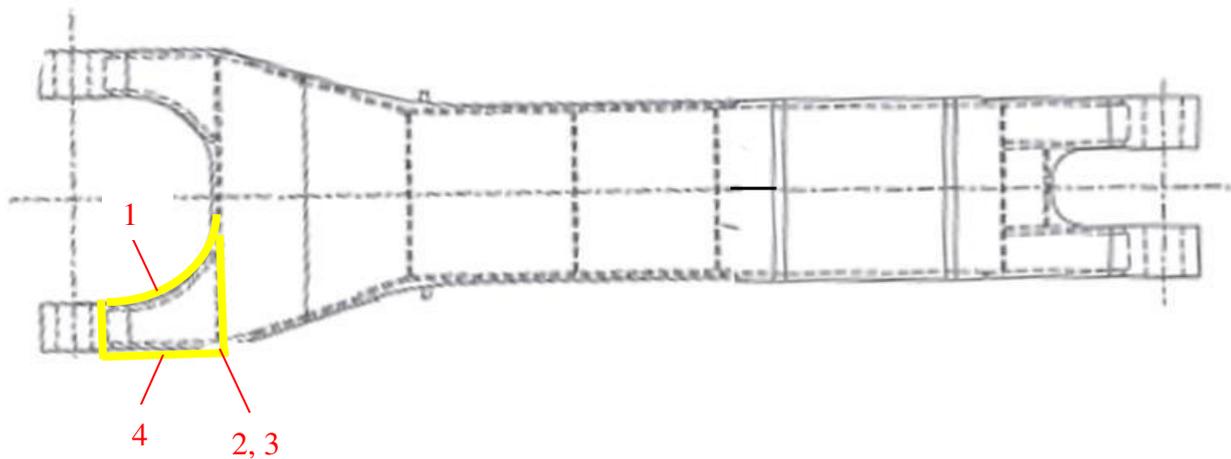
**FIGURE 5 – INTERNAL BAY #1:**

Defect No.	Length in mm	Defect No.	Length in mm
No. 1	360 BC	No. 3	10 SW
No. 2	1200 SW	No. 4	800, 750 TC

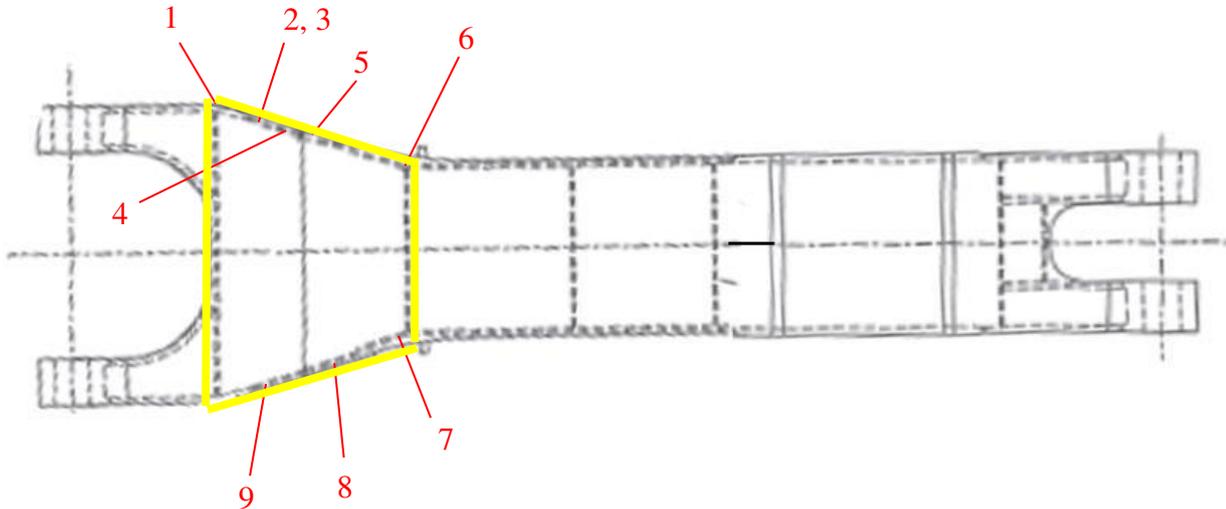
**FIGURE 6 – INTERNAL BAY #2:**

Defect No.	Length in mm	Defect No.	Length in mm
No. 1	1300 SW	No. 6	40, 10 TC
No. 2	10 MH	No. 7	650 SW
No. 3	10 MH	No. 8	1700 TC
No. 4	1700 BC	No. 9	1700 BC
No. 5	1700 TC

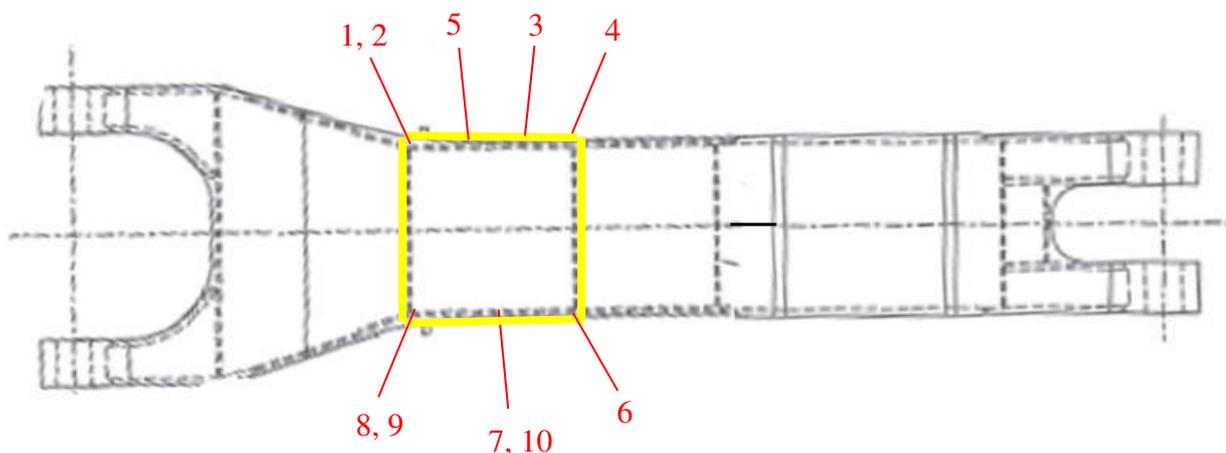
**FIGURE 7 – INTERNAL BAY #3:**

Defect No.	Length in mm	Defect No.	Length in mm
No. 1	500 SW	No. 6	1400 SW
No. 2	700 SW	No. 7	1500 TC
No. 3	1500 TC	No. 8	600 SW
No. 4	1400 SW	No. 9	600 SW
No. 5	1500 BC	No. 10	1500 BC

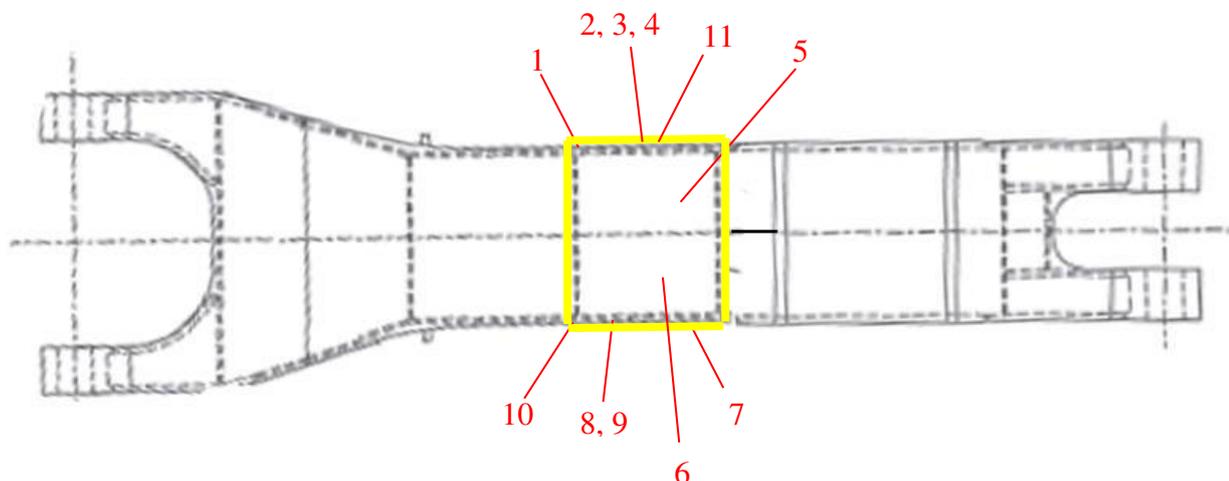
**FIGURE 8 – INTERNAL BAY #4:**

Defect No.	Length in mm	Defect No.	Length in mm
No. 1	1800 SW	No. 7	1000 SW
No. 2	50 TC	No. 8	50 TC
No. 3	1400 TC	No. 9	600 BC
No. 4	1500 BC	No. 10	1800 SW
No. 5	2800 TC/SW	No. 11	100 MH
No. 6	2800 TC/SW

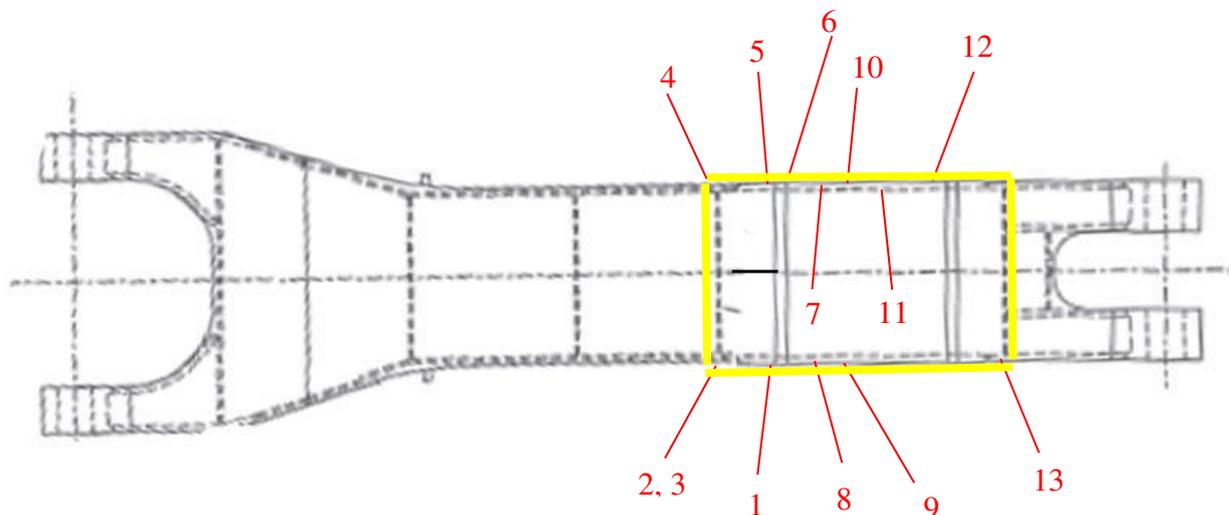
**FIGURE 9 – INTERNAL BAY #5:**

Defect No.	Length in mm	Defect No.	Length in mm
No. 1	600 TC	No. 8	2200 TT/SW
No. 2	400 SW	No. 9	3600 BC
No. 3	200 SW	No. 10	3600 BC
No. 4	150 SW	No. 11	1100 TC
No. 5	600 TC	No. 12	300 TC
No. 6	200 TT	No. 13	300 TC
No. 7	1000 TT/SW

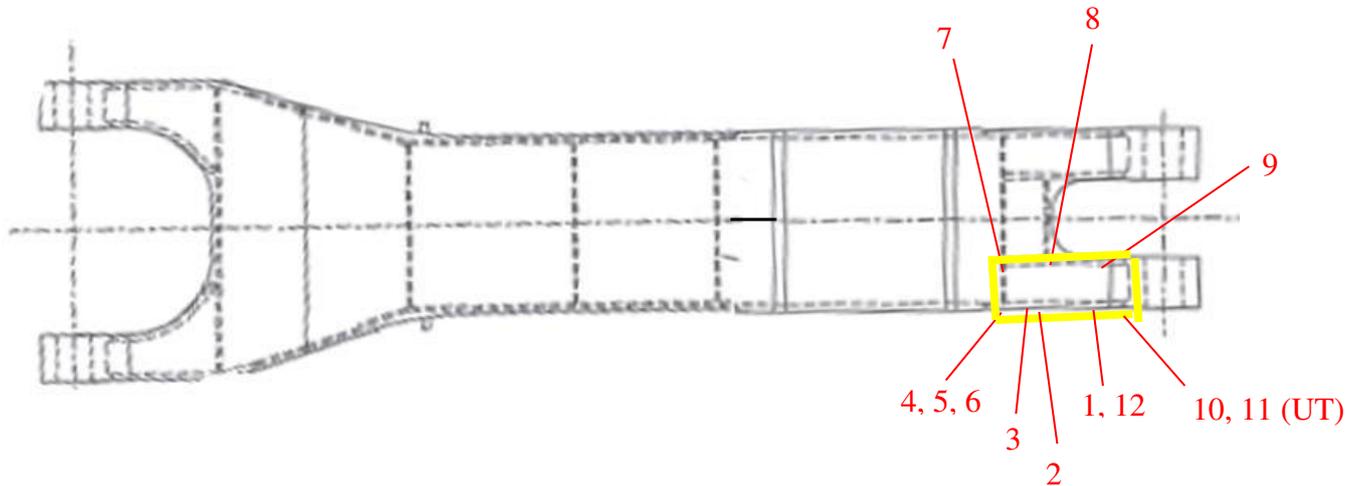
**FIGURE 10 – INTERNAL BAY #6:**

Defect No.	Length in mm	Defect No.	Length in mm
No. 1	370 BC	No. 7	360 TC
No. 2	130 MH	No. 8	80 TC
No. 3	140 SW	No. 9	60 TC
No. 4	90 SW	No. 10	120 MH
No. 5	220 MH	No. 11	170 TC
No. 6	30 SW	No. 12	70, 60 TC

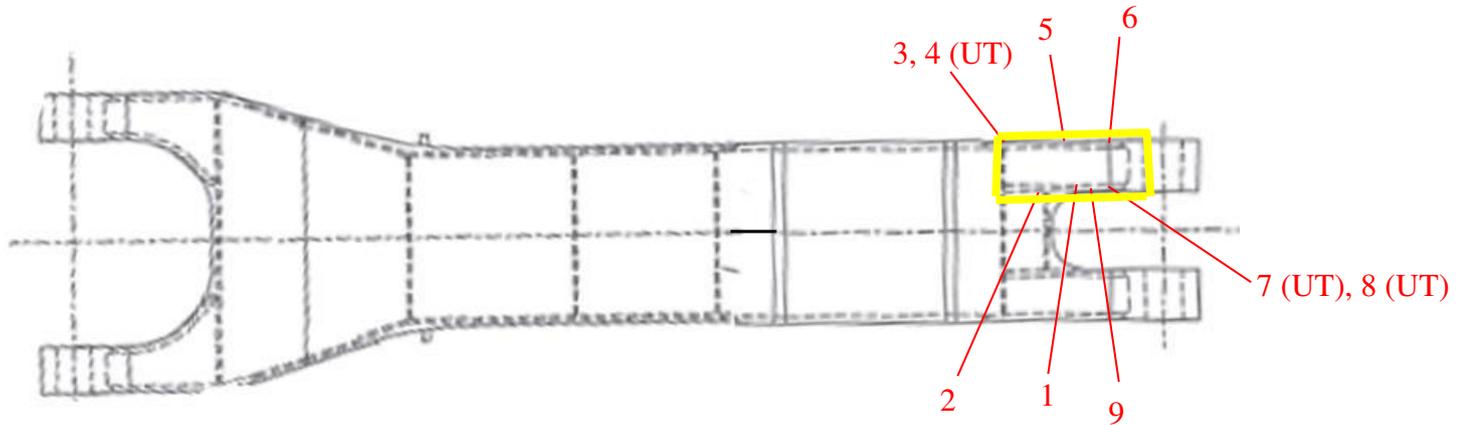
**FIGURE 11 – INTERNAL BAY #7:**

Internal Boom Bay #7 Job No. 27861 <i>100% Inspection of Prepared Welds</i>	➤ Cracking Evident - Refer to Figures 11 & Table 8.0 for Results
Internal Boom Bay #8 Job No. 27861 <i>100% Inspection of Prepared Welds</i>	➤ Cracking Evident - Refer to Figures 12 & Table 9.0 for Results

Defect No.	Length in mm	Defect No.	Length in mm
No. 1	150 BC	No. 6	530 SW
No. 2	190 BC	No. 7	1200 SW
No. 3	1150 SW	No. 8	170 TC
No. 4	250 TC	No. 9	720 TC
No. 5	350 MH

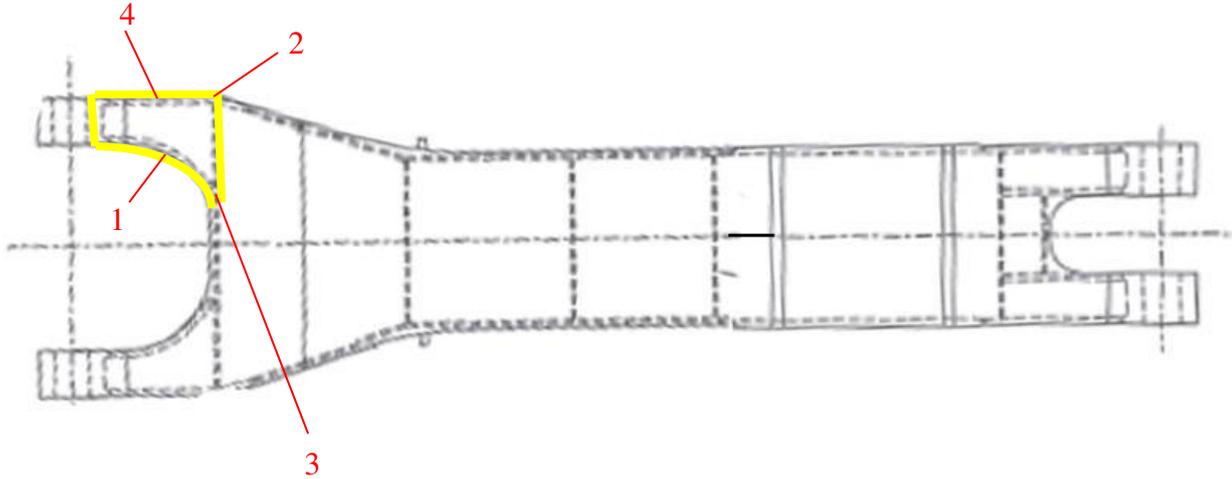
**RESULTS OF EXAMINATION CONTINUED****FIGURE 12 – INTERNAL BAY #8:**

Defect No.	Length in mm	Defect No.	Length in mm
No. 1	350 BC	No. 3	40 TC
No. 2	650, 1100 SW	No. 4	750 TC
