UNIT 390 HITACHI EX5500 LOADER

Walkthrough inspections

Job Number: 2687871-1

VISUAL INSPECTION TEST REPORT

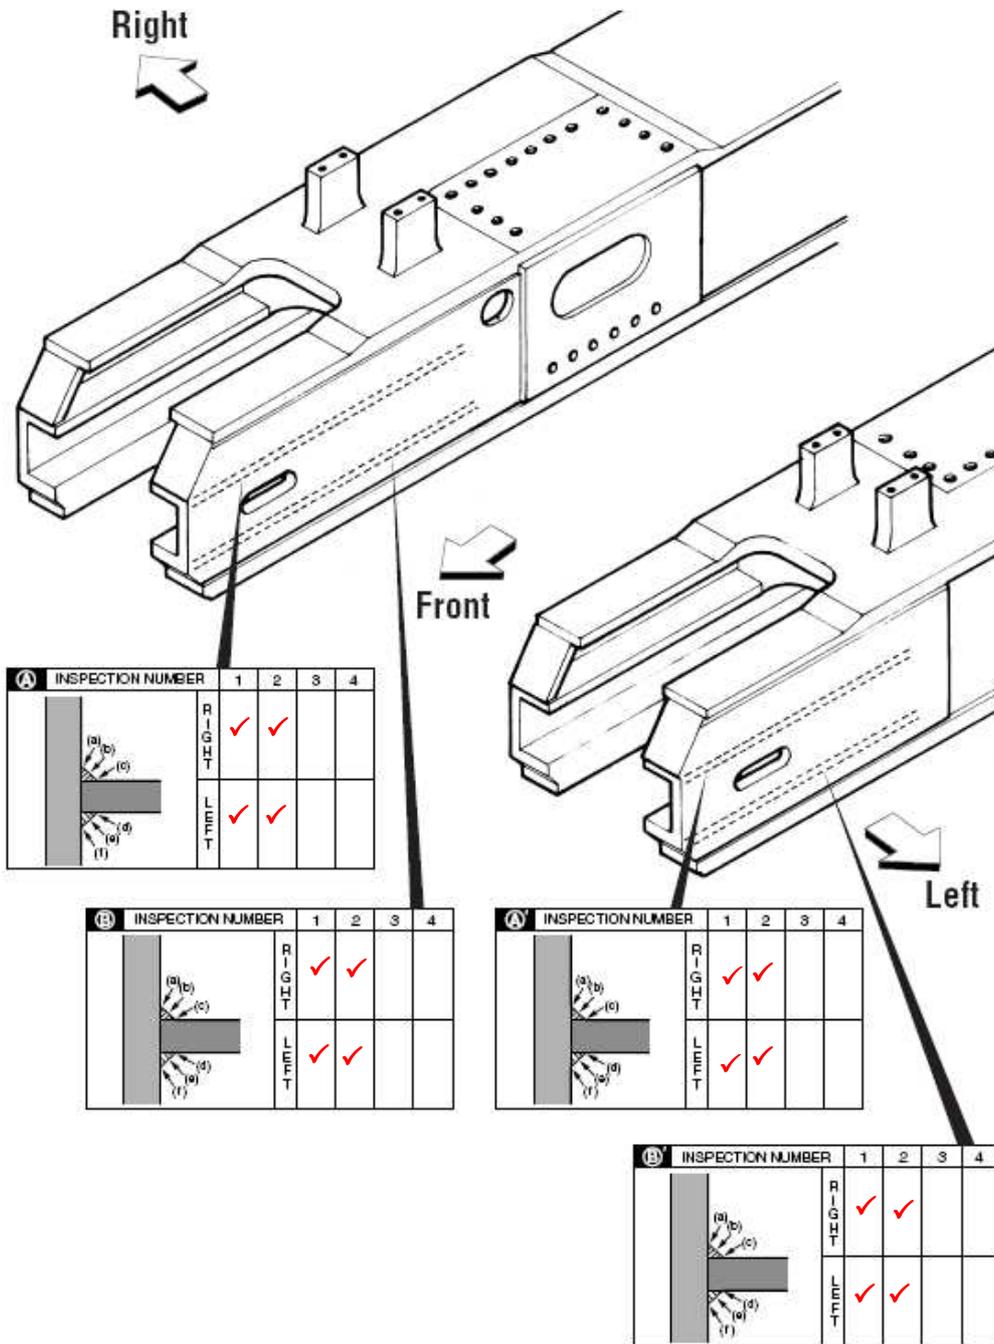
Diagram 2A

- **Track frame –** **Cracking detected**, See diagram 1A
- **Side Frames –** **No cracking detected**, See diagram 2A
- **Mainframe –** **No Cracking detected**, See diagram 3A-C
- **Boom –** **No cracking detected**, See diagram 4A-E
(Rams have damage see page 23 for details)
- **Stick –** **No cracking detected**, See diagram 5A-D
