INSPECTION REPORT

UNDERCARRIAGE WEAR

| Site Visit / Machine Summary | |
|---|---|
| Machine ID | 5491 |
| Machine Model | EX5500 |

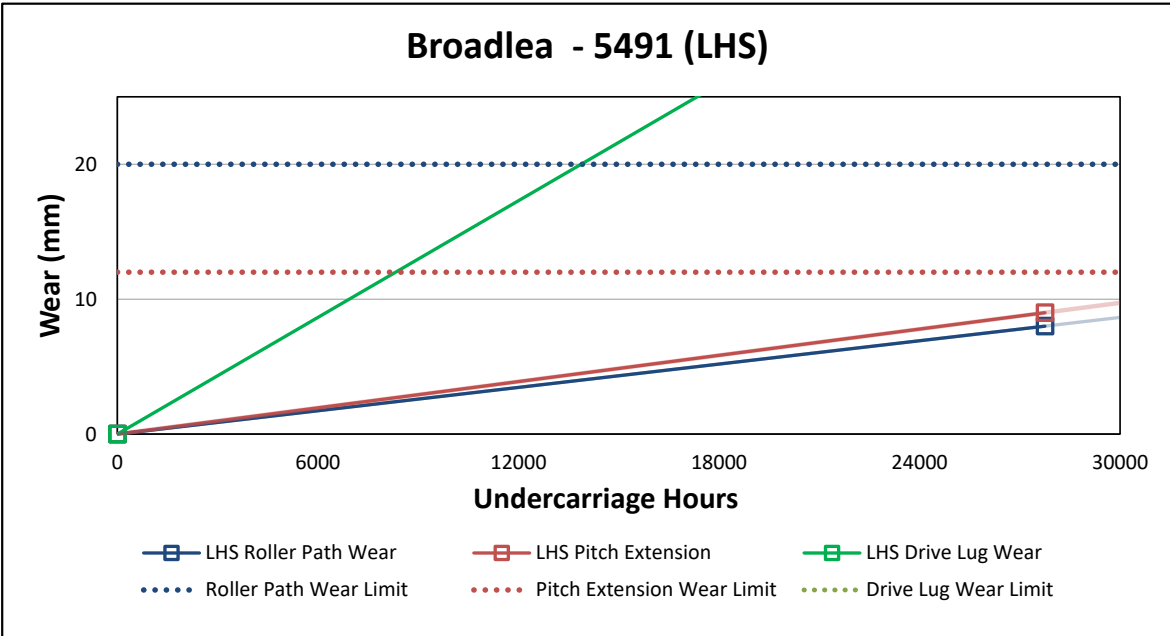
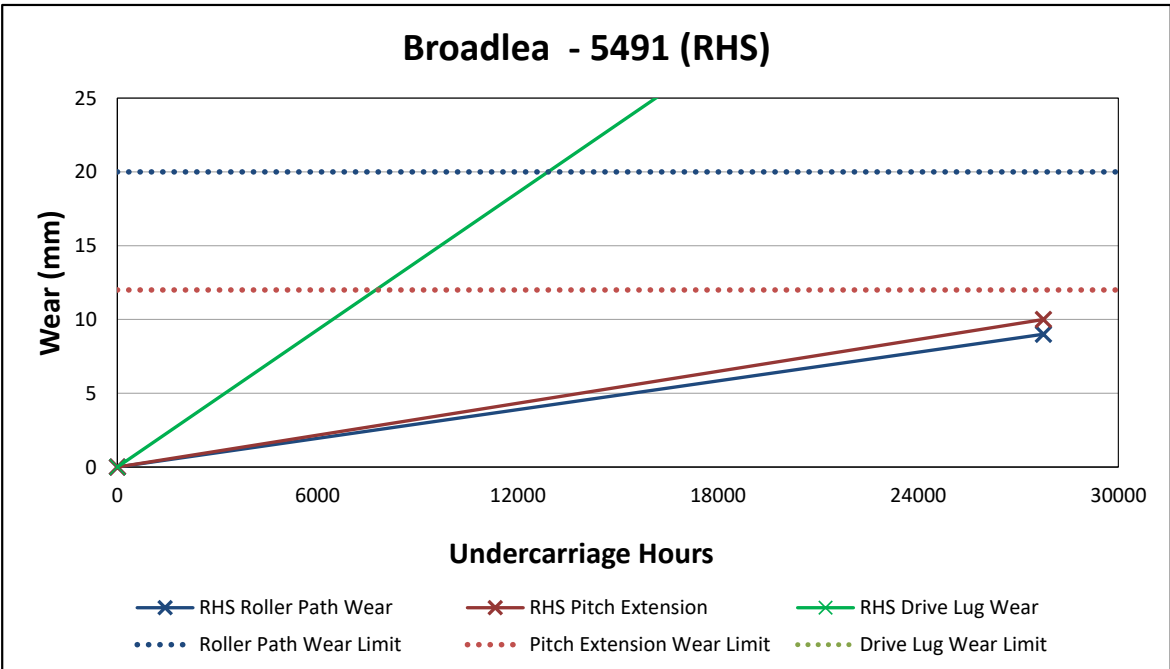
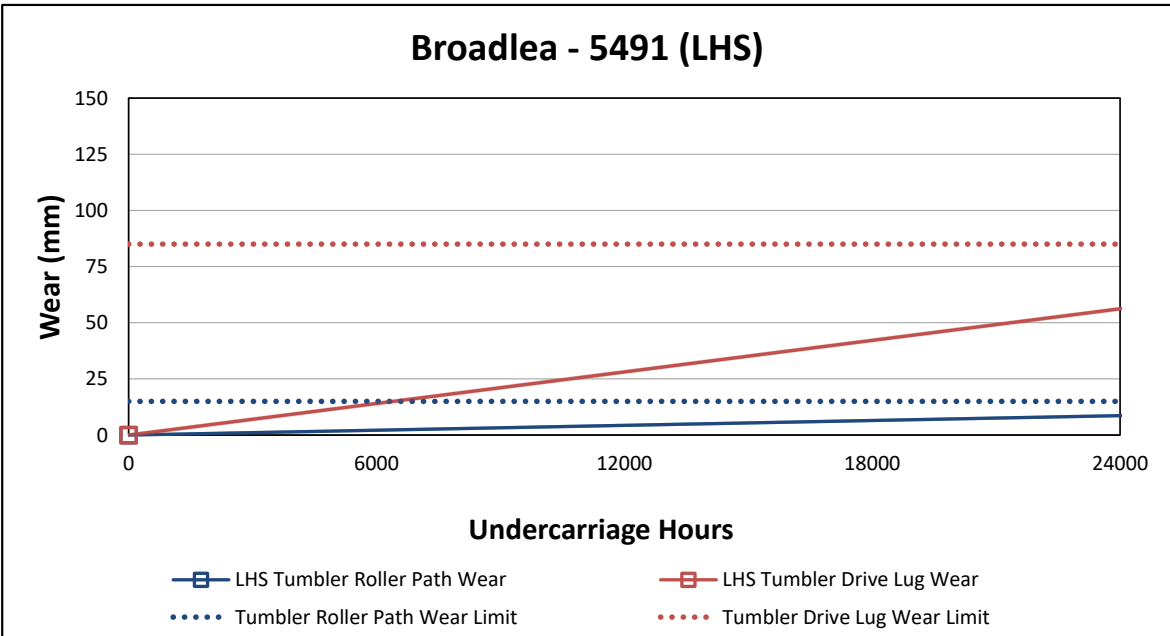
| Component Wear Measurement Summary 16/05/2023 | | | | | | | | | | |
| LHS | 9.0 | 75% | 8.0 | 40% | 40.0 | 53% | 10.0 | 67% | 65.0 | 76% |
| RHS | 10.0 | 83% | 9.0 | 45% | 43.0 | 57% | 11.0 | 73% | 70.0 | 82% |

- Schedule change out of undercarriage should be planned now as this undercarriage is at the end of life stages and wear will increase rapidly for the last hours left.

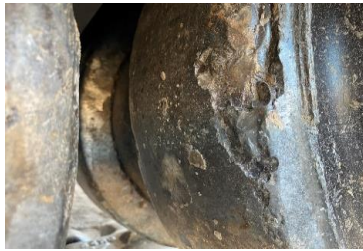
Figure 6 - LHS & RHS Rollers

| Load Rollers | <p>Load rollers were in a serviceable condition but have shards of steel missing from both sides of the roller indicating the hardened steel surface is starting to wear through and this will increase the wear rate moving forward an increased inspection should be scheduled.</p> |
