## **INSPECTION REPORT NO. M23-8959**

**MACHINE IDENTIFICATION:** **Hitachi EX3600 Excavator EX0043**

**SUBJECT:** Inspection and non-destructive testing of Hitachi EX3600 excavator EX0043 at Broadlea Coal Mine.

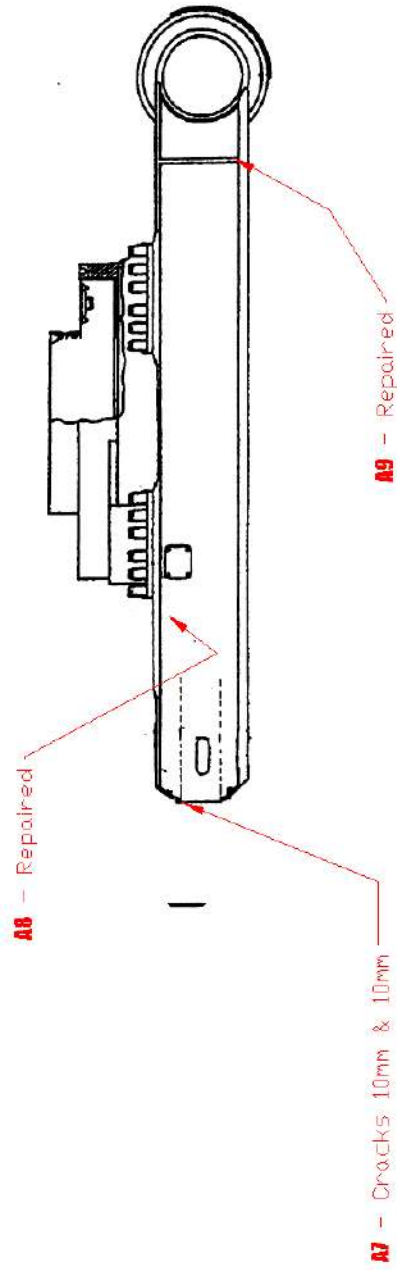
**Figure-A1**

Defect No.	Location	Defect Details		Figure No.	Previous Length (M22-830)
		Type	Length (Mm) / Description		
A7	Side Frame - Left Hand Side	Crack	10 & 10	A1	10 & 10
A8	Side Frame - Left Hand Side	Cracks	Repaired	A1	35
A9	Side Frame - Left Hand Side	Cracks	Repaired	A1	40
B1	Slew Internal	Crack	Repaired	B1	50
B2	Slew Internal	Crack	10	B1	-
B3	Slew Internal	Crack	420	B1	-
B4	Slew Internal	Crack	40+	B1	-
B8	Track Frame	Crack	20	B1	30 & 80
B9	Track Frame Slew	Crack	Not Inspected	B1	42, 5, 5 & 10
B11	Track Frame Slew	Crack	Repaired	B1	10, 10 & 10
B12	Track Frame Slew	Crack	Not Inspected	B1	20 & 22
B15	Track Frame	Cracks	Repaired	B1	35 & 130
B19	Slew Internal	Crack	Repaired	B1	170
B20	Track Frame	Crack	Repaired	B1	195
B21	Track Frame	Crack	Repaired	B1	200
B22	Track Frame	Crack	Repaired	B1	20
B23	Track Frame	Missing Bolt	Repaired	B1	-
B24	Track Frame	Missing Bolt	Repaired	B1	-
B25	Slew Internal	Crack	Repaired	B1	-

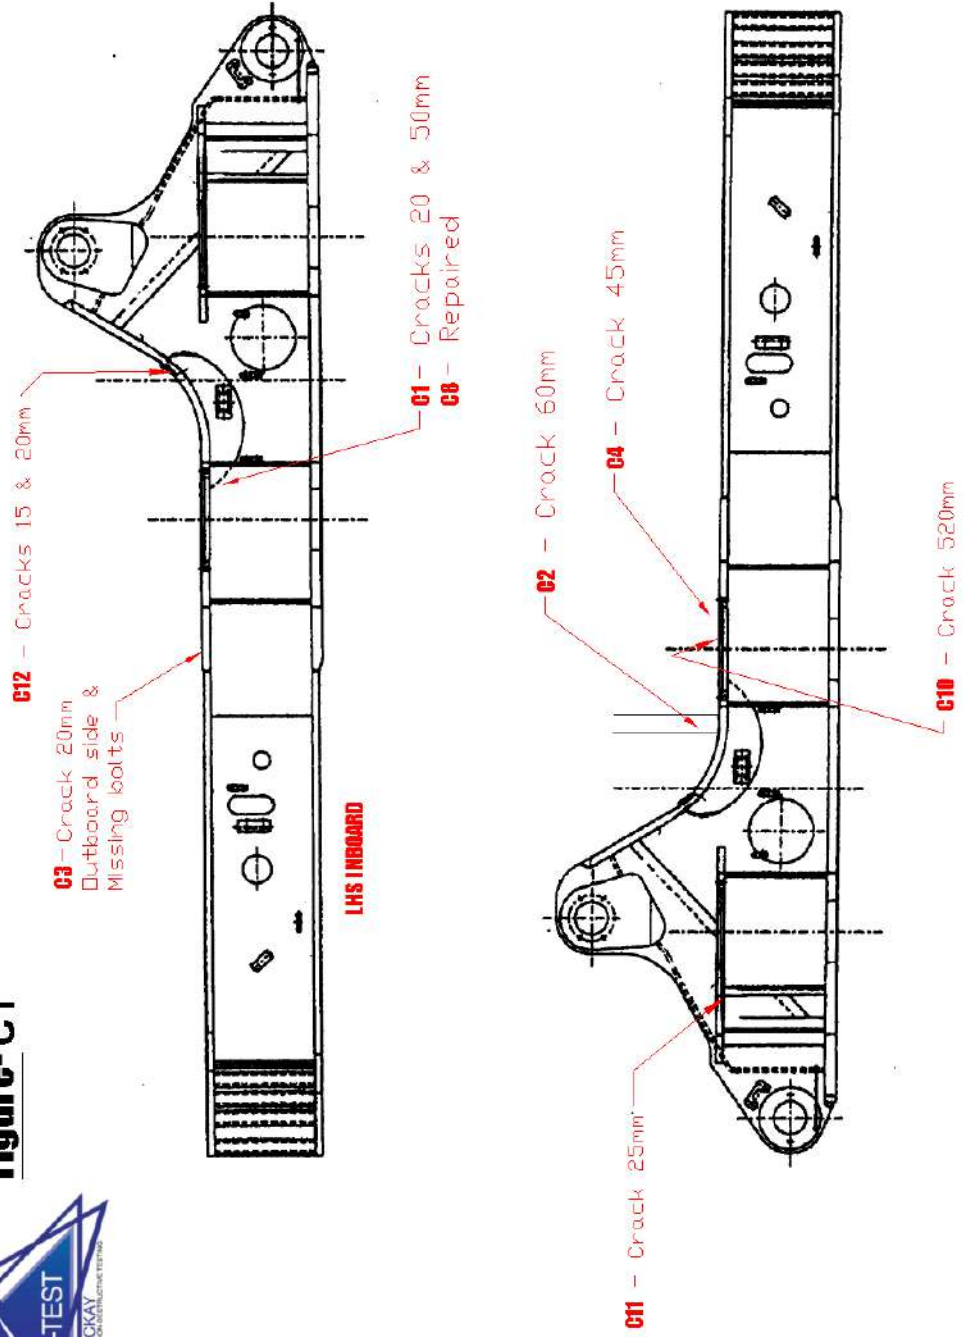
**Figure-C1**

Defect No.	Location	Defect Details		Figure No.	Previous Length (M23-8300)
		Type	Length (mm) / Description		
C1	Left Hand Side Inboard	Cracks	20 & 50	C1	85
C2	Hydraulic Bracket	Crack	60	C1	15+
C3	External Left Hand Outboard Side	Crack & Missing Bolts	20	C1	20
C4	External Right Hand Outboard Side	Crack	45	C1	45
C6	Main Frame Right Hand Outboard Side	Crack	40	C2	80
C7	Main Frame Right Hand Outboard Side	Crack	Repaired	C2	90
C8	Main Frame Left Hand Inboard Side	Cracks	Repaired	C1	380
C9	Main Frame Right Hand Outboard Side	Crack	20	C2	100
C10	Main Frame Right Hand Outboard Side	Crack	520	C1	520
C11	Front Middle Outboard	Crack	Not Inspected	C1	25
C12	External Left Hand Outboard Side	Cracks	15 & 20	C1	-
C13	Center of Main Frame	Crack	30	C2	-
C14	Main Frame Right Hand Outboard Side	Crack	30	C2	-
C15	Main Frame Right Hand Outboard Side	Crack	10	C2	-
D2	Boom - Left Hand Side	Cracks	Not Inspected	D1	15 & 30
D3	Boom - Left Hand Side Outboard	Crack	30	D1	-

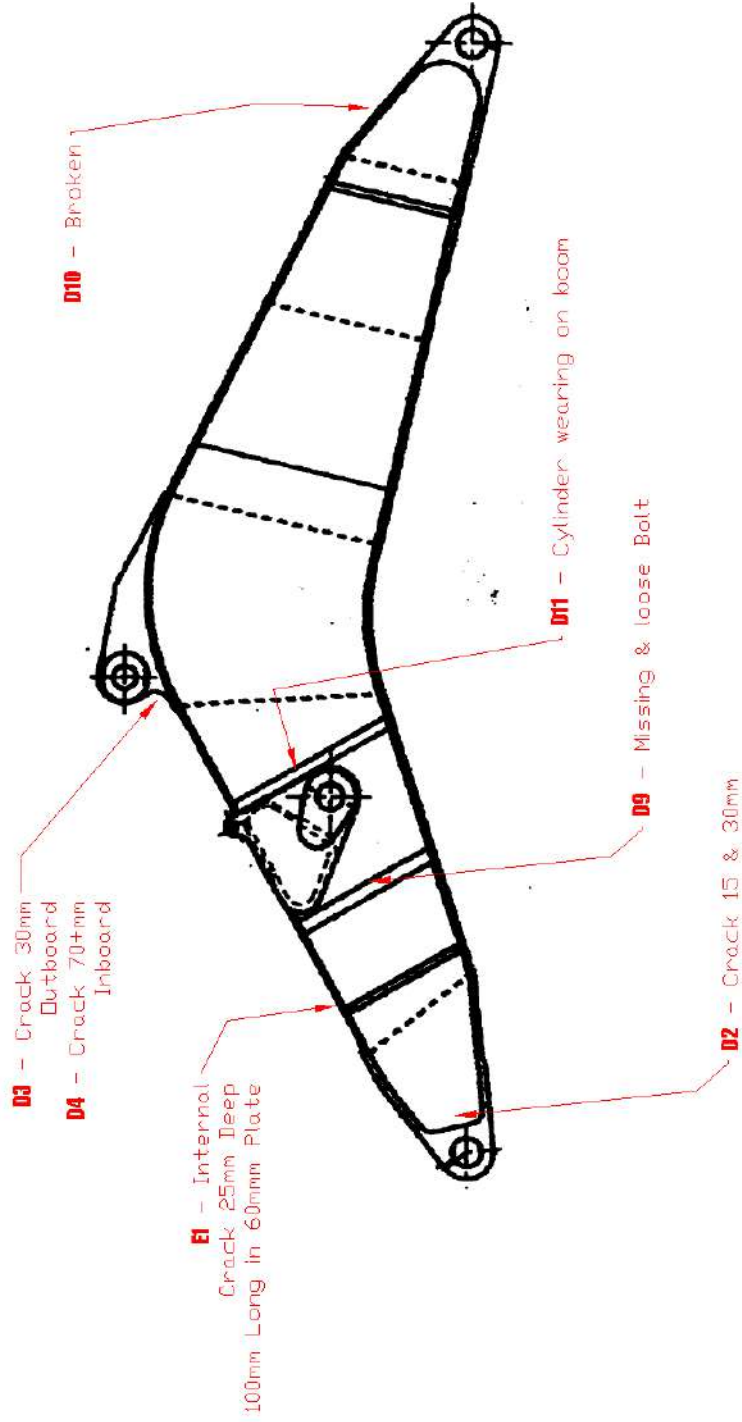
**Figure- D1**

D4	Boom - Left Hand Side Inboard	Crack	70+	D1	-
D5	Boom - Right Hand Side	Missing Clamp & Cracks	Repaired	D2	120 & 140
D6	Boom - Right Hand Side	Crack	Repaired	D2	85
D7	Boom - Left Hand Side Outboard	Crack	15	D2	-
D8	Boom - Left Hand Side Inboard	Crack	70	D2	-
D9	Boom - Left Hand Side	Missing / Loose Bolt	-	D1	-
D10	Boom - Left Hand Side	Broken	-	D1	-
D11	Boom - Left Hand Side	Cylinder Wearing on Boom	-	D1	-

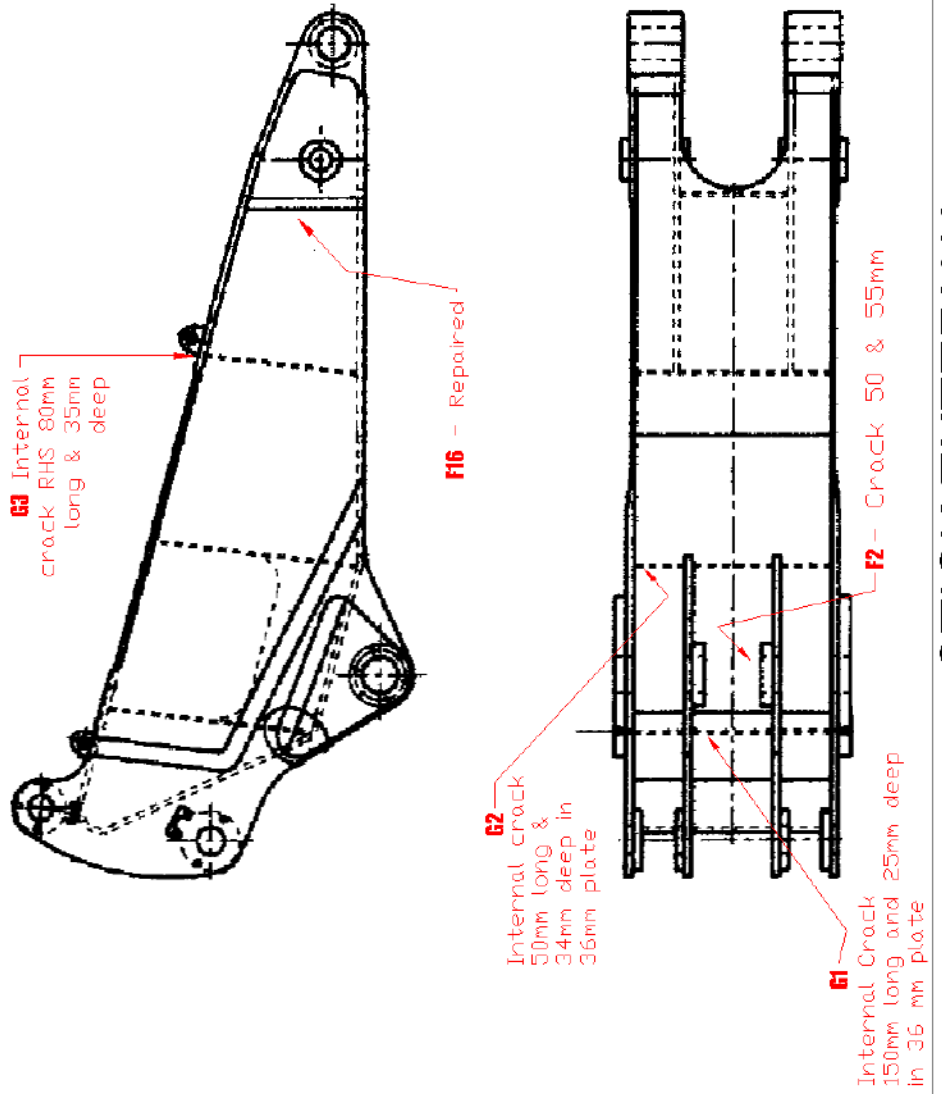
**Figure- F1**

Defect No.	Location	Defect Details		Figure No.	Previous Length (M22-8300)
		Type	Length (mm) / Description		
E1	Boom Left Hand Side - Internal	Crack	Not Inspected	D1	25mm Deep 100mm Long
F2	Stick	Cracks	50 & 55	F1	Repaired
F16	Stick - Left Hand Side - External	Crack	Repaired	F1	-
G1	Stick - Right Hand Side - Internal	Crack	Not Inspected	F1	150mm long 25mm deep
G2	Stick - Right Hand Side - Internal	Crack	Not Inspected	F1	50mm long 34mm deep
G3	Stick - Right Hand Side - Internal	Crack	Not Inspected	F1	80mm long 35mm deep
H1	Bucket - Outboard Right Hand Side	Cracks	Not Inspected	H4	10, 10 & 35
H2	Bucket - Outboard Left Hand Side	Crack	Not Inspected	H4	10 & 10
H3	Bucket - Front plate	Cracks	Not Inspected	H4	Repaired
H4	Bucket - Underside Right Hand Side	Crack	Not Inspected	H1	60
H5	Bucket - Underside Left Hand Side	Crack	Not Inspected	H1	110
H6	Bucket - Underside Left Hand Side	Crack	Not Inspected	H1	100
H7	Bucket - Inboard Right Hand Side	Crack	Not Inspected	H3	80

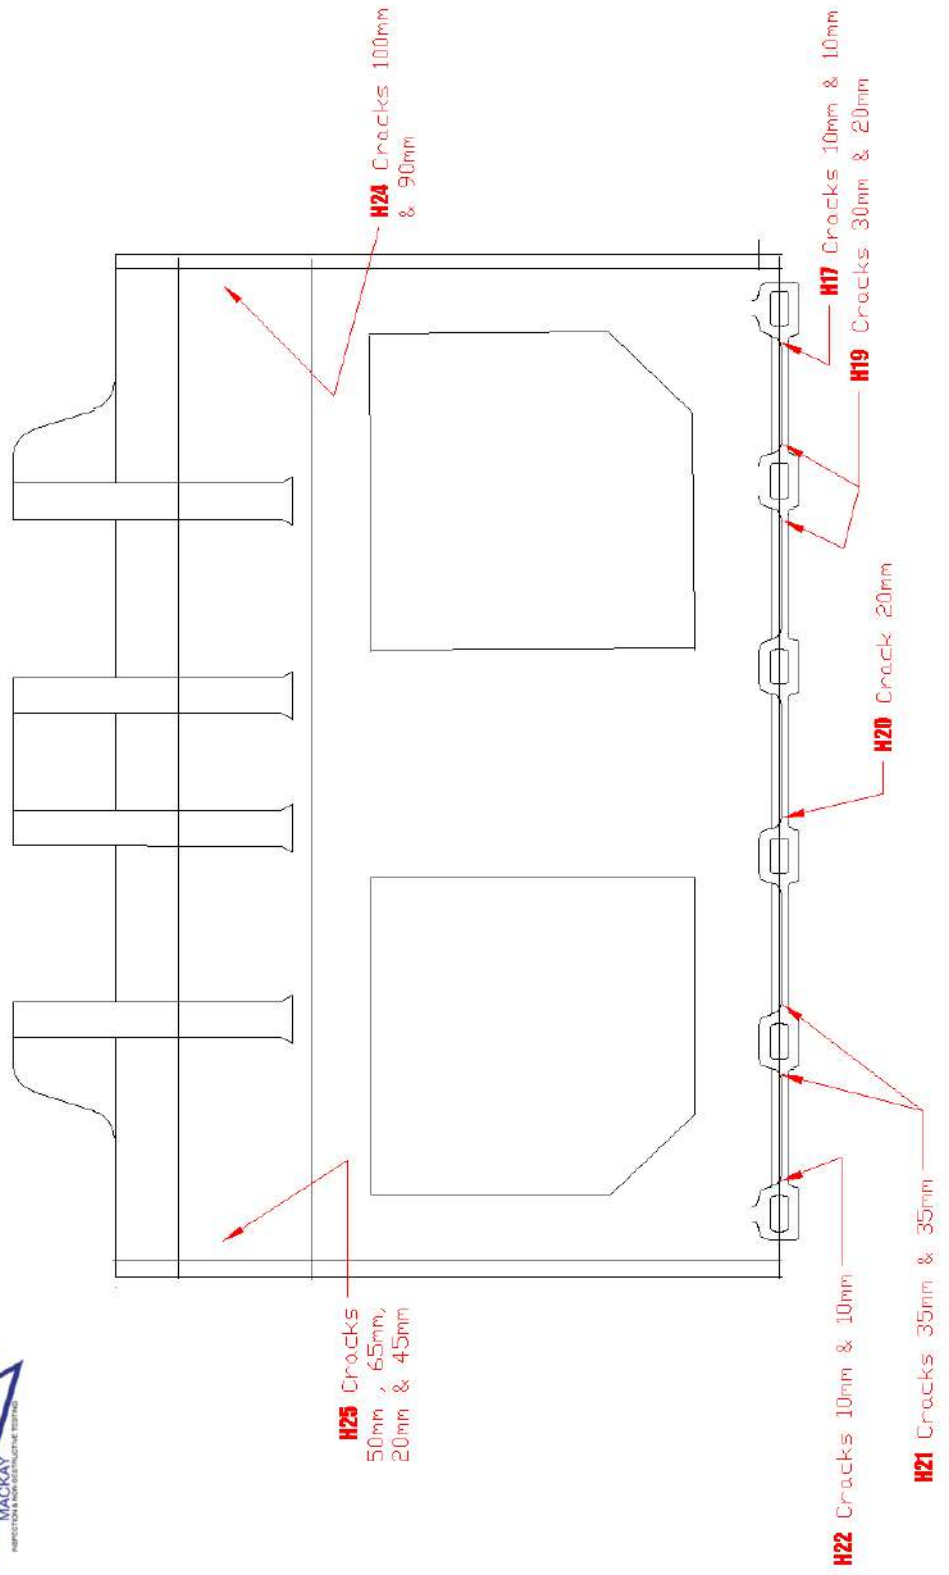
**Figure-H2**

H8	Bucket - Inboard Left Hand Side	Crack	Not Inspected	H3	60
H9	Bucket - Left Hand Outboard Side	Crack	Not Inspected	H4	10
H10	Bucket - Left Hand Outboard Side	Crack	Not Inspected	H4	100
H11	Bucket - Left Hand Outboard Side	Crack	Not Inspected	H4	15
H12	Bucket - Right Hand Outboard Side	Crack	Not Inspected	H4	20
H13	Bucket - Right Hand Outboard Side	Crack	Not Inspected	H4	10
H14	Bucket - Right Hand Outboard Side	Crack	Not Inspected	H4	35
H15	Bucket - Right Hand Outboard Side	Crack	Not Inspected	H4	65
H16	Bucket - Right Hand Outboard Side	Cracks	Not Inspected	H4	15 & 15
H17	Bucket - Lip	Cracks	Not Inspected	H2	10 & 10

Defect No.	Location	Defect Details		Figure No.	Previous Length (M22-8300)
		Type	Length (mm) / Description		
H18	Bucket - Underside Floor	Crack	Not Inspected	H4	300
H19	Bucket - Lip	Cracks	Not Inspected	H2	30 & 20
H20	Bucket - Lip	Crack	Not Inspected	H2	20
H21	Bucket - Lip	Cracks	Not Inspected	H2	35 & 35
H22	Bucket - Lip	Cracks	Not Inspected	H2	10 & 10
H23	Bucket - Underside Floor	Cracks	Not Inspected	H4	10 & 20
H24	Bucket - Right Hand Inboard Side	Cracks	Not Inspected	H2	100 & 90
H25	Bucket - Left Hand Inboard Side	Cracks	Not Inspected	H2	50, 65, 20 & 45
H26	Bucket - Rear	Crack	Not Inspected	H1	32
I1	Bucket Link - Left Hand Side	Cracks	Not Inspected	I1	5, 5 & 5
J1	Engine House - Left Hand Side External	Mechanical Damage & Missing Bolt	-	-	-
J2	Engine House - Rear External	Corrosion	-	-	-
J3	Engine House - Rear External	Missing Bolt	-	-	-
J4	Engine House - Center Walkway	Missing Bolt	-	-	-
J5	Right Hand Side Walkway - Operators Cab	Missing Bolt	-	-	-

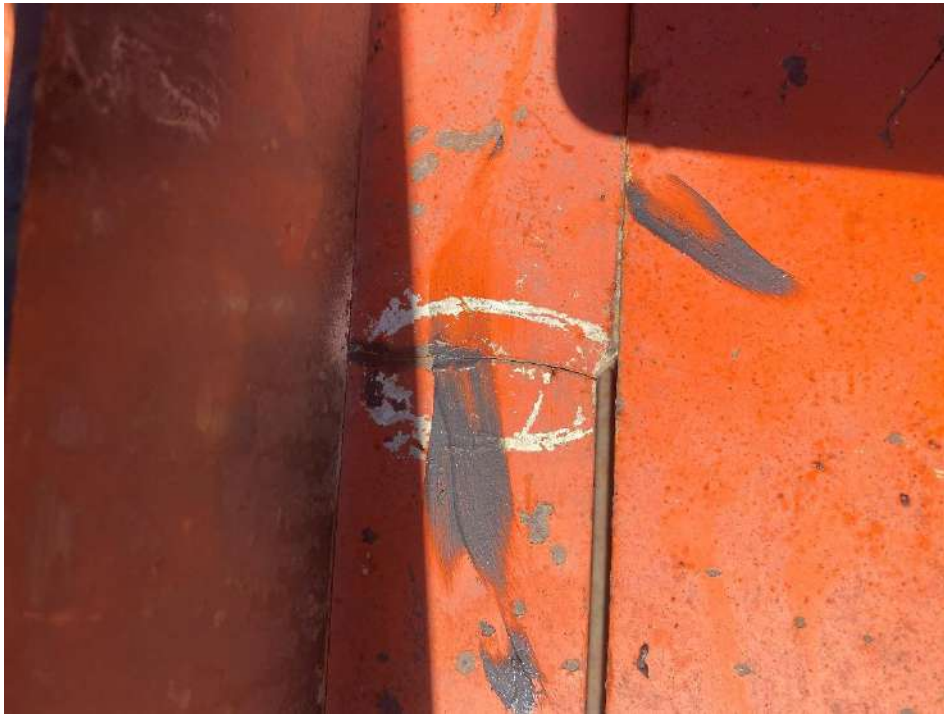
DEFECT NO. J6

J6	Fan House Roof	Crack	60	-	-
