THIESS (PARKED/EXPOSED)

Model	D10T	Job Site	Sonoma sites minespec nebo		Inspection Date	13Sep22
Manufacturer	Caterpillar		<u>Left</u>	<u>Right</u>	Next Inspection Date	--
Serial Number	RJG02519	Track Sag (145 mm - 165 mm)	--	--	Next Inspection Hours	--
Reference Number	DZ1592	Frame Ext (max 193 mm)	--	--	<u>Underfoot Conditions</u>	
Hour Meter Reading	--	Frame Ext %	--	--	Impact	Moderate
Hours Per Week	72.92	Dry Joints	--	--	Abrasion	Moderate
Total Odometer Reading	--	Link Roller System	55%	60%	Moisture	Moderate
Forward Odometer	--				Packing	Moderate
Reverse Odometer	--				Bushing Allowable Wear	Greater
Distance Per Week	--				Link Allowable Wear	Greater

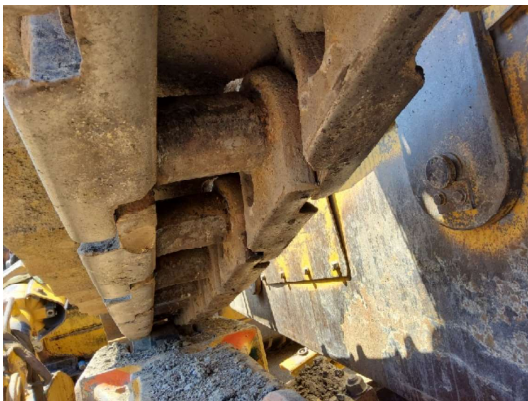
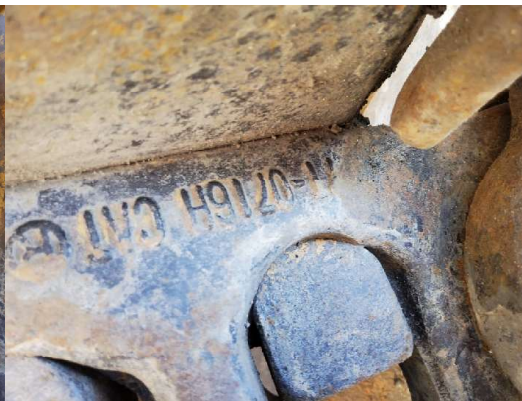
Left Track Link 1

Component	Status		Part Number		Measurement (mm)		Percent Worn	
	Left	Right	Left	Right	Left	Right	Left	Right
Link Assemblies	Left:2389851				Right:2389851			
Track Link	Original	Original	7T0715	7T0715	51.8	50.5	59%	65%
NOTES: L/Heidelberg has 7t0716 link assy				NOTES: --

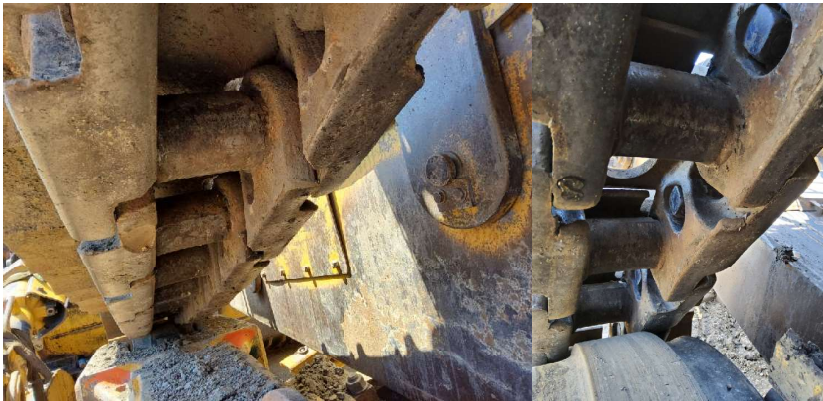
Left Track Bushing 1

Bushing (Ext)	Original	Original	6Y2057	6Y2057	15.5	10	44%	90%
NOTES: --				NOTES: R/H side has 3784942 link assy

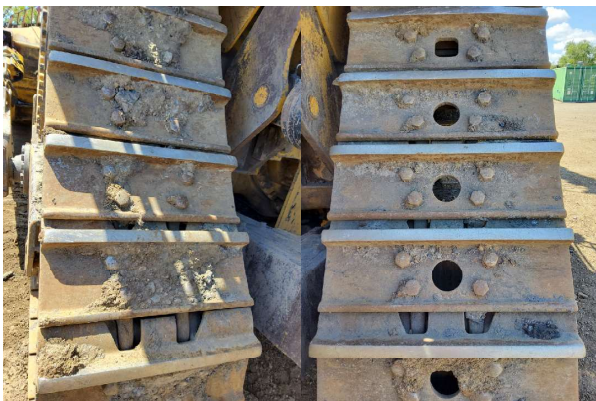
Left Track Shoe 1

Track Shoe	Left Width:710mm				Right Width:710mm			
	Original	Original	7T0724	7T0724	72	79	35%	24%

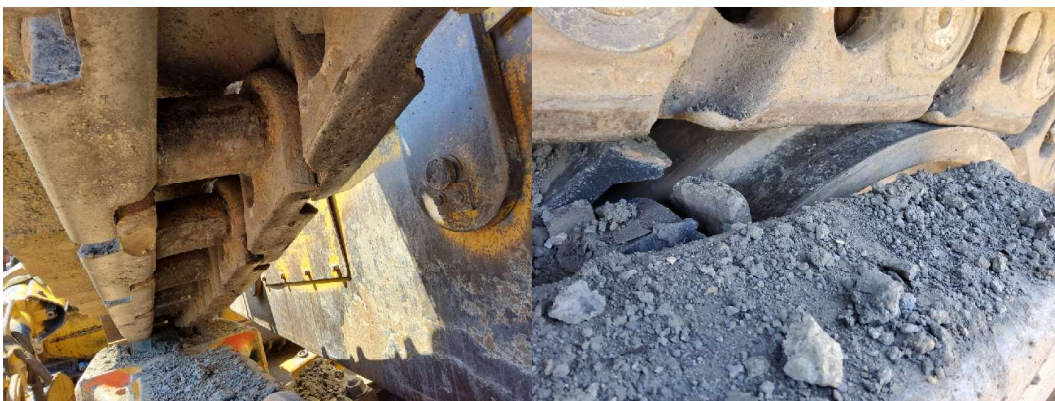
Left Idler 1

Idlers								
Front	Original	Original	1253537	1253537	24	25	32%	40%
Rear	Original	Original	1253537	1253537	23	27	26%	56%

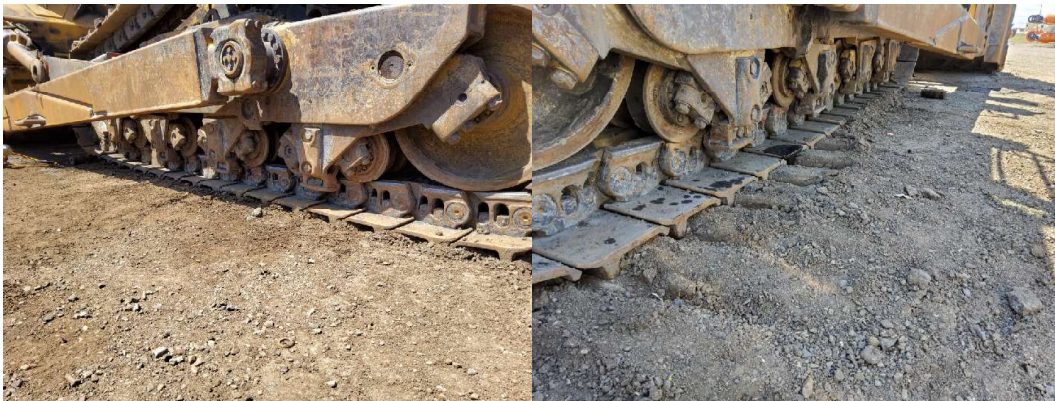
Left Track Roller 1

Front	S	Original	Original	3097679	3097679	60	56.4	45%	54%
2	S	Original	Original	3097679	3097679	58	64	50%	33%
3	D	Original	Original	3097678	3097678	62	64	21%	13%
4	D	Original	Original	3097678	3097678	59	62	33%	21%
5	D	Original	Original	3097678	3097678	58.6	59.3	34%	32%
6	D	Original	Original	3097678	3097678	58.7	62	34%	21%
7	S	Original	Original	3097679	3097679	58.9	62.1	48%	41%
8	S	Original	Original	3097679	3097679	69.8	63	10%	37%

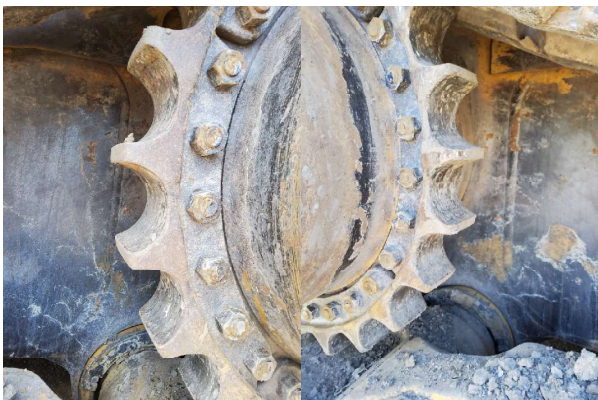
Left Sprocket

Original	Original	2782374	2782374	--	--	--	--	
CONDITION: Good				CONDITION: Good
