# REPAIRER'S DATA REPORT

**JOB NUMBER: 27861**

**Description: REFURB EX5600 BOOM**

## STRUCTURAL INTEGRITY SURVEY REPORT FOR THE STRUCTURE REPORT NUMBER HMI 23-033.7

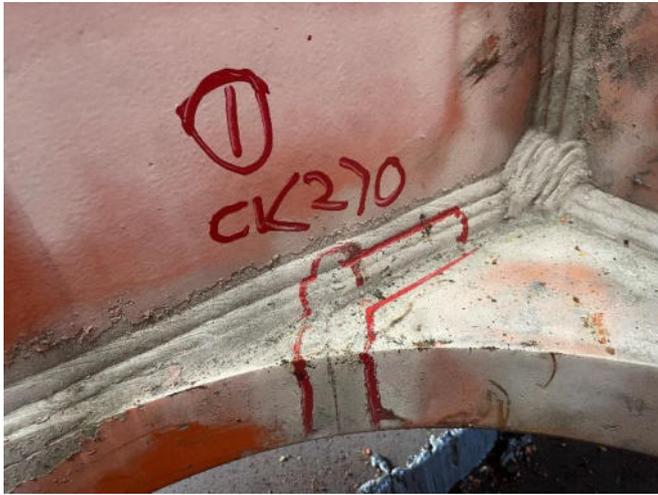
PHOTOGRAPH NO. 1 – EXTERNAL BOOM  
TYPICAL VIEW OF DEFECT #1

PHOTOGRAPH NO. 1 – EXTERNAL BOOM  
TYPICAL VIEW OF REPAIRED DEFECT #1

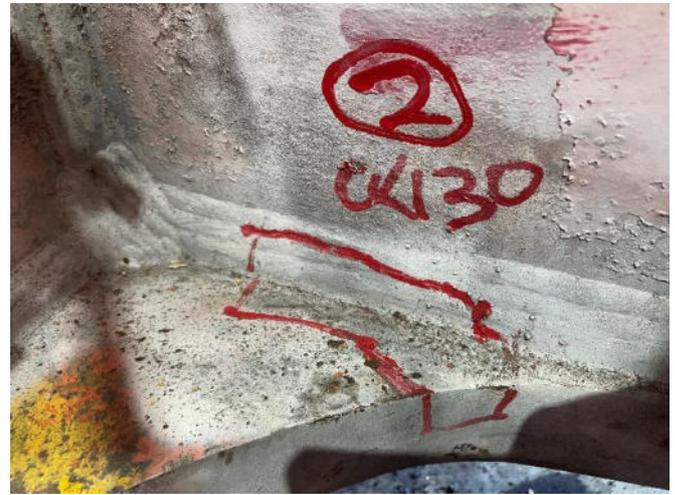
PHOTOGRAPH NO. 2 – EXTERNAL BOOM  
TYPICAL VIEW OF DEFECT #2

PHOTOGRAPH NO. 2 – EXTERNAL BOOM  
TYPICAL VIEW OF REPAIRED DEFECT #2

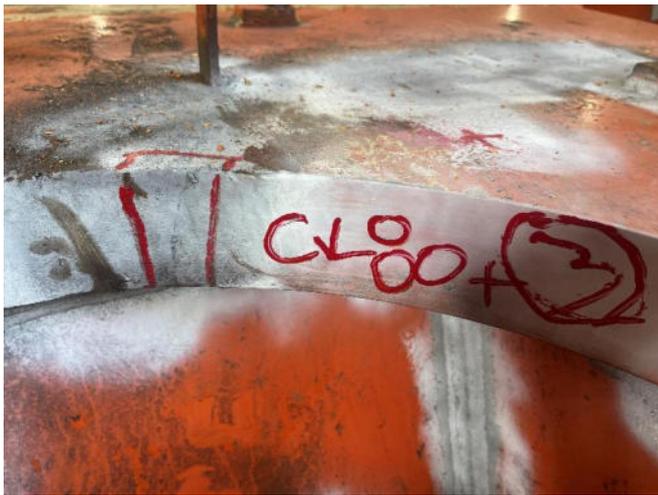
PHOTOGRAPH NO. 3 - EXTERNAL BOOM  
TYPICAL VIEW OF DEFECT #3

PHOTOGRAPH NO. 3 - EXTERNAL BOOM  
TYPICAL VIEW OF REPAIRED DEFECT #3

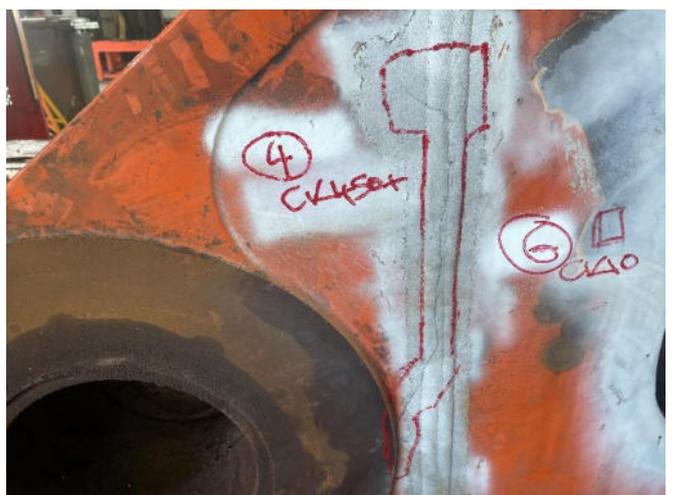
PHOTOGRAPH NO. 4 – EXTERNAL BOOM  
TYPICAL VIEW OF DEFECT #4

PHOTOGRAPH NO. 4 – EXTERNAL BOOM  
TYPICAL VIEW OF REPAIRED DEFECT #4

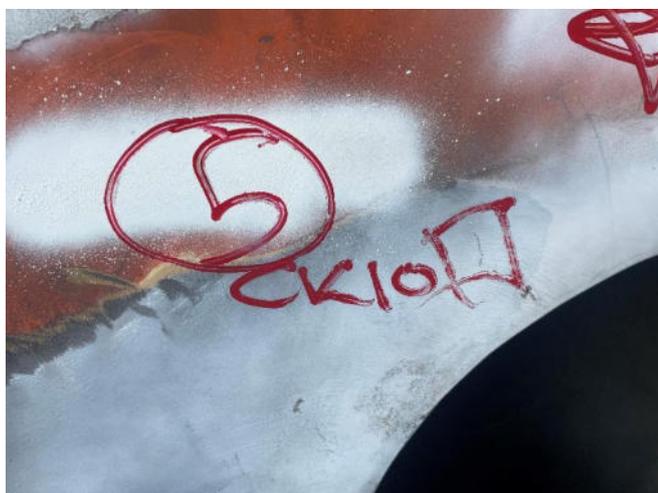
PHOTOGRAPH NO. 5 – EXTERNAL BOOM  
TYPICAL VIEW OF DEFECT #5

PHOTOGRAPH NO. 5 – EXTERNAL BOOM  
TYPICAL VIEW OF REPAIRED DEFECT #5

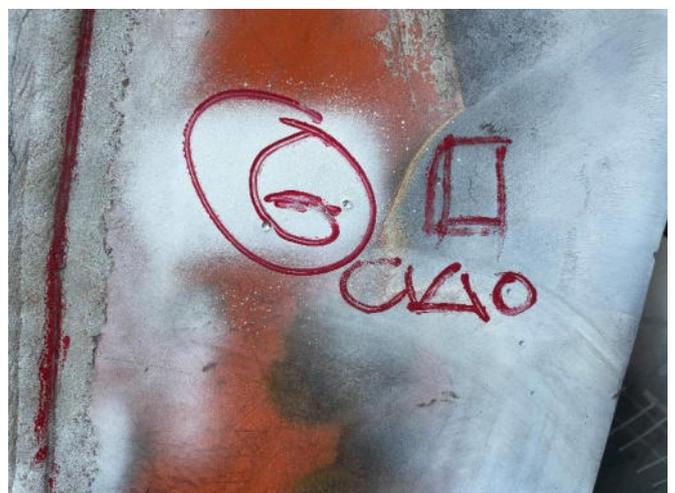
PHOTOGRAPH NO. 6 – EXTERNAL BOOM  
TYPICAL VIEW OF DEFECT #6

PHOTOGRAPH NO. 6 – EXTERNAL BOOM  
TYPICAL VIEW OF REPAIRED DEFECT #6

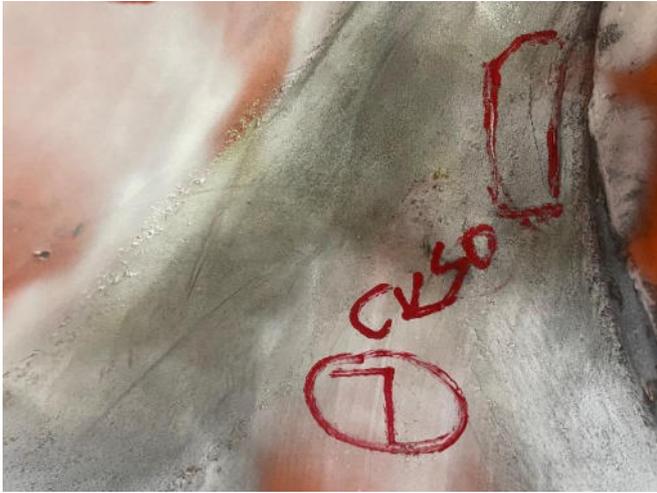
PHOTOGRAPH NO. 7 – EXTERNAL BOOM  
TYPICAL VIEW OF DEFECT #7

PHOTOGRAPH NO. 7 – EXTERNAL BOOM  
TYPICAL VIEW OF REPAIRED DEFECT #7

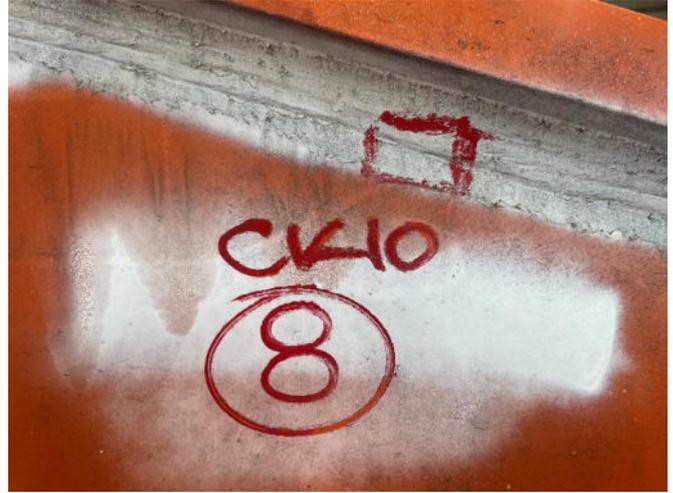
PHOTOGRAPH NO. 8 – EXTERNAL BOOM  
TYPICAL VIEW OF DEFECT #8

PHOTOGRAPH NO. 8 – EXTERNAL BOOM  
TYPICAL VIEW OF REPAIRED DEFECT #8

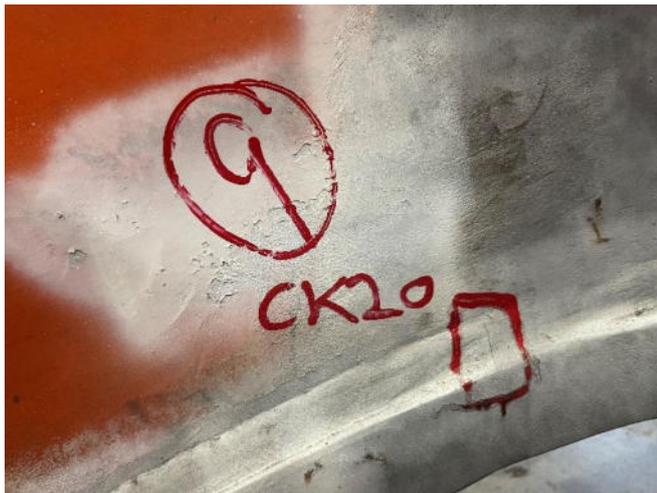
PHOTOGRAPH NO. 9 – EXTERNAL BOOM  
TYPICAL VIEW OF DEFECT #9

PHOTOGRAPH NO. 9 – EXTERNAL BOOM  
TYPICAL VIEW OF REPAIRED DEFECT #9

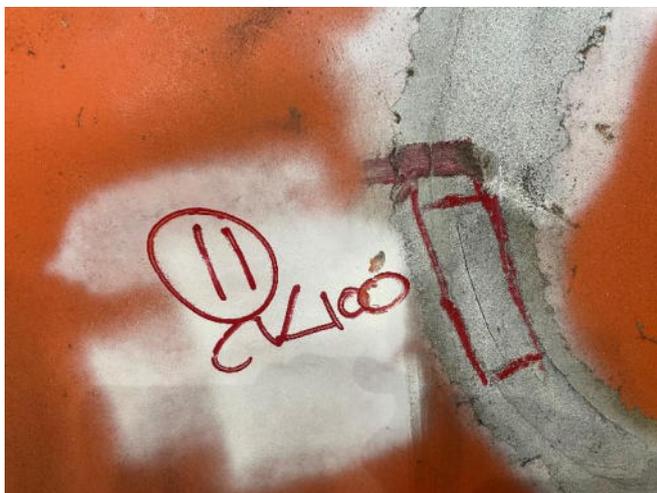
PHOTOGRAPH NO. 11 – EXTERNAL BOOM  
TYPICAL VIEW OF DEFECT #11

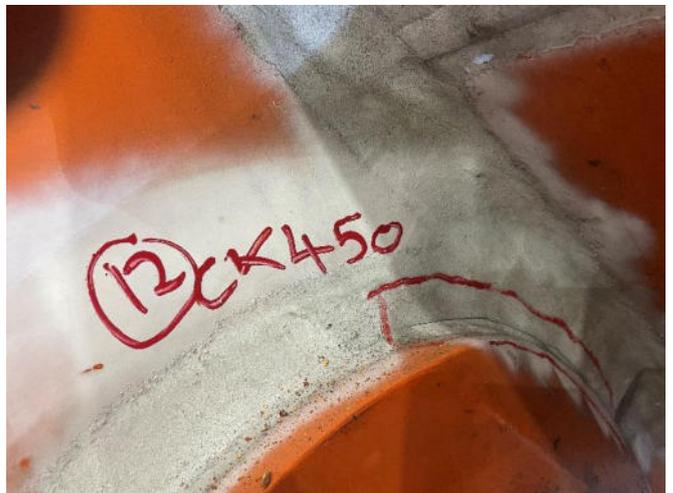
PHOTOGRAPH NO. 12 – EXTERNAL BOOM  
TYPICAL VIEW OF DEFECT #12

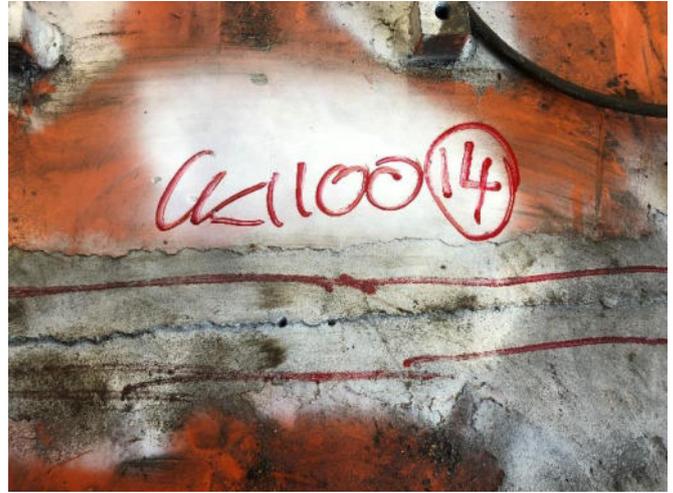
PHOTOGRAPH NO. 14 – EXTERNAL BOOM  
TYPICAL VIEW OF DEFECT #14

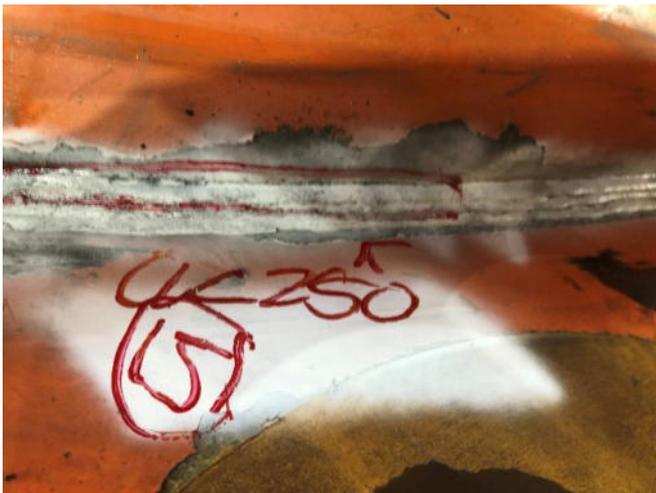
PHOTOGRAPH NO. 15 – EXTERNAL BOOM  
TYPICAL VIEW OF DEFECT #15

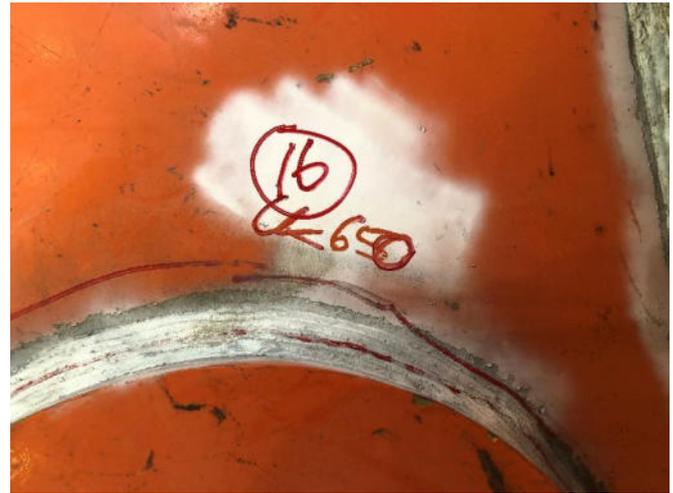
PHOTOGRAPH NO. 16 – EXTERNAL BOOM  
TYPICAL VIEW OF DEFECT #16

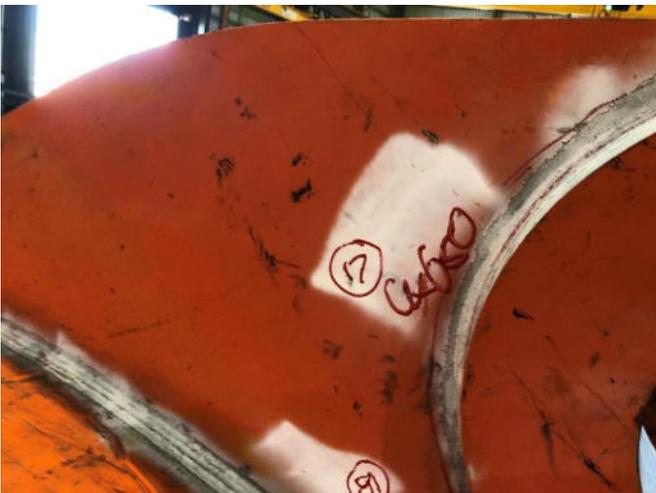
PHOTOGRAPH NO. 17 – EXTERNAL BOOM  
TYPICAL VIEW OF DEFECT #17

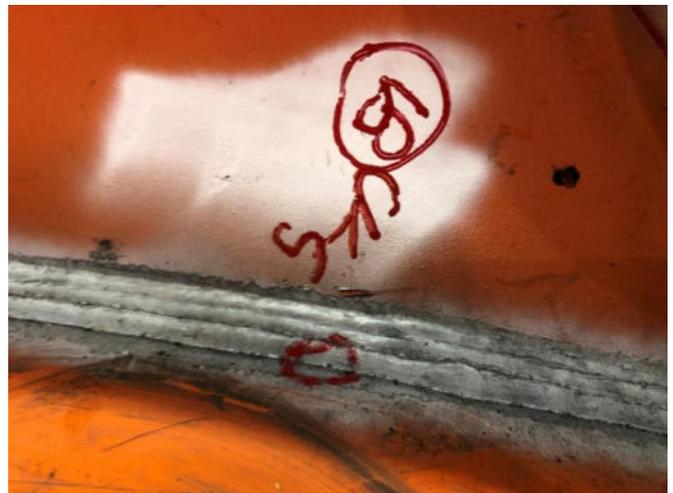
PHOTOGRAPH NO. 18 – EXTERNAL BOOM  
TYPICAL VIEW OF DEFECT #18

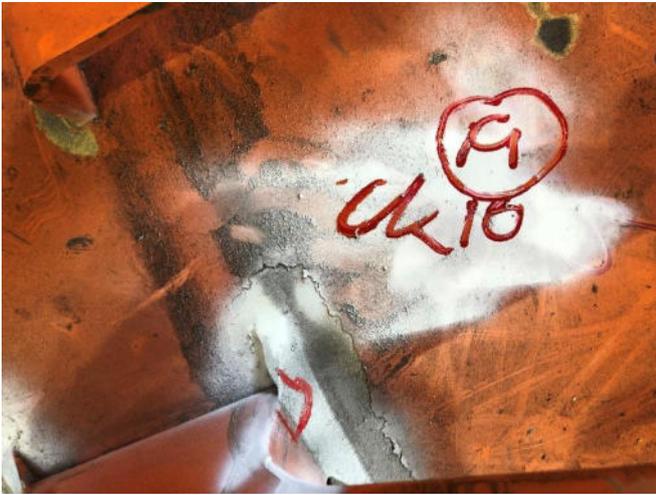
PHOTOGRAPH NO. 19 – EXTERNAL BOOM  
TYPICAL VIEW OF DEFECT #19

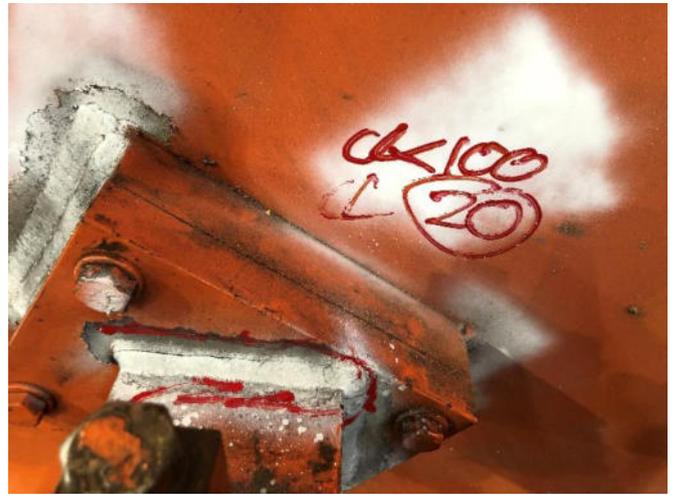
PHOTOGRAPH NO. 20 – EXTERNAL BOOM  
TYPICAL VIEW OF DEFECT #20

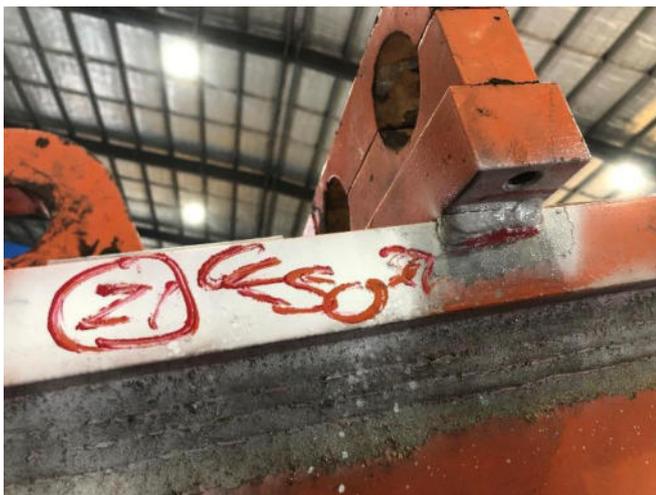
PHOTOGRAPH NO. 21 – EXTERNAL BOOM  
TYPICAL VIEW OF DEFECT #21

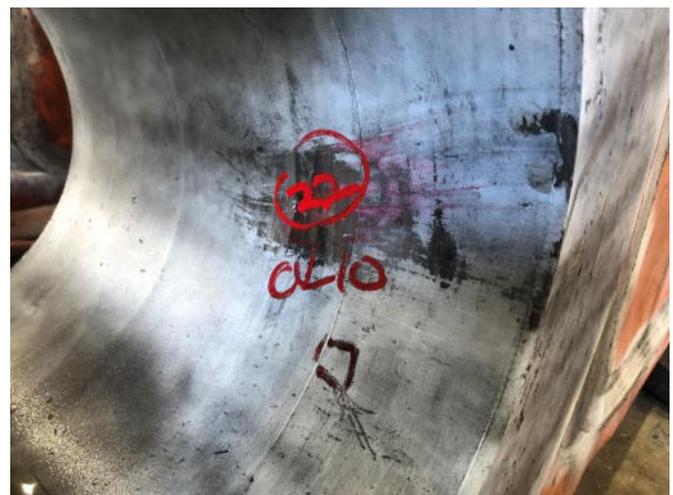
PHOTOGRAPH NO. 22 – EXTERNAL BOOM  
TYPICAL VIEW OF DEFECT #22

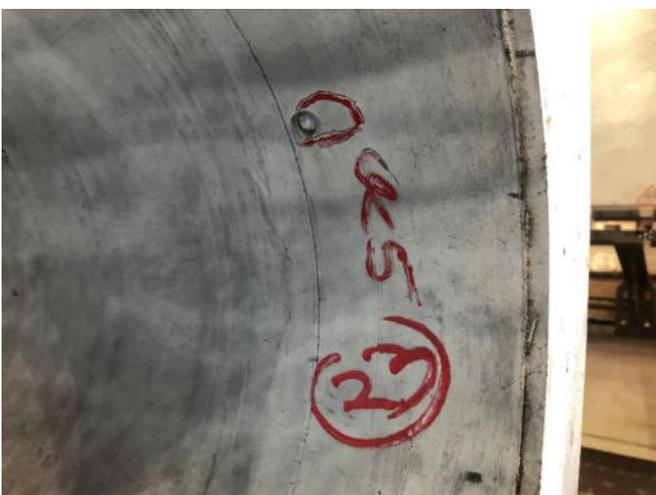
PHOTOGRAPH NO. 23 – EXTERNAL BOOM  
TYPICAL VIEW OF DEFECT #23

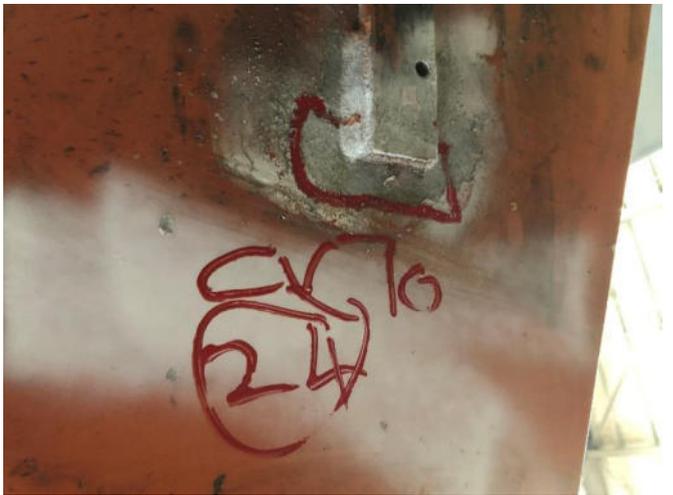
PHOTOGRAPH NO. 24 – EXTERNAL BOOM  
TYPICAL VIEW OF DEFECT #24

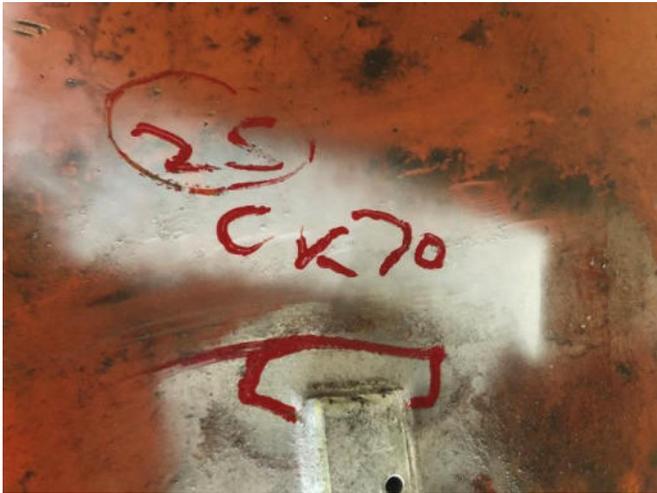
PHOTOGRAPH NO. 25 – EXTERNAL BOOM  
TYPICAL VIEW OF DEFECT #25

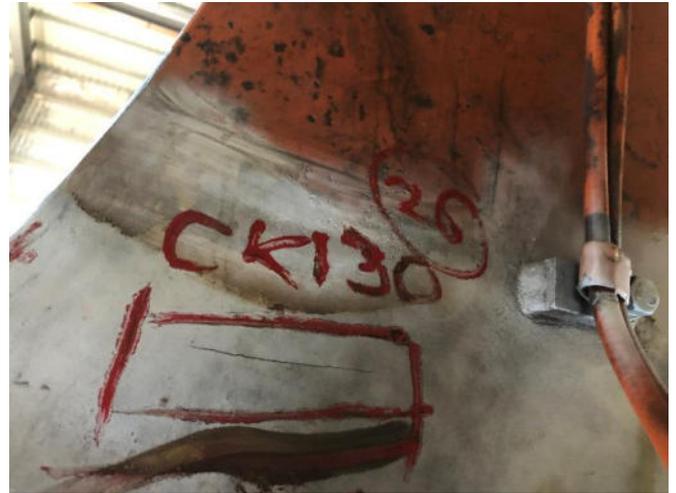
PHOTOGRAPH NO. 26 – EXTERNAL BOOM  
TYPICAL VIEW OF DEFECT #26

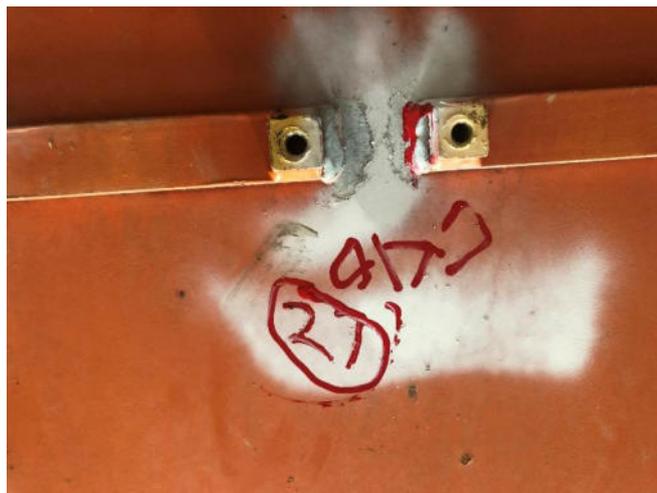
PHOTOGRAPH NO. 27 – EXTERNAL BOOM  
TYPICAL VIEW OF DEFECT #27

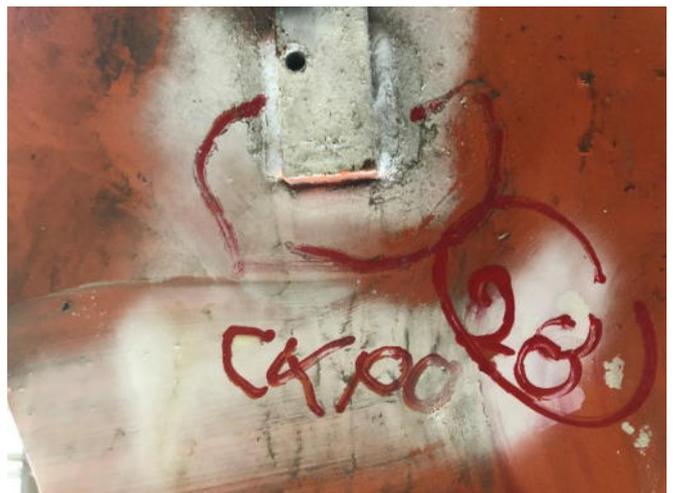
PHOTOGRAPH NO. 28 – EXTERNAL BOOM  
TYPICAL VIEW OF DEFECT #28

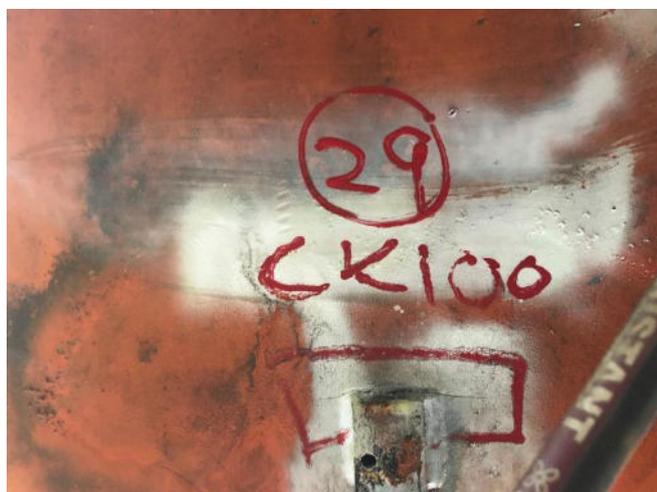
PHOTOGRAPH NO. 29 – EXTERNAL BOOM  
TYPICAL VIEW OF DEFECT #29

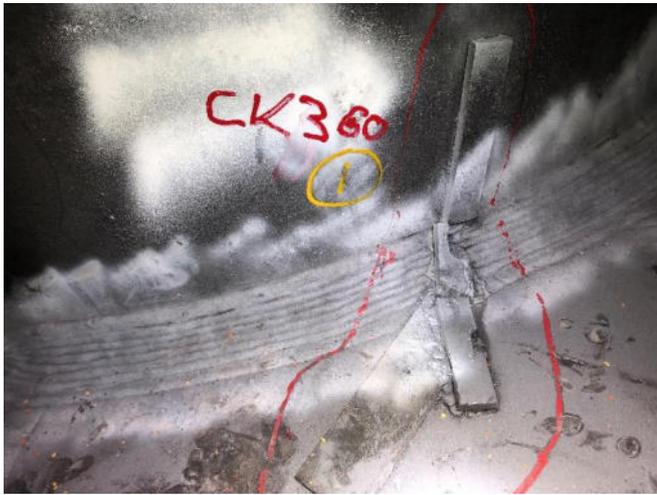
PHOTOGRAPH NO. 31 – INTERNAL BOOM BAY #1  
TYPICAL VIEW OF DEFECT #1

PHOTOGRAPH NO. 31 – INTERNAL BOOM BAY #1  
TYPICAL VIEW OF REPAIRED DEFECT #1

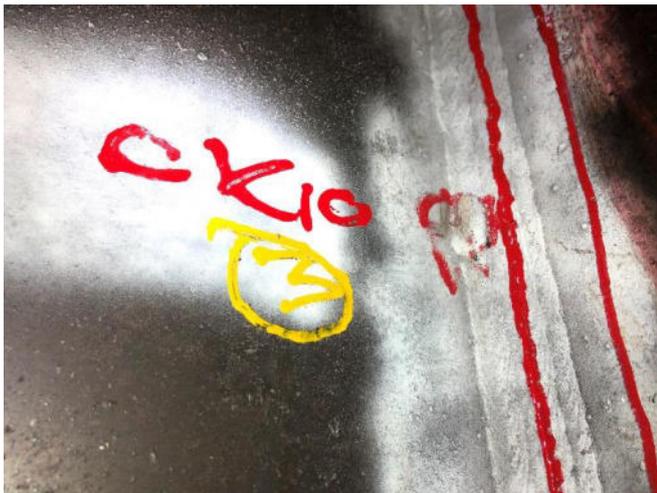
PHOTOGRAPH NO. 33 – INTERNAL BOOM BAY #1  
TYPICAL VIEW OF DEFECT #3

PHOTOGRAPH NO. 33 – INTERNAL BOOM BAY #1  
TYPICAL VIEW OF REPAIRED DEFECT #3

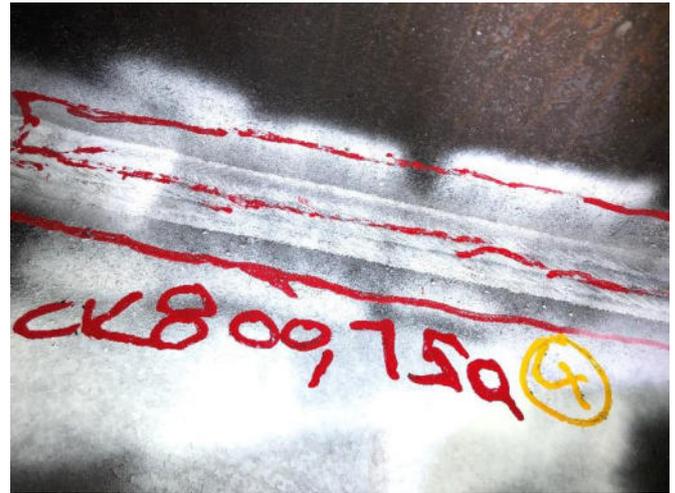
PHOTOGRAPH NO. 34 – INTERNAL BOOM BAY #1  
TYPICAL VIEW OF DEFECT #4

PHOTOGRAPH NO. 34 – INTERNAL BOOM BAY #1  
TYPICAL VIEW OF REPAIRED DEFECT #4

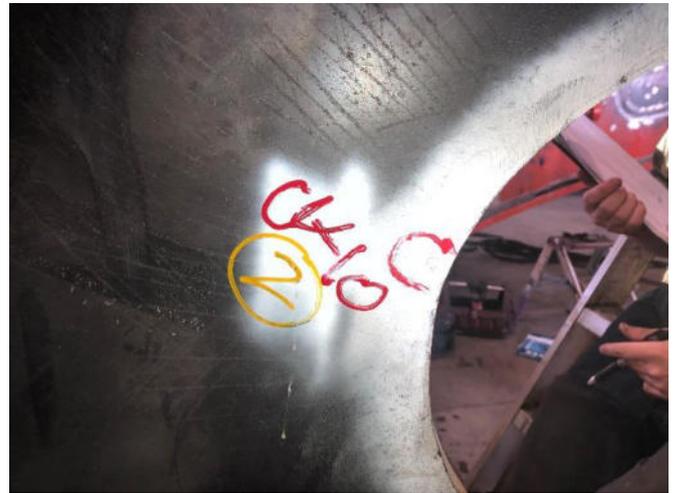
PHOTOGRAPH NO. 36 – INTERNAL BOOM BAY #2  
TYPICAL VIEW OF DEFECT #2

PHOTOGRAPH NO. 36 – INTERNAL BOOM BAY #2  
TYPICAL VIEW OF REPAIRED DEFECT #2

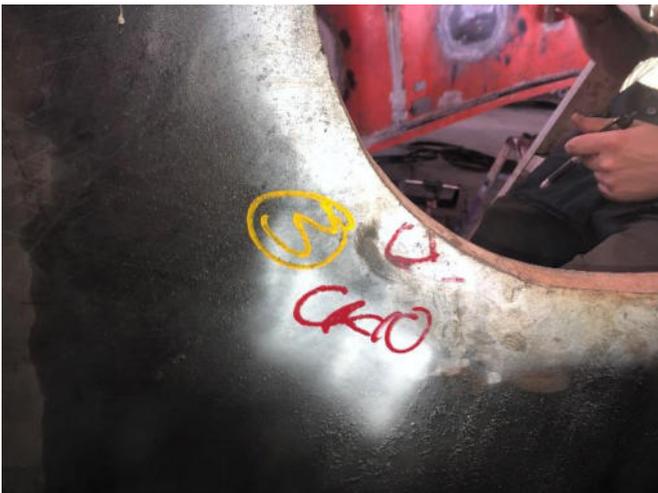
PHOTOGRAPH NO. 37 – INTERNAL BOOM BAY #2  
TYPICAL VIEW OF DEFECT #3

PHOTOGRAPH NO. 37 – INTERNAL BOOM BAY #2  
TYPICAL VIEW OF REPAIRED DEFECT #3

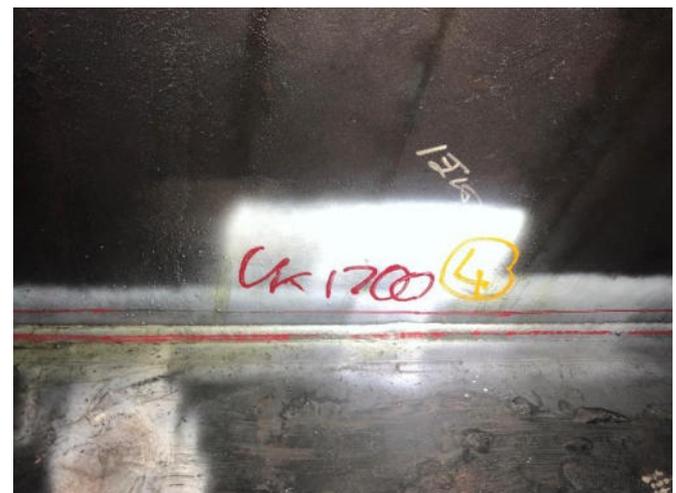
PHOTOGRAPH NO. 38 – INTERNAL BOOM BAY #2  
TYPICAL VIEW OF DEFECT #4

PHOTOGRAPH NO. 38 – INTERNAL BOOM BAY #2  
TYPICAL VIEW OF REPAIRED DEFECT #4

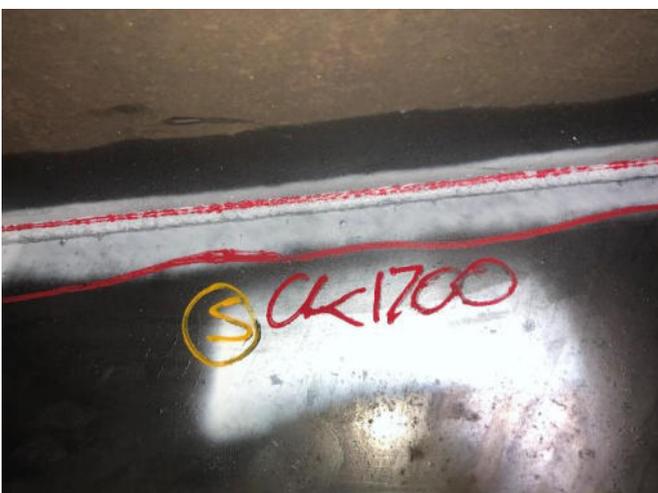
PHOTOGRAPH NO. 39 – INTERNAL BOOM BAY #2  
TYPICAL VIEW OF DEFECT #5

PHOTOGRAPH NO. 39 – INTERNAL BOOM BAY #2  
TYPICAL VIEW OF REPAIRED DEFECT #5

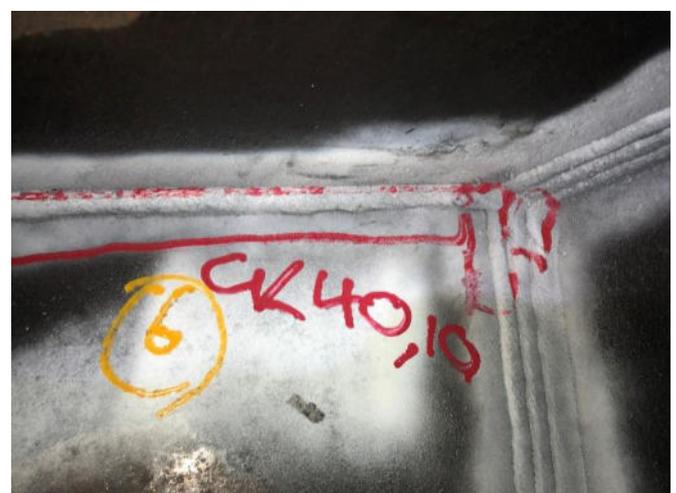
PHOTOGRAPH NO. 40 – INTERNAL BOOM BAY #2  
TYPICAL VIEW OF DEFECT #6

PHOTOGRAPH NO. 40 – INTERNAL BOOM BAY #2  
TYPICAL VIEW OF REPAIRED DEFECT #6

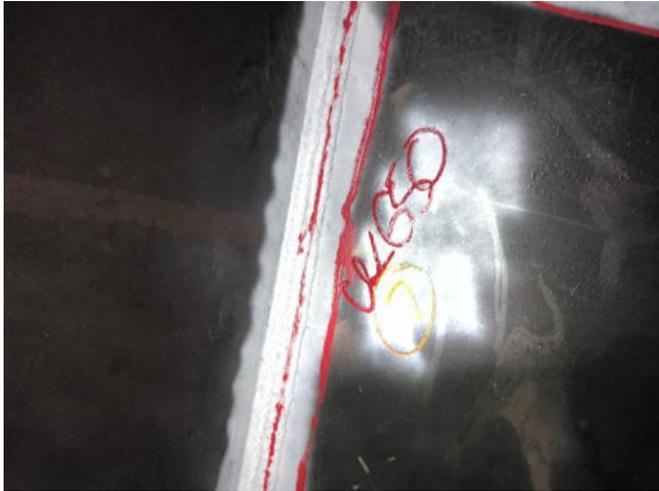
PHOTOGRAPH NO. 41 – INTERNAL BOOM BAY #2  
TYPICAL VIEW OF DEFECT #7

PHOTOGRAPH NO. 41 – INTERNAL BOOM BAY #2  
TYPICAL VIEW OF REPAIRED DEFECT #7

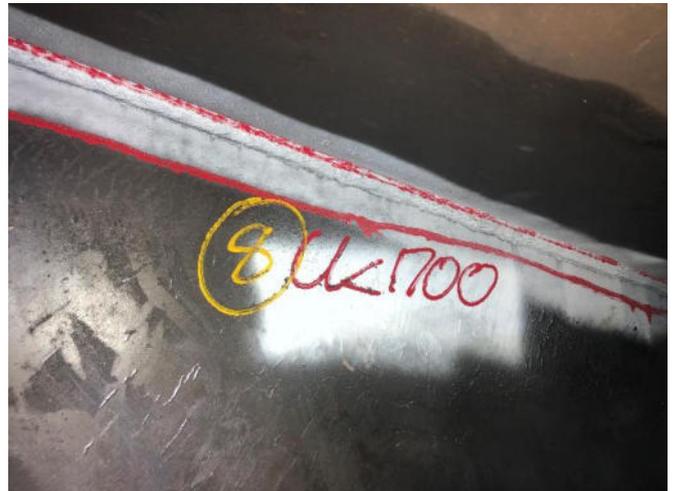
PHOTOGRAPH NO. 42 – INTERNAL BOOM BAY #2  
TYPICAL VIEW OF DEFECT #8

PHOTOGRAPH NO. 42 – INTERNAL BOOM BAY #2  
TYPICAL VIEW OF REPAIRED DEFECT #8

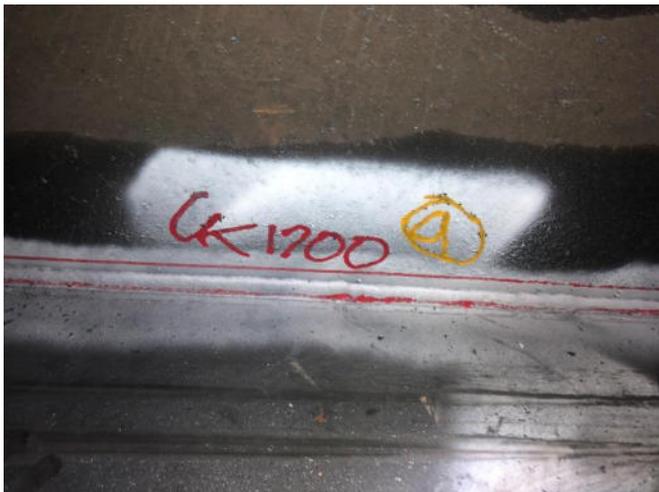
PHOTOGRAPH NO. 43 – INTERNAL BOOM BAY #2  
TYPICAL VIEW OF DEFECT #9

PHOTOGRAPH NO. 43 – INTERNAL BOOM BAY #2  
TYPICAL VIEW OF REPAIRED DEFECT #9

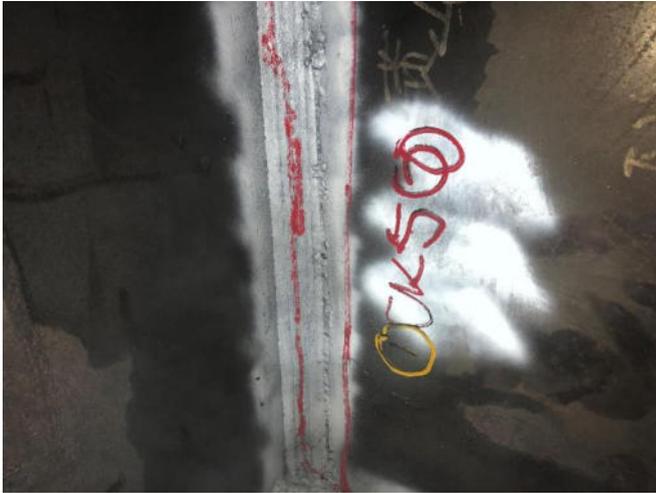
PHOTOGRAPH NO. 44 – INTERNAL BOOM BAY #3  
TYPICAL VIEW OF DEFECT #1

PHOTOGRAPH NO. 44 – INTERNAL BOOM BAY #3  
TYPICAL VIEW OF REPAIRED DEFECT #1

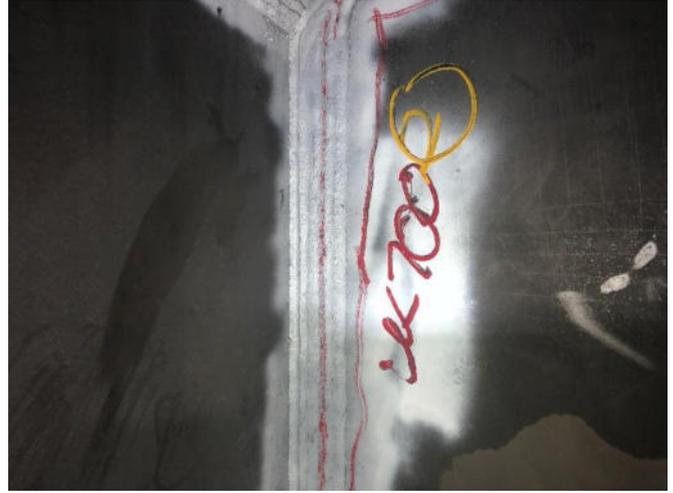
PHOTOGRAPH NO. 45 – INTERNAL BOOM BAY #3  
TYPICAL VIEW OF DEFECT #2

PHOTOGRAPH NO. 45 – INTERNAL BOOM BAY #3  
TYPICAL VIEW OF REPAIRED DEFECT #2

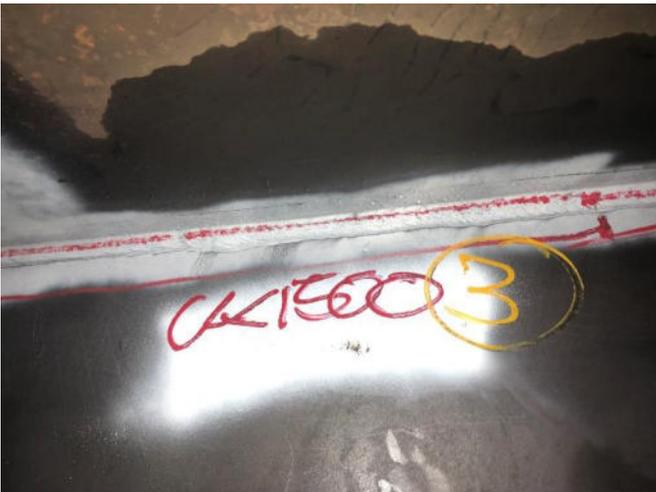
PHOTOGRAPH NO. 46 – INTERNAL BOOM BAY #3  
TYPICAL VIEW OF DEFECT #3

PHOTOGRAPH NO. 46 – INTERNAL BOOM BAY #3  
TYPICAL VIEW OF REPAIRED DEFECT #3

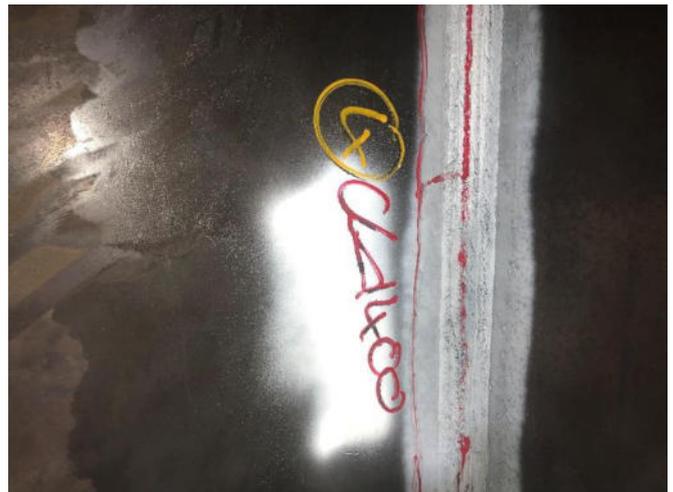
PHOTOGRAPH NO. 47 – INTERNAL BOOM BAY #3  
TYPICAL VIEW OF DEFECT #4

PHOTOGRAPH NO. 47 – INTERNAL BOOM BAY #3  
TYPICAL VIEW OF REPAIRED DEFECT #4

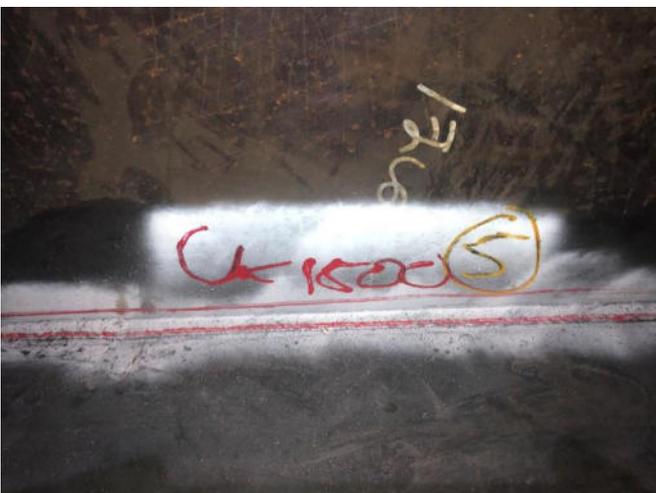
PHOTOGRAPH NO. 48 – INTERNAL BOOM BAY #3  
TYPICAL VIEW OF DEFECT #5

PHOTOGRAPH NO. 48 – INTERNAL BOOM BAY #3  
TYPICAL VIEW OF REPAIRED DEFECT #5

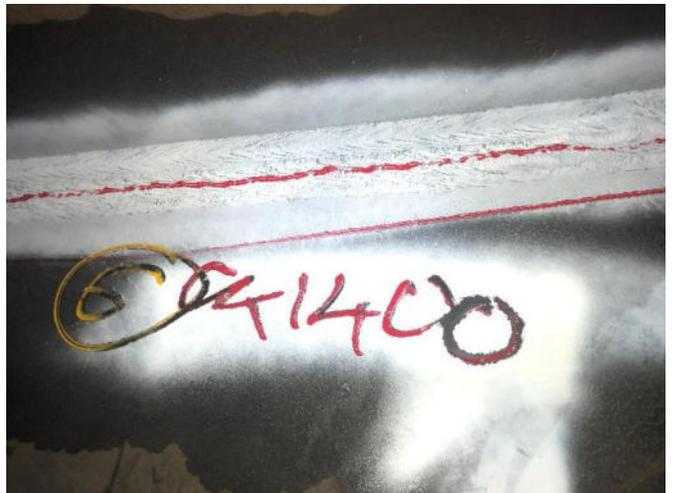
PHOTOGRAPH NO. 49 – INTERNAL BOOM BAY #3  
TYPICAL VIEW OF DEFECT #6

PHOTOGRAPH NO. 49 – INTERNAL BOOM BAY #3  
TYPICAL VIEW OF REPAIRED DEFECT #6

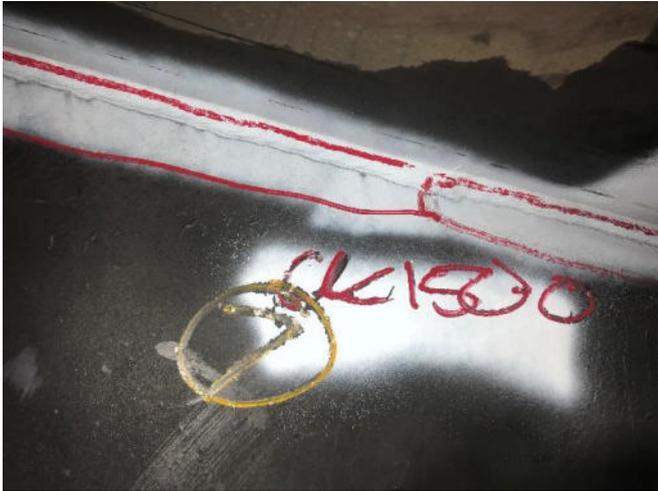
PHOTOGRAPH NO. 50 – INTERNAL BOOM BAY #3  
TYPICAL VIEW OF DEFECT #7

PHOTOGRAPH NO. 50 – INTERNAL BOOM BAY #3  
TYPICAL VIEW OF REPAIRED DEFECT #7

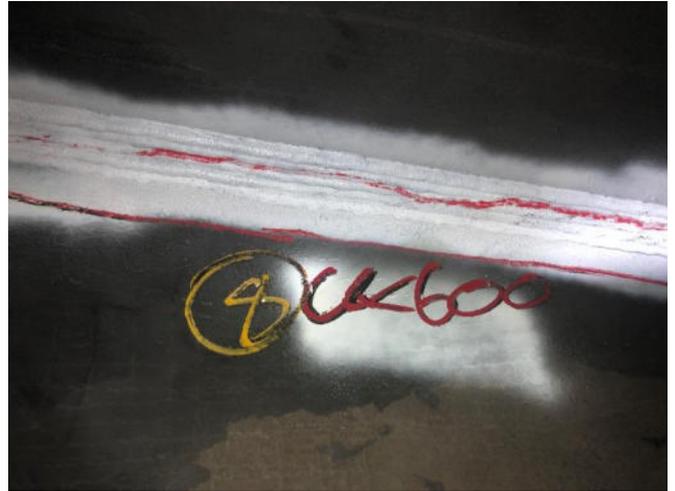
PHOTOGRAPH NO. 51 – INTERNAL BOOM BAY #3  
TYPICAL VIEW OF DEFECT #8

PHOTOGRAPH NO. 51 – INTERNAL BOOM BAY #3  
TYPICAL VIEW OF REPAIRED DEFECT #8

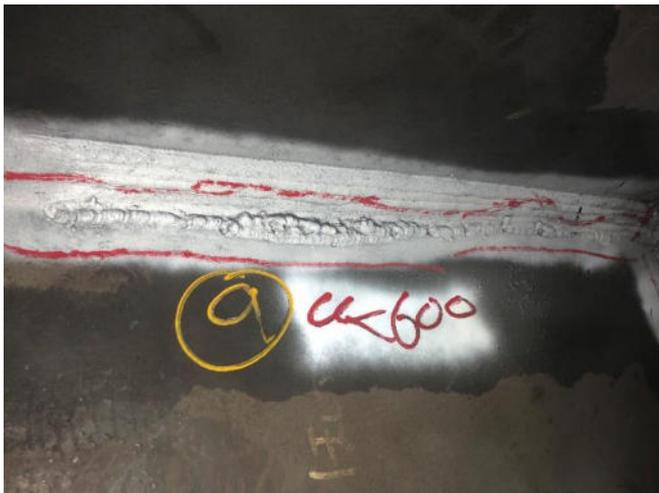
PHOTOGRAPH NO. 52 – INTERNAL BOOM BAY #3  
TYPICAL VIEW OF DEFECT #9

PHOTOGRAPH NO. 52 – INTERNAL BOOM BAY #3  
TYPICAL VIEW OF REPAIRED DEFECT #9

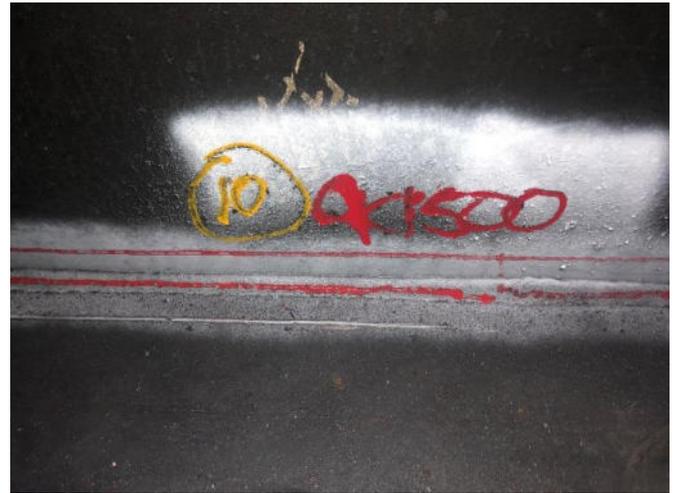
PHOTOGRAPH NO. 53 – INTERNAL BOOM BAY #3  
TYPICAL VIEW OF DEFECT #10

PHOTOGRAPH NO. 53 – INTERNAL BOOM BAY #3  
TYPICAL VIEW OF REPAIRED DEFECT #10

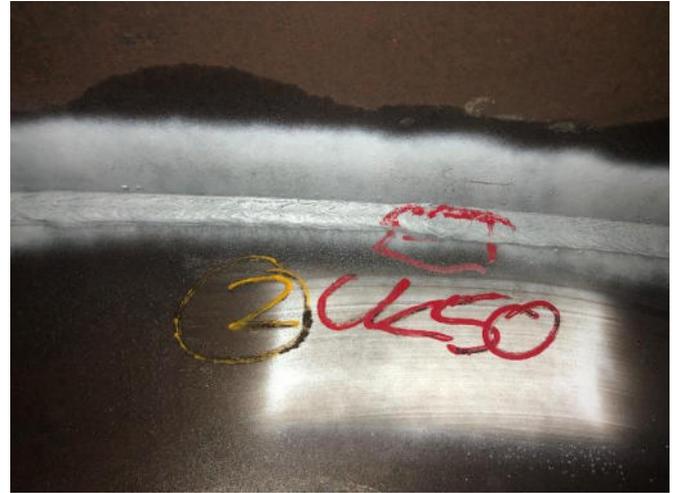
PHOTOGRAPH NO. 55 – INTERNAL BOOM BAY #4  
TYPICAL VIEW OF DEFECT #2

PHOTOGRAPH NO. 55 – INTERNAL BOOM BAY #4  
TYPICAL VIEW OF REPAIRED DEFECT #2

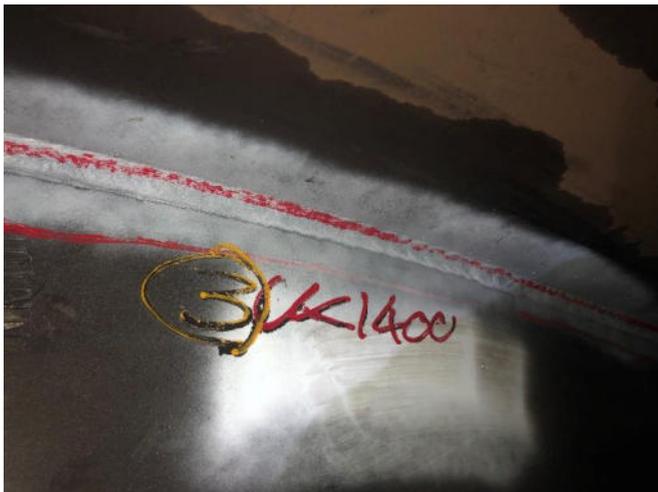
PHOTOGRAPH NO. 56 – INTERNAL BOOM BAY #4  
TYPICAL VIEW OF DEFECT #3

PHOTOGRAPH NO. 56 – INTERNAL BOOM BAY #4  
TYPICAL VIEW OF REPAIRED DEFECT #3

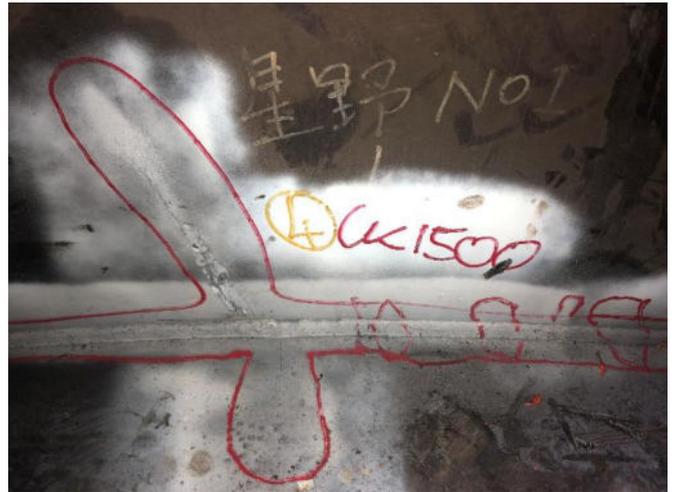
PHOTOGRAPH NO. 57 – INTERNAL BOOM BAY #4  
TYPICAL VIEW OF DEFECT #4

PHOTOGRAPH NO. 57 – INTERNAL BOOM BAY #4  
TYPICAL VIEW OF REPAIRED DEFECT #4

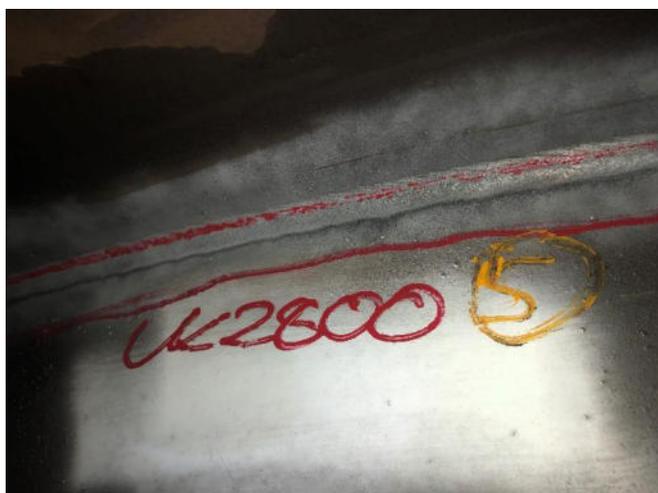
PHOTOGRAPH NO. 58 – INTERNAL BOOM BAY #4  
TYPICAL VIEW OF DEFECT #5

PHOTOGRAPH NO. 58 – INTERNAL BOOM BAY #4  
TYPICAL VIEW OF REPAIRED DEFECT #5

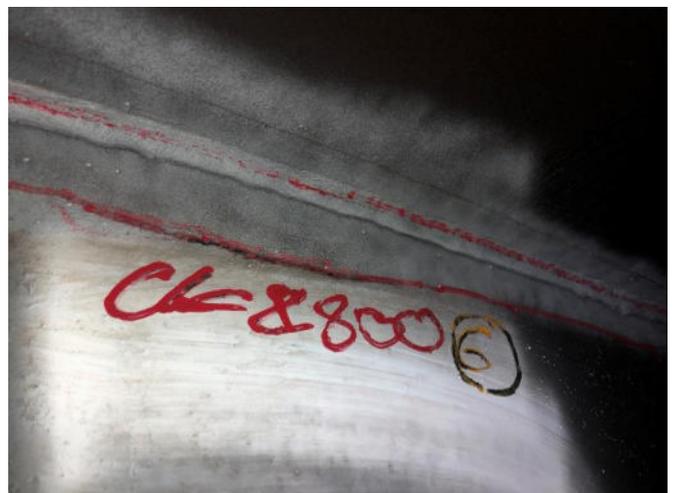
PHOTOGRAPH NO. 59 – INTERNAL BOOM BAY #4  
TYPICAL VIEW OF DEFECT #6

PHOTOGRAPH NO. 59 – INTERNAL BOOM BAY #4  
TYPICAL VIEW OF REPAIRED DEFECT #6

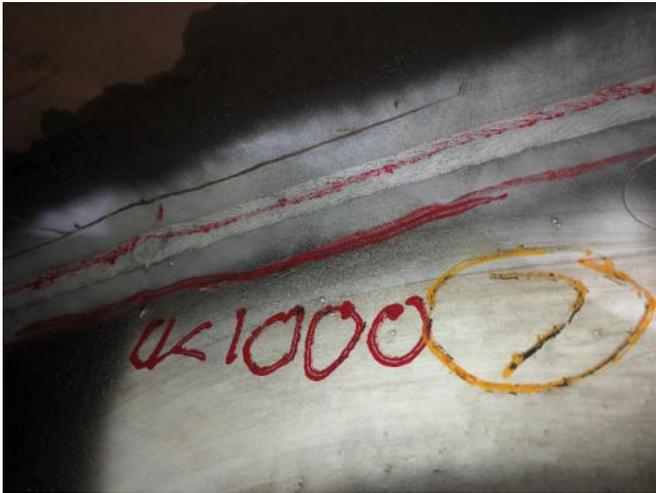
PHOTOGRAPH NO. 60 – INTERNAL BOOM BAY #4  
TYPICAL VIEW OF DEFECT #7

PHOTOGRAPH NO. 60 – INTERNAL BOOM BAY #4  
TYPICAL VIEW OF REPAIRED DEFECT #7

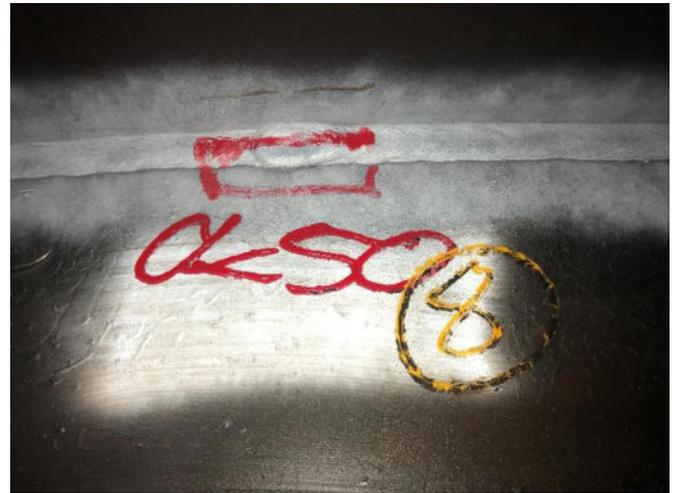
PHOTOGRAPH NO. 61 – INTERNAL BOOM BAY #4  
TYPICAL VIEW OF DEFECT #8

PHOTOGRAPH NO. 61 – INTERNAL BOOM BAY #4  
TYPICAL VIEW OF REPAIRED DEFECT #8

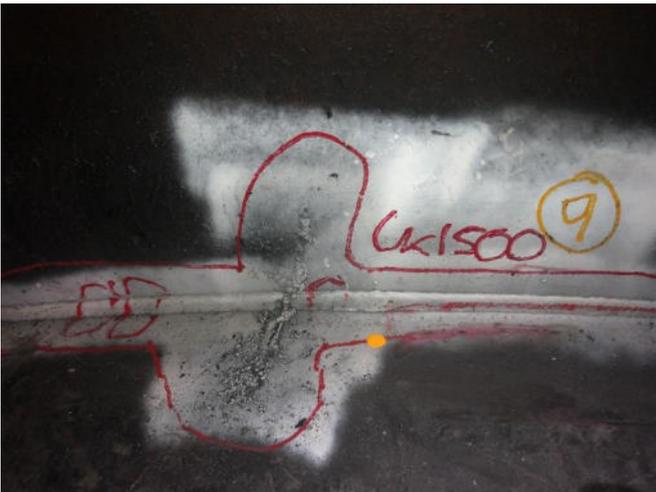
PHOTOGRAPH NO. 62 – INTERNAL BOOM BAY #4  
TYPICAL VIEW OF DEFECT #9

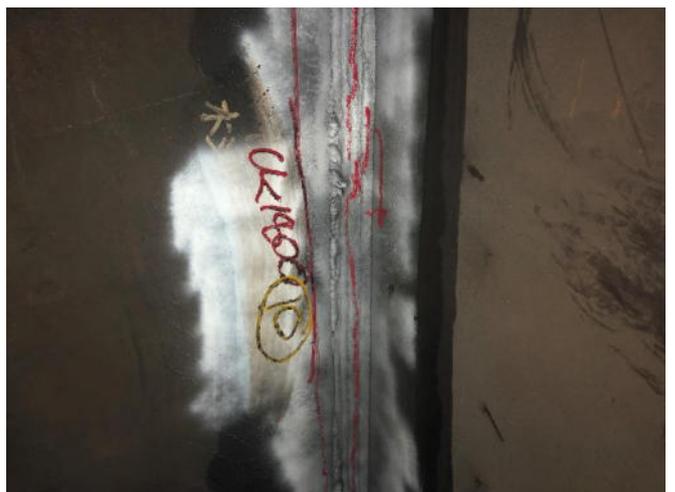
PHOTOGRAPH NO. 63 – INTERNAL BOOM BAY #4  
TYPICAL VIEW OF DEFECT #10

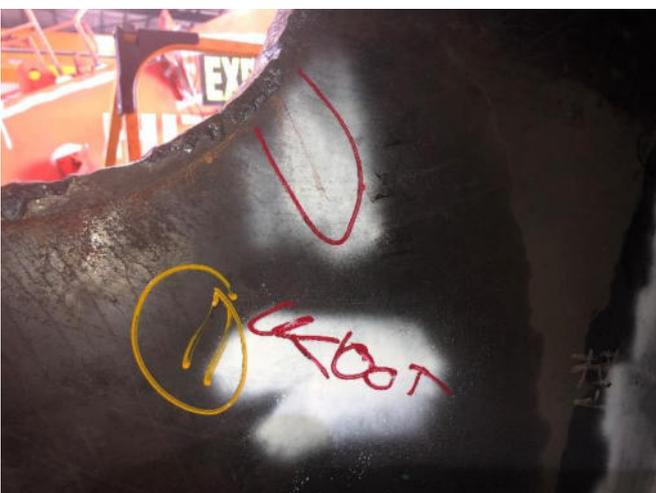
PHOTOGRAPH NO. 64 – INTERNAL BOOM BAY #4  
TYPICAL VIEW OF DEFECT #11

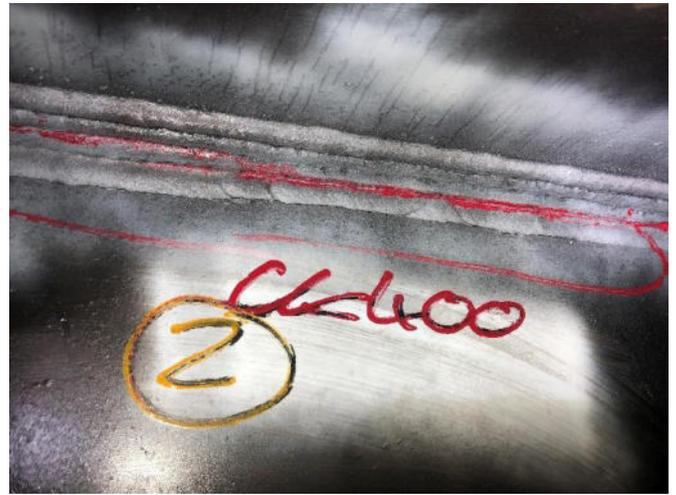
PHOTOGRAPH NO. 66 – INTERNAL BOOM BAY #5  
TYPICAL VIEW OF DEFECT #2

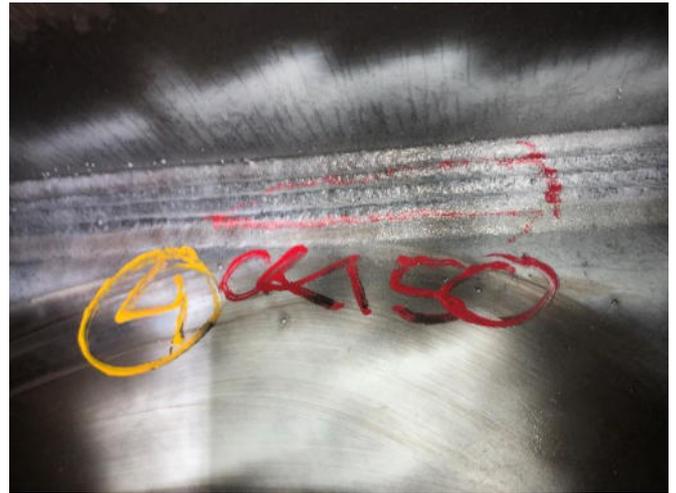
PHOTOGRAPH NO. 68 – INTERNAL BOOM BAY #5  
TYPICAL VIEW OF DEFECT #4

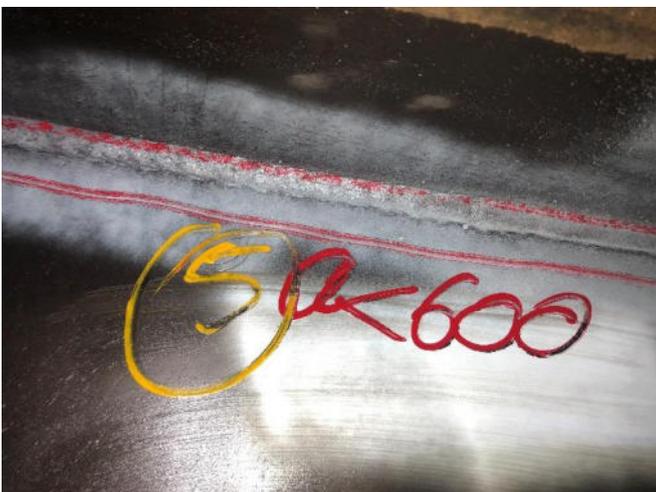
PHOTOGRAPH NO. 69 – INTERNAL BOOM BAY #5  
TYPICAL VIEW OF DEFECT #5

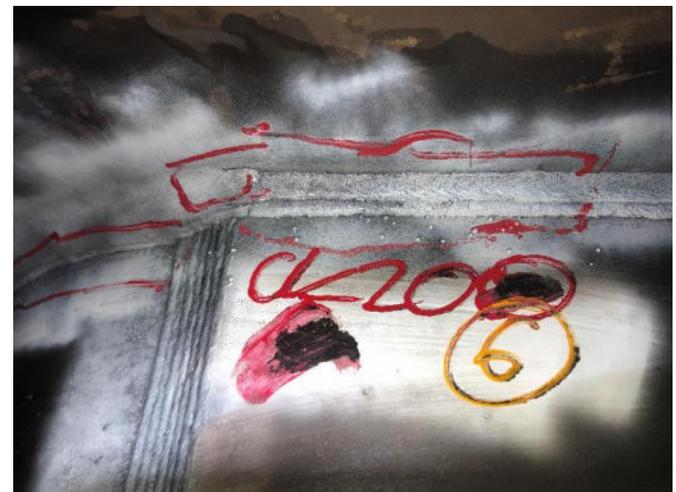
PHOTOGRAPH NO. 70 – INTERNAL BOOM BAY #5  
TYPICAL VIEW OF DEFECT #6

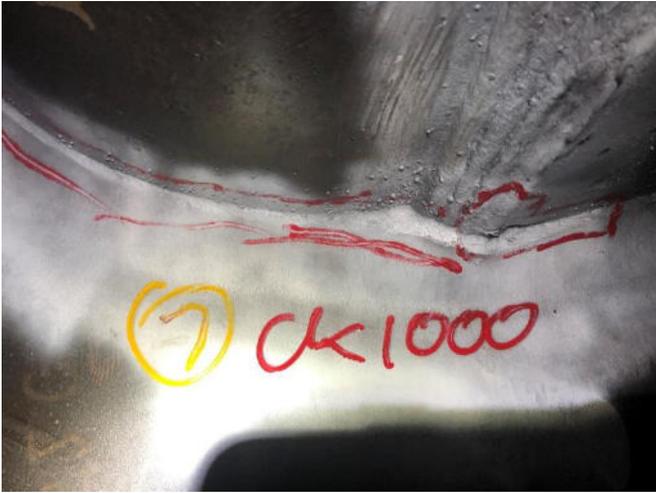
PHOTOGRAPH NO. 71 – INTERNAL BOOM BAY #5  
TYPICAL VIEW OF DEFECT #7

PHOTOGRAPH NO. 71 – INTERNAL BOOM BAY #5  
TYPICAL VIEW OF REPAIRED DEFECT #7

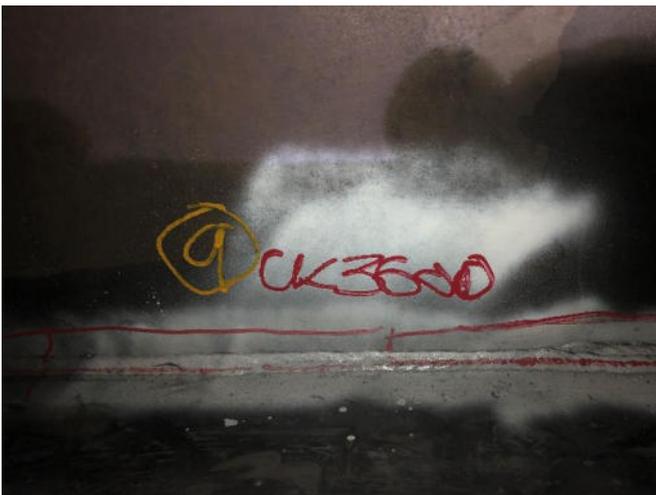
PHOTOGRAPH NO. 73 – INTERNAL BOOM BAY #5  
TYPICAL VIEW OF DEFECT #9

PHOTOGRAPH NO. 73 – INTERNAL BOOM BAY #5  
TYPICAL VIEW OF REPAIRED DEFECT #9
