# REPAIRER'S DATA REPORT

**JOB NUMBER: 27861**

**Description: REFURB EX5600 BOOM**

## STRUCTURAL INTEGRITY SURVEY REPORT FOR THE STRUCTURE REPORT NUMBER HMI 23-033.7

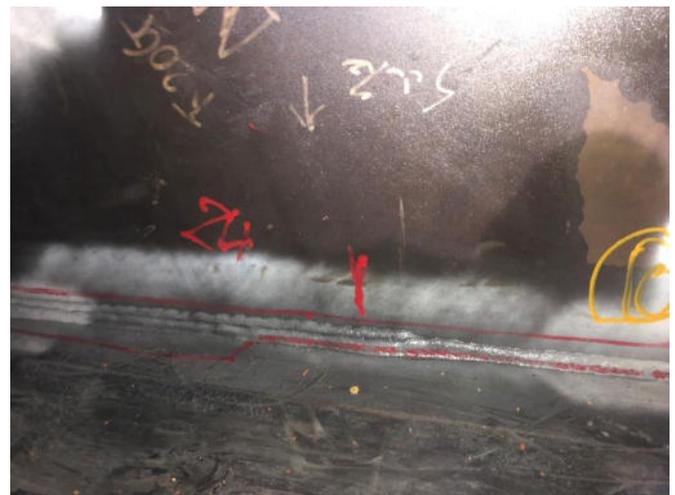
PHOTOGRAPH NO. 74 – INTERNAL BOOM BAY #5  
TYPICAL VIEW OF DEFECT #10

PHOTOGRAPH NO. 74 – INTERNAL BOOM BAY #5  
TYPICAL VIEW OF REPAIRED DEFECT #10

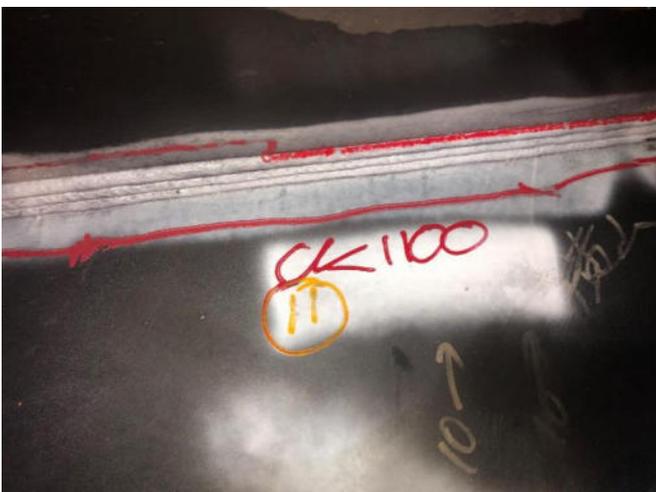
PHOTOGRAPH NO. 75 – INTERNAL BOOM BAY #5  
TYPICAL VIEW OF DEFECT #11

PHOTOGRAPH NO. 75 – INTERNAL BOOM BAY #5  
TYPICAL VIEW OF REPAIRED DEFECT #11

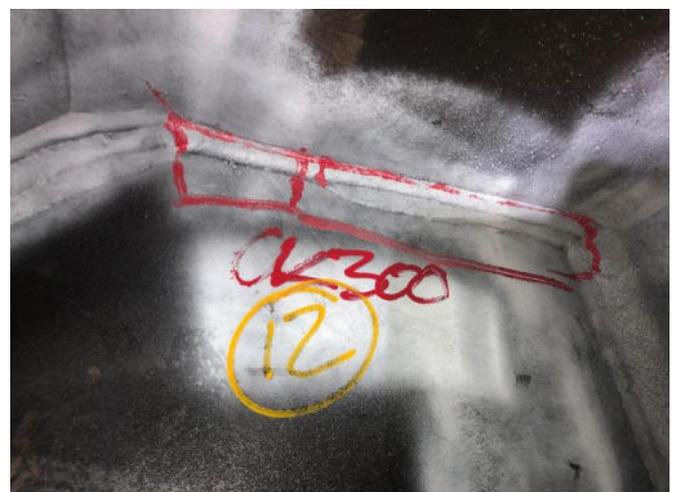
PHOTOGRAPH NO. 76 – INTERNAL BOOM BAY #5  
TYPICAL VIEW OF DEFECT #12

PHOTOGRAPH NO. 76 – INTERNAL BOOM BAY #5  
TYPICAL VIEW OF REPAIRED DEFECT #12

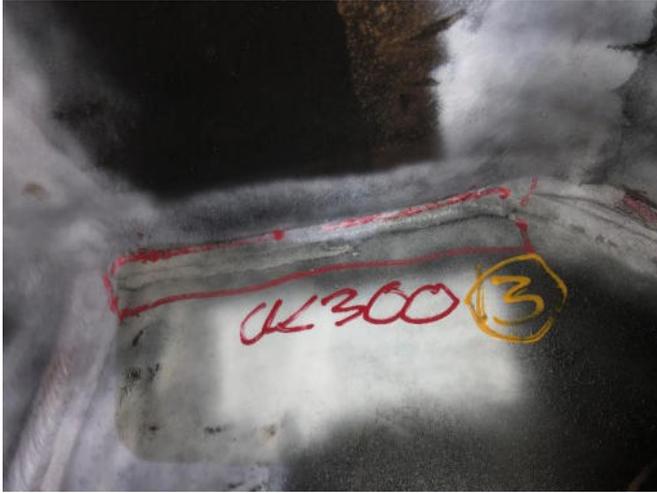
PHOTOGRAPH NO. 77 – INTERNAL BOOM BAY #5  
TYPICAL VIEW OF DEFECT #13

PHOTOGRAPH NO. 77 – INTERNAL BOOM BAY #5  
TYPICAL VIEW OF REPAIRED DEFECT #13

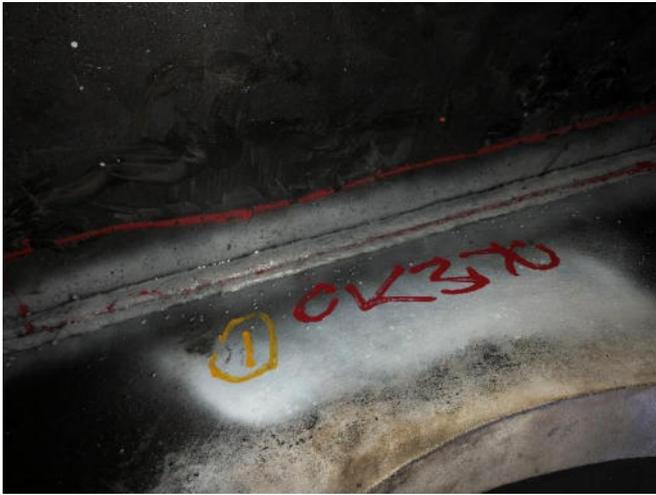
PHOTOGRAPH NO. 78 – INTERNAL BOOM BAY #6  
TYPICAL VIEW OF DEFECT #1

PHOTOGRAPH NO. 78 – INTERNAL BOOM BAY #6  
TYPICAL VIEW OF REPAIRED DEFECT #1

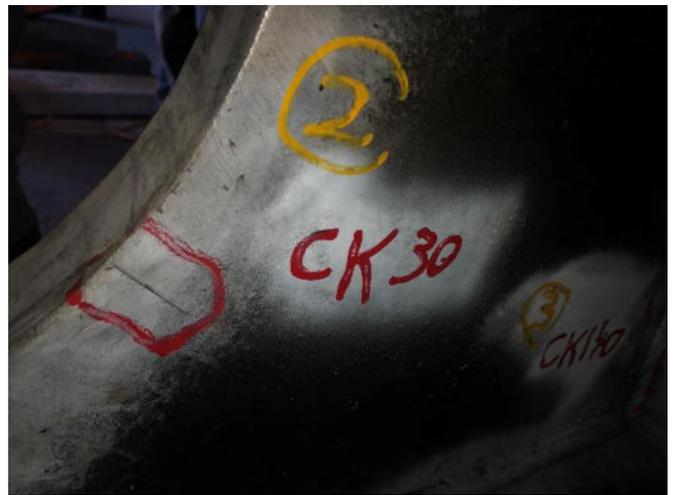
PHOTOGRAPH NO. 79 – INTERNAL BOOM BAY #6  
TYPICAL VIEW OF DEFECT #2

PHOTOGRAPH NO. 79 – INTERNAL BOOM BAY #6  
TYPICAL VIEW OF REPAIRED DEFECT #2

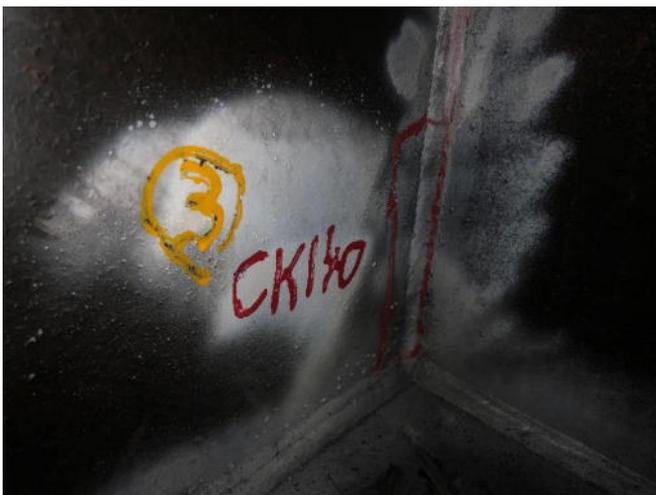
PHOTOGRAPH NO. 80 – INTERNAL BOOM BAY #6  
TYPICAL VIEW OF DEFECT #3

PHOTOGRAPH NO. 80 – INTERNAL BOOM BAY #6  
TYPICAL VIEW OF REPAIRED DEFECT #3

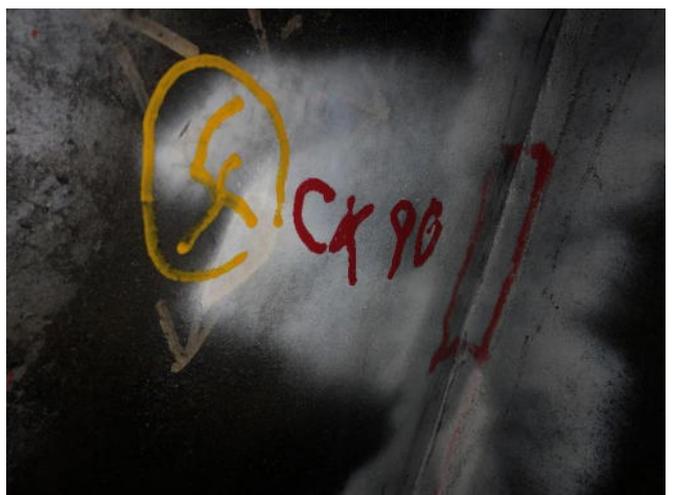
PHOTOGRAPH NO. 81 – INTERNAL BOOM BAY #6  
TYPICAL VIEW OF DEFECT #4

PHOTOGRAPH NO. 81 – INTERNAL BOOM BAY #6  
TYPICAL VIEW OF REPAIRED DEFECT #4

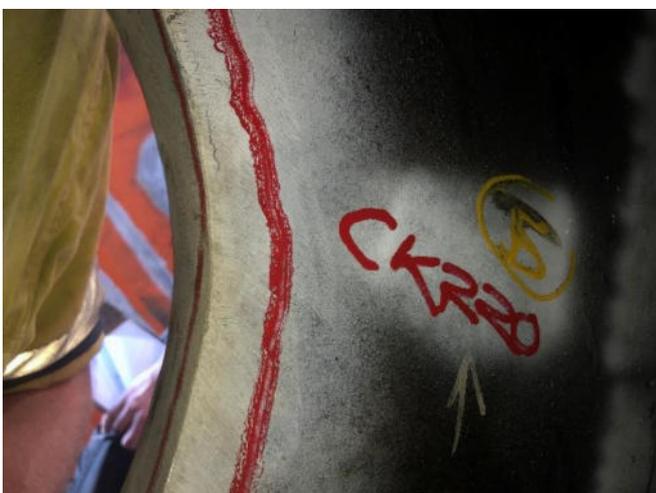
PHOTOGRAPH NO. 82 – INTERNAL BOOM BAY #6  
TYPICAL VIEW OF DEFECT #5

PHOTOGRAPH NO. 82 – INTERNAL BOOM BAY #6  
TYPICAL VIEW OF REPAIRED DEFECT #5

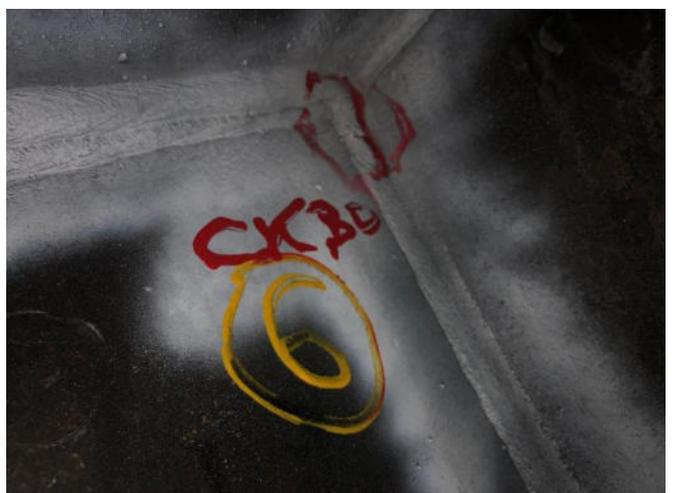
PHOTOGRAPH NO. 83 – INTERNAL BOOM BAY #6  
TYPICAL VIEW OF DEFECT #6

PHOTOGRAPH NO. 83 – INTERNAL BOOM BAY #6  
TYPICAL VIEW OF REPAIRED DEFECT #6

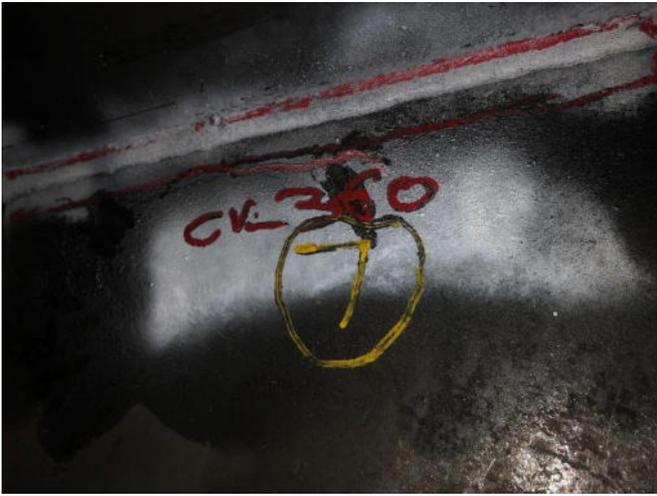
PHOTOGRAPH NO. 84 – INTERNAL BOOM BAY #6  
TYPICAL VIEW OF DEFECT #7

PHOTOGRAPH NO. 84 – INTERNAL BOOM BAY #6  
TYPICAL VIEW OF REPAIRED DEFECT #7

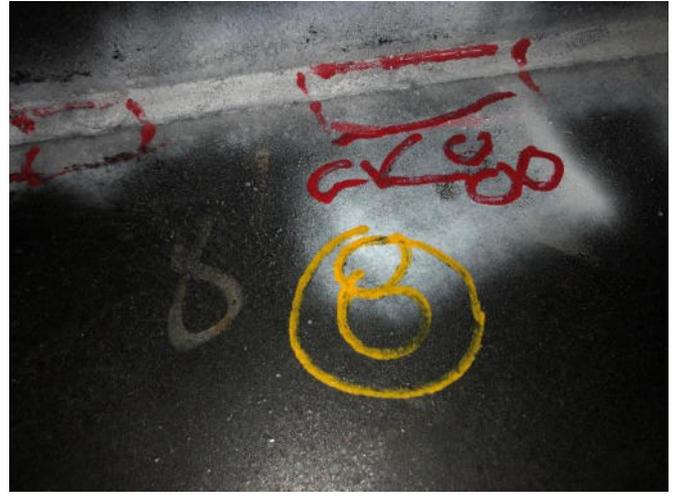
PHOTOGRAPH NO. 85 – INTERNAL BOOM BAY #6  
TYPICAL VIEW OF DEFECT #8

PHOTOGRAPH NO. 85 – INTERNAL BOOM BAY #6  
TYPICAL VIEW OF REPAIRED DEFECT #8

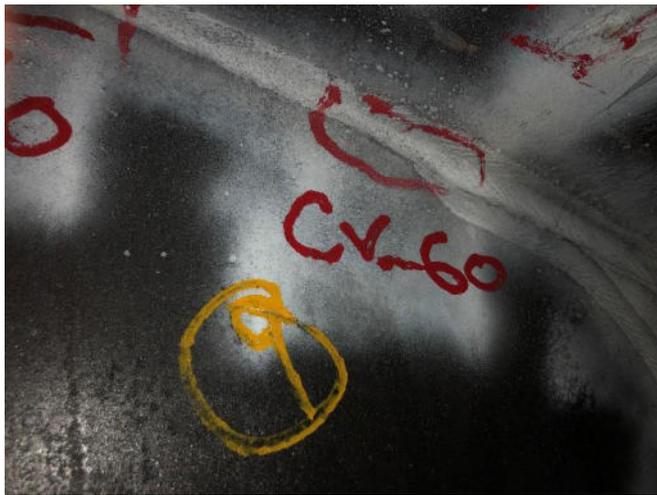
PHOTOGRAPH NO. 86 – INTERNAL BOOM BAY #6  
TYPICAL VIEW OF DEFECT #9

PHOTOGRAPH NO. 86 – INTERNAL BOOM BAY #6  
TYPICAL VIEW OF REPAIRED DEFECT #9

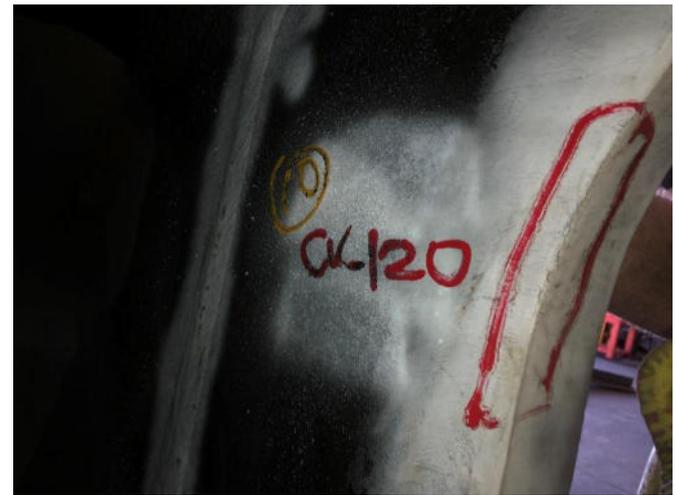
PHOTOGRAPH NO. 87 – INTERNAL BOOM BAY #6  
TYPICAL VIEW OF DEFECT #10

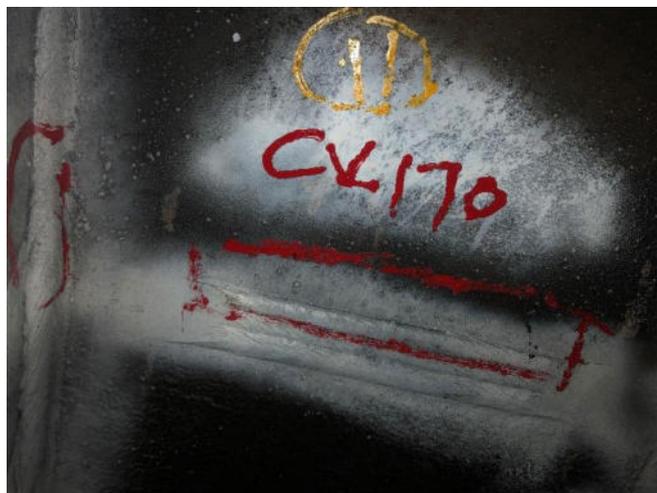
PHOTOGRAPH NO. 88 – INTERNAL BOOM BAY #6  
TYPICAL VIEW OF DEFECT #11

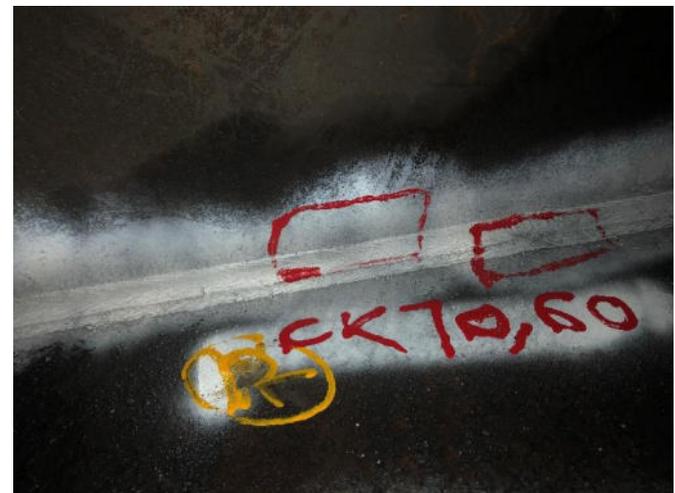
PHOTOGRAPH NO. 89 – INTERNAL BOOM BAY #6  
TYPICAL VIEW OF DEFECT #12

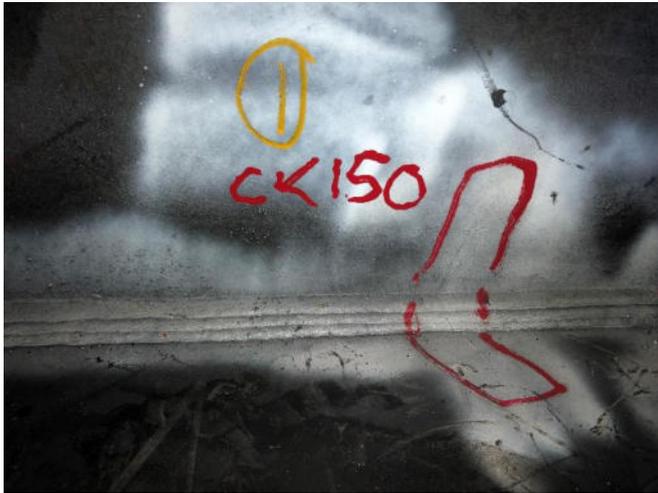
PHOTOGRAPH NO. 90 – INTERNAL BOOM BAY #7  
TYPICAL VIEW OF DEFECT #1

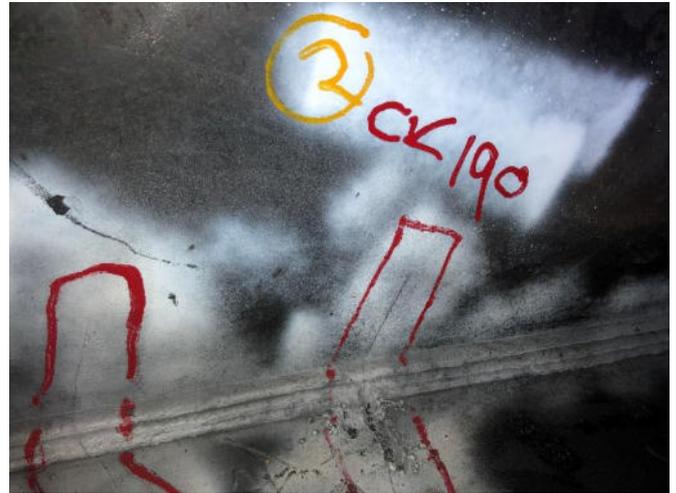
PHOTOGRAPH NO. 91 – INTERNAL BOOM BAY #7  
TYPICAL VIEW OF DEFECT #2

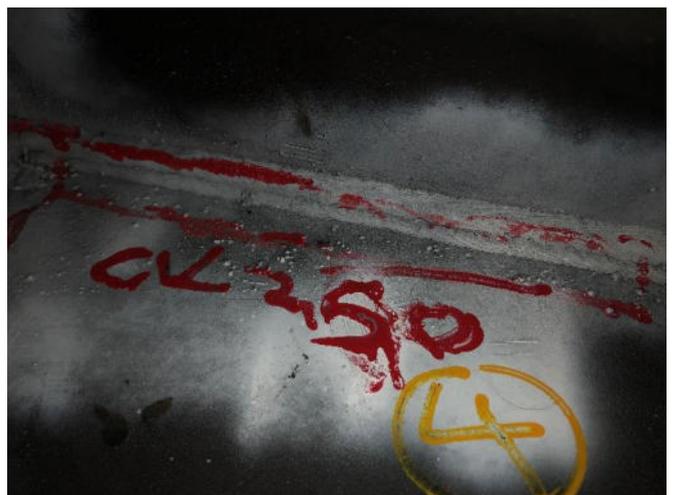
PHOTOGRAPH NO. 93 – INTERNAL BOOM BAY #7  
TYPICAL VIEW OF DEFECT #4

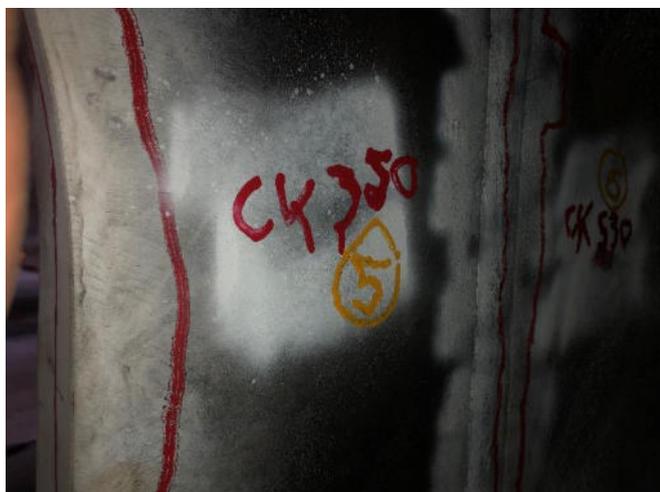
PHOTOGRAPH NO. 94 – INTERNAL BOOM BAY #7  
TYPICAL VIEW OF DEFECT #5

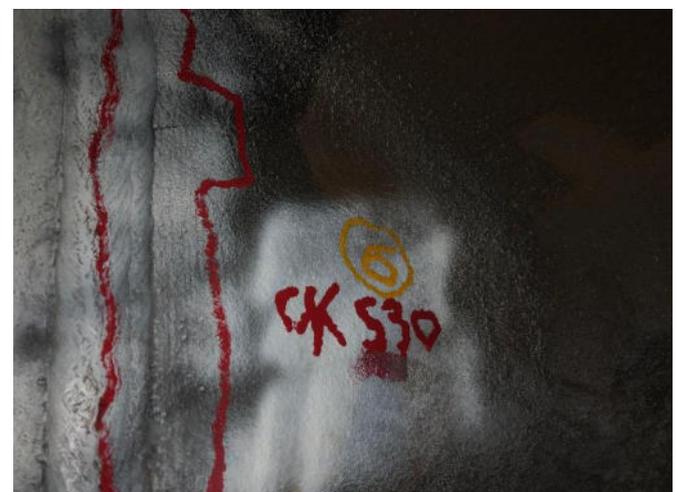
PHOTOGRAPH NO. 95 – INTERNAL BOOM BAY #7  
TYPICAL VIEW OF DEFECT #6

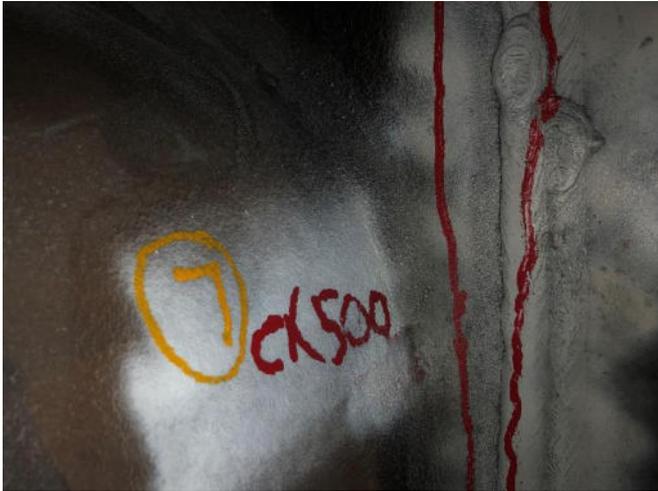
PHOTOGRAPH NO. 96 – INTERNAL BOOM BAY #7  
TYPICAL VIEW OF DEFECT #7

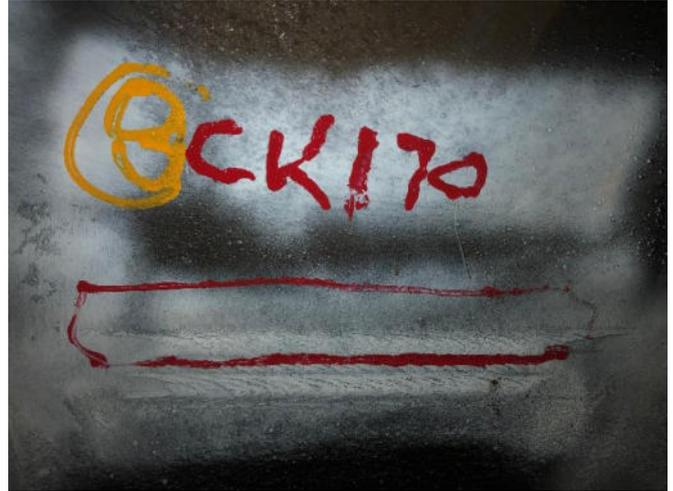
PHOTOGRAPH NO. 97 – INTERNAL BOOM BAY #7  
TYPICAL VIEW OF DEFECT #8

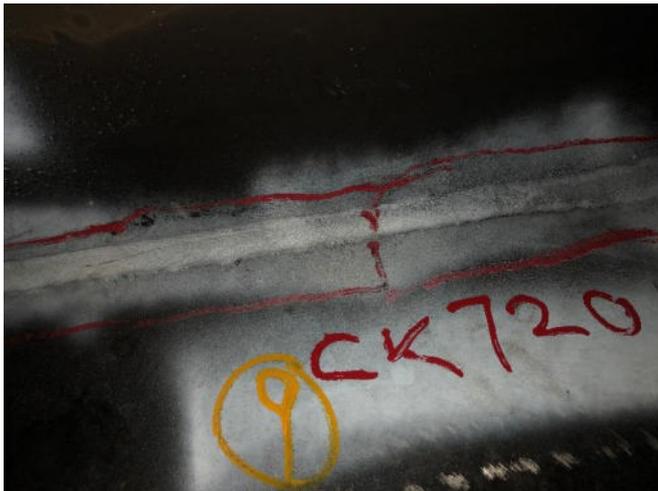
PHOTOGRAPH NO. 98 – INTERNAL BOOM BAY #7  
TYPICAL VIEW OF DEFECT #9

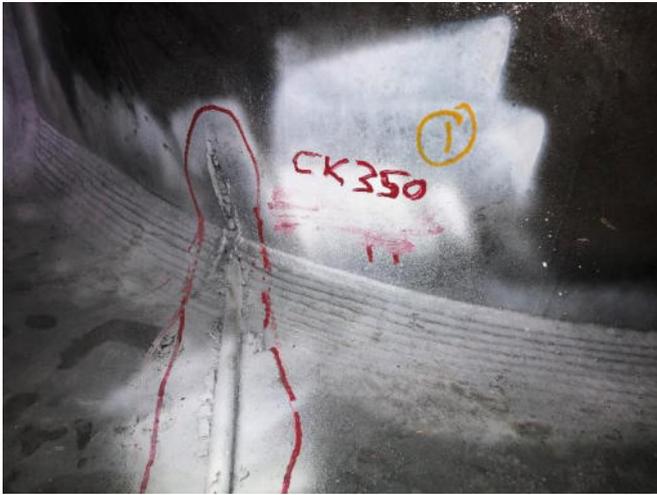
PHOTOGRAPH NO. 99 – INTERNAL BOOM BAY #8  
TYPICAL VIEW OF DEFECT #1

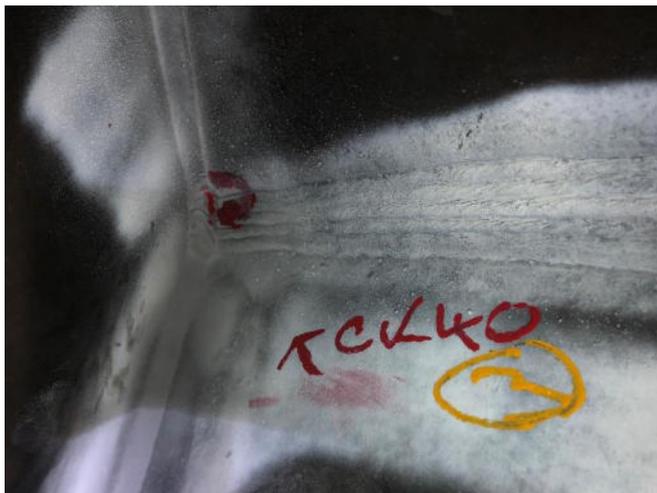
PHOTOGRAPH NO. 101 – INTERNAL BOOM BAY #8  
TYPICAL VIEW OF DEFECT #3

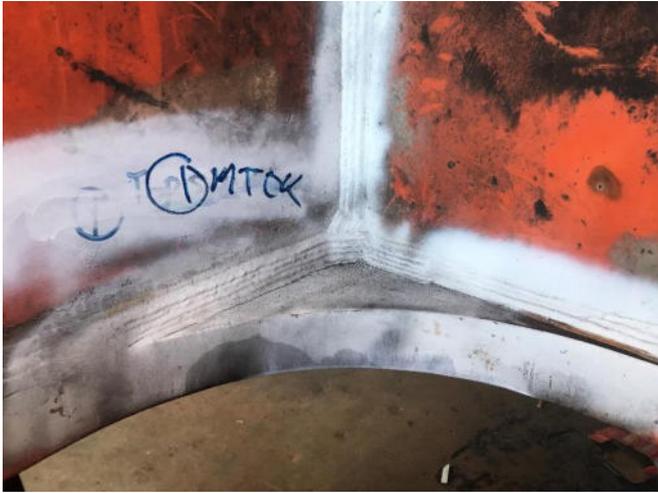
PHOTOGRAPH NO. 1 – EXTERNAL BOOM  
TYPICAL VIEW OF REPAIRED DEFECT #1

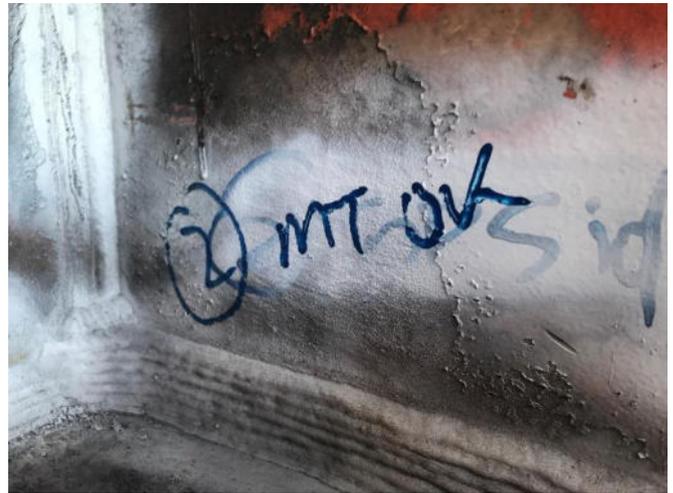
PHOTOGRAPH NO. 2 – EXTERNAL BOOM  
TYPICAL VIEW OF REPAIRED DEFECT #2

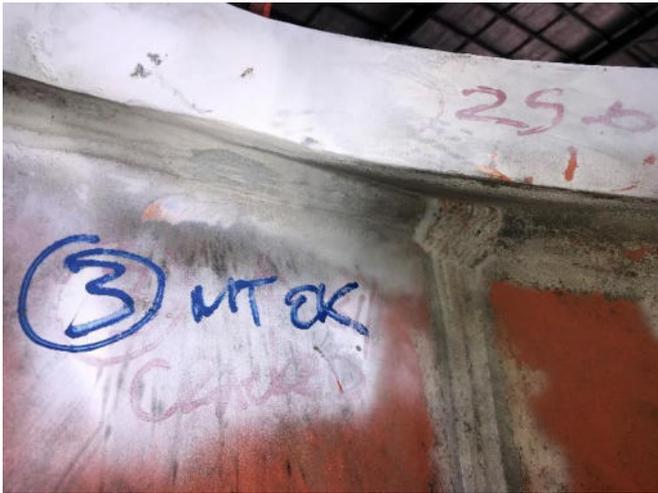
PHOTOGRAPH NO. 3 - EXTERNAL BOOM  
TYPICAL VIEW OF REPAIRED DEFECT #3

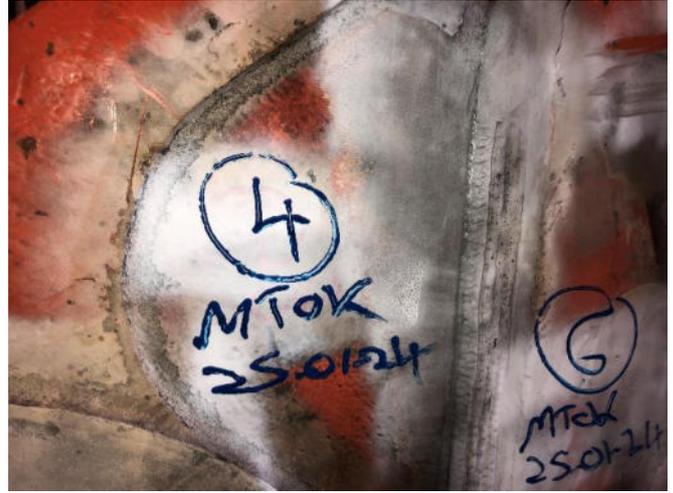
PHOTOGRAPH NO. 4 – EXTERNAL BOOM  
TYPICAL VIEW OF REPAIRED DEFECT #4

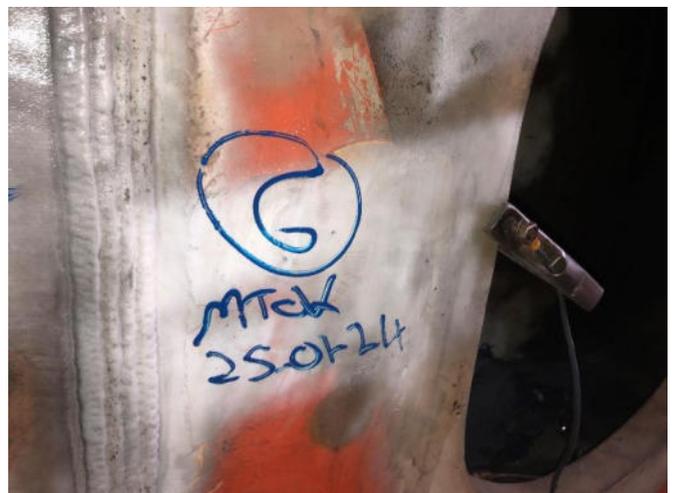
PHOTOGRAPH NO. 6 – EXTERNAL BOOM  
TYPICAL VIEW OF REPAIRED DEFECT #6

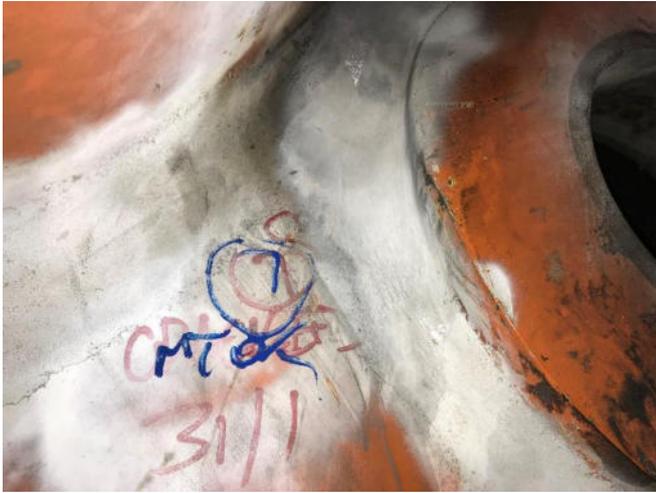
PHOTOGRAPH NO. 7 – EXTERNAL BOOM  
TYPICAL VIEW OF REPAIRED DEFECT #7

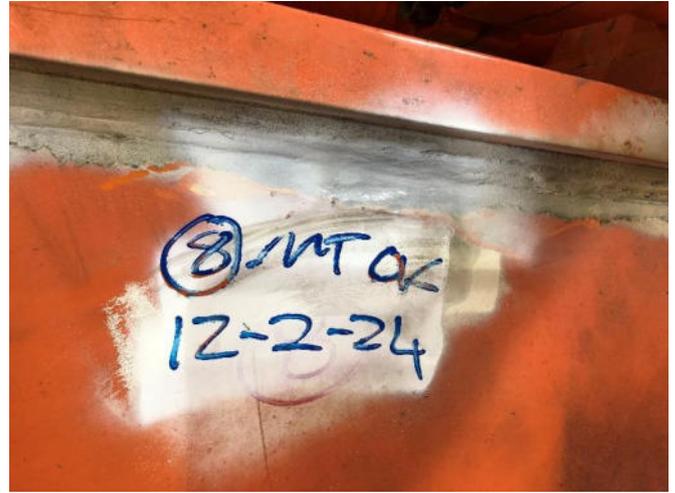
PHOTOGRAPH NO. 8 – EXTERNAL BOOM  
TYPICAL VIEW OF REPAIRED DEFECT #8

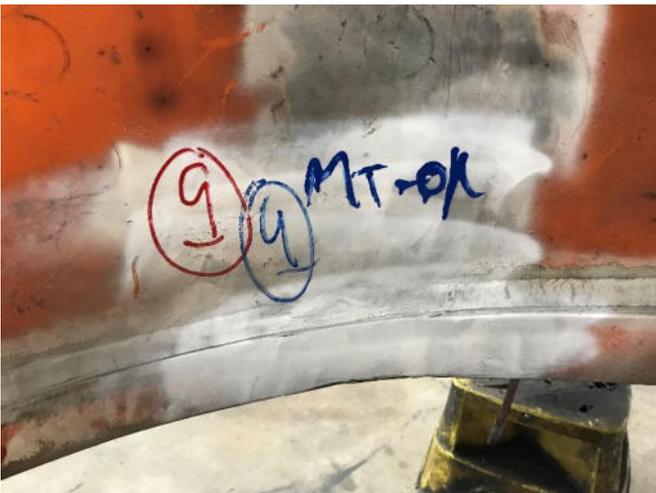
PHOTOGRAPH NO. 9 – EXTERNAL BOOM  
TYPICAL VIEW OF REPAIRED DEFECT #9

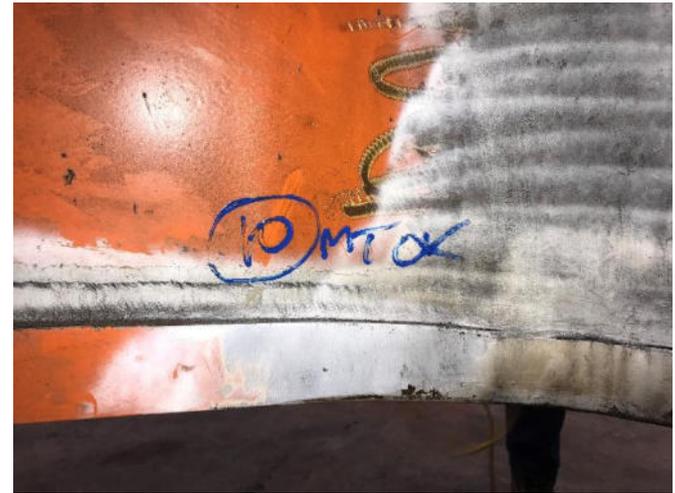
PHOTOGRAPH NO. 10 – EXTERNAL BOOM  
TYPICAL VIEW OF REPAIRED DEFECT #10

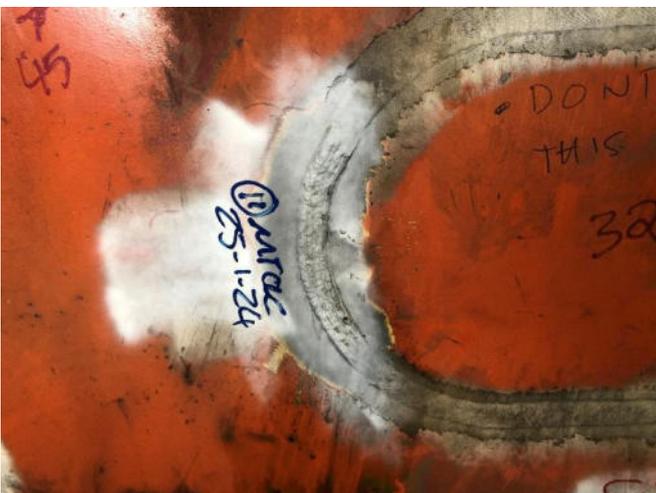
PHOTOGRAPH NO. 11 – EXTERNAL BOOM  
TYPICAL VIEW OF REPAIRED DEFECT #11

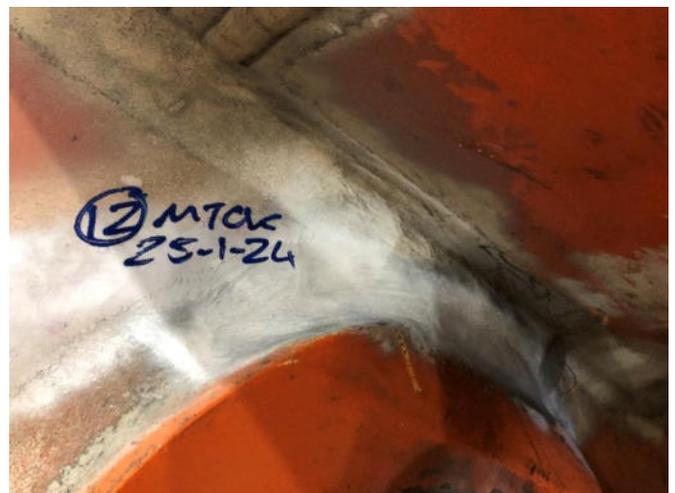
PHOTOGRAPH NO. 12 – EXTERNAL BOOM  
TYPICAL VIEW OF REPAIRED DEFECT #12

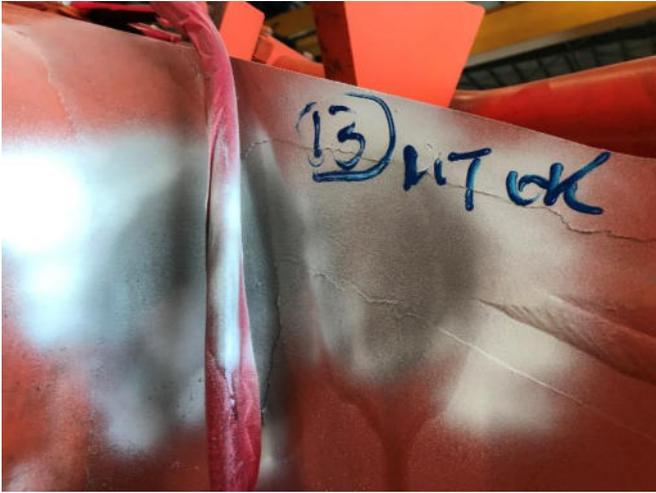
PHOTOGRAPH NO. 13 – EXTERNAL BOOM  
TYPICAL VIEW OF REPAIRED DEFECT #13

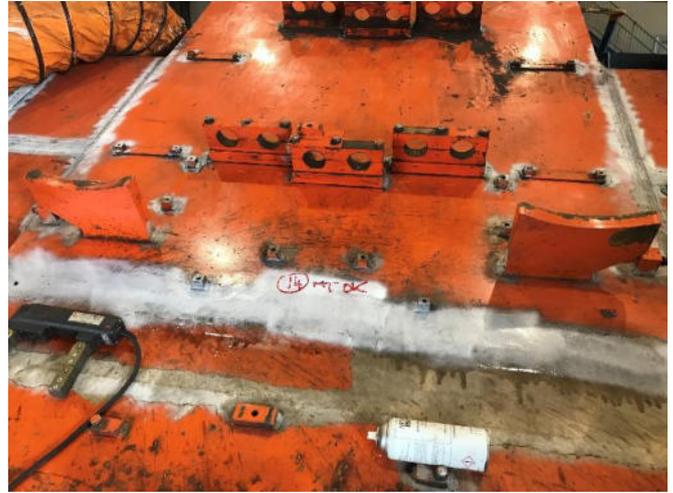
PHOTOGRAPH NO. 14 – EXTERNAL BOOM  
TYPICAL VIEW OF REPAIRED DEFECT #14

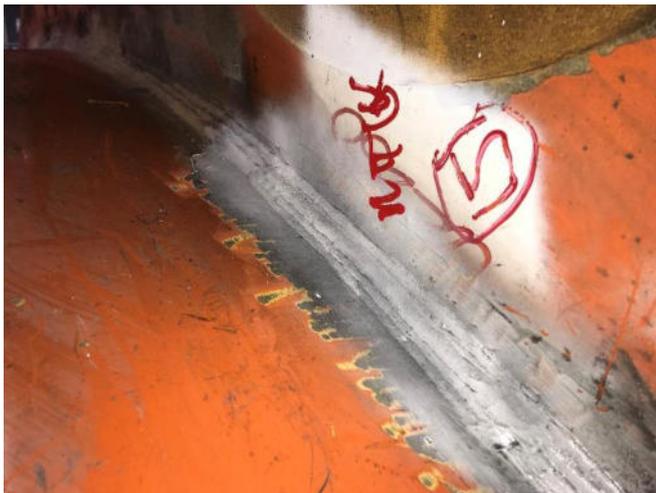
PHOTOGRAPH NO. 15 – EXTERNAL BOOM  
TYPICAL VIEW OF REPAIRED DEFECT #15

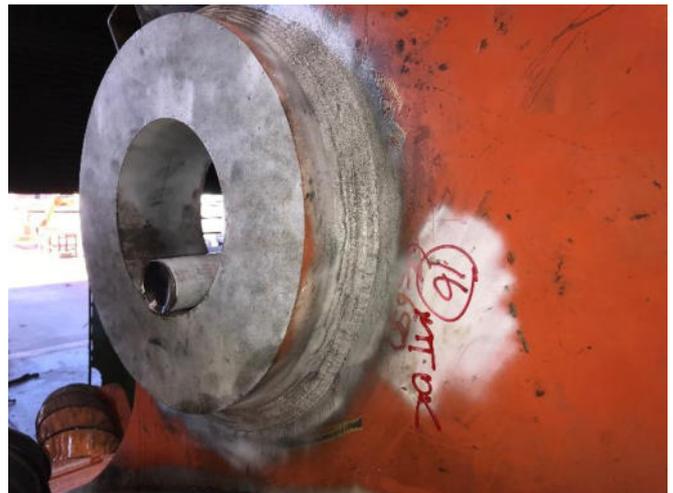
PHOTOGRAPH NO. 16 – EXTERNAL BOOM  
TYPICAL VIEW OF REPAIRED DEFECT #16

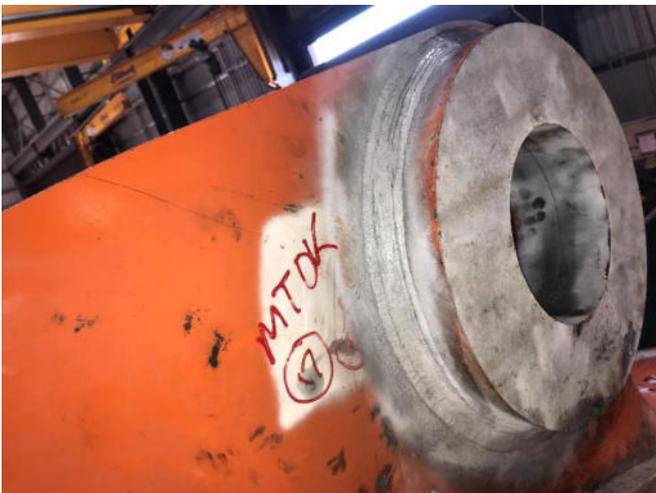
PHOTOGRAPH NO. 17 – EXTERNAL BOOM  
TYPICAL VIEW OF REPAIRED DEFECT #17

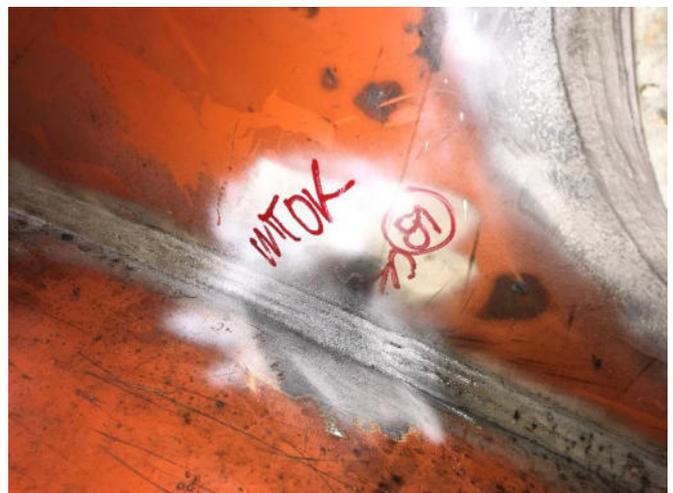
PHOTOGRAPH NO. 18 – EXTERNAL BOOM  
TYPICAL VIEW OF REPAIRED DEFECT #18

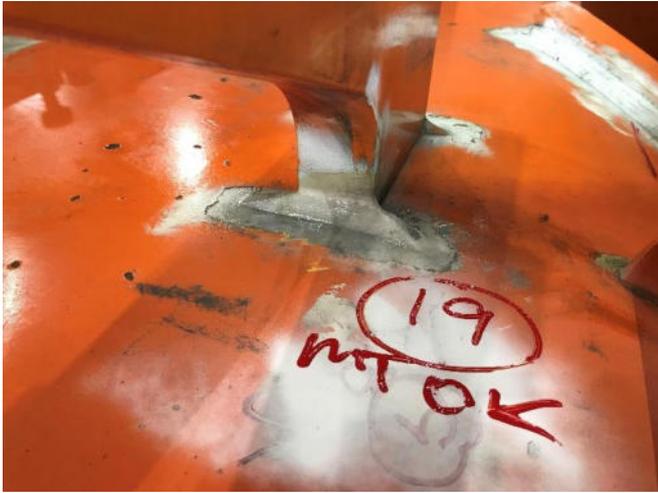
PHOTOGRAPH NO. 19 – EXTERNAL BOOM  
TYPICAL VIEW OF REPAIRED DEFECT #19

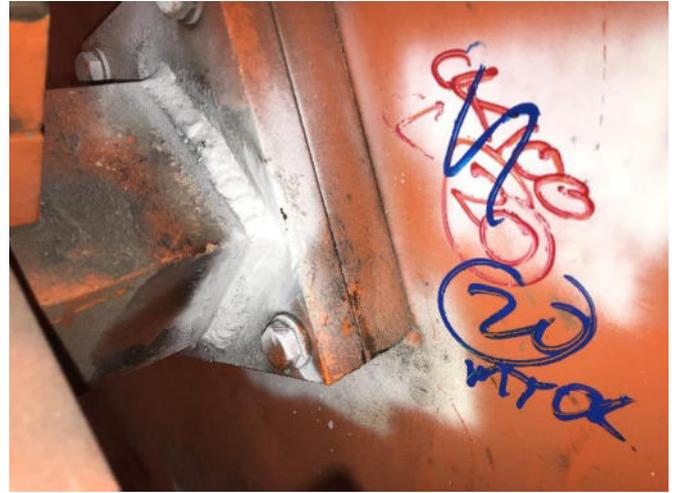
PHOTOGRAPH NO. 20 – EXTERNAL BOOM  
TYPICAL VIEW OF REPAIRED DEFECT #20

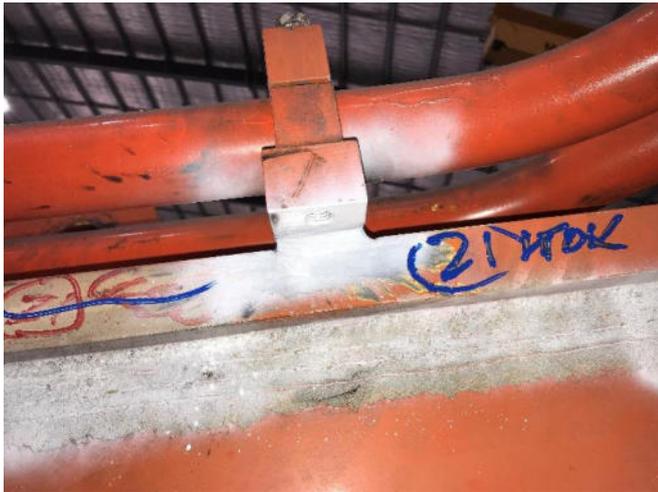
PHOTOGRAPH NO. 21 – EXTERNAL BOOM  
TYPICAL VIEW OF REPAIRED DEFECT #21

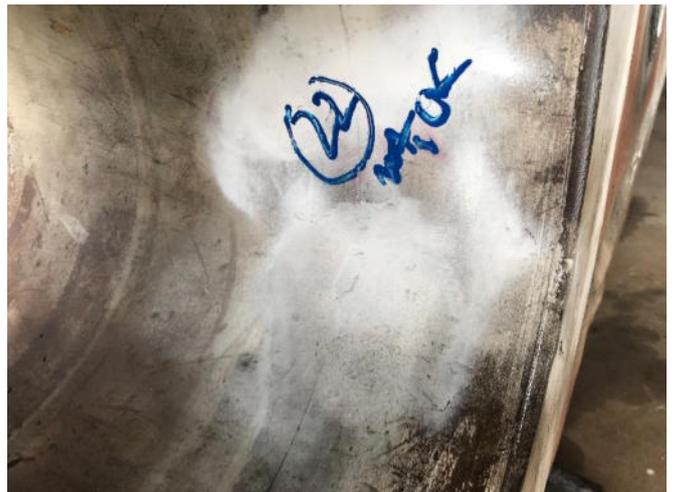
PHOTOGRAPH NO. 22 – EXTERNAL BOOM  
TYPICAL VIEW OF REPAIRED DEFECT #22

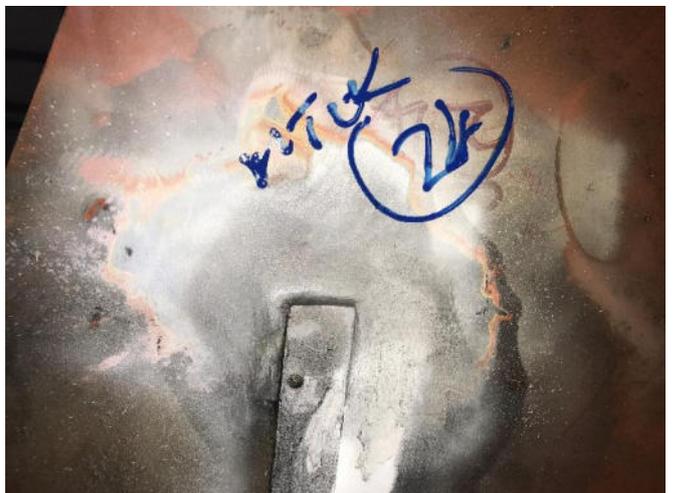
PHOTOGRAPH NO. 24 – EXTERNAL BOOM  
TYPICAL VIEW OF REPAIRED DEFECT #24

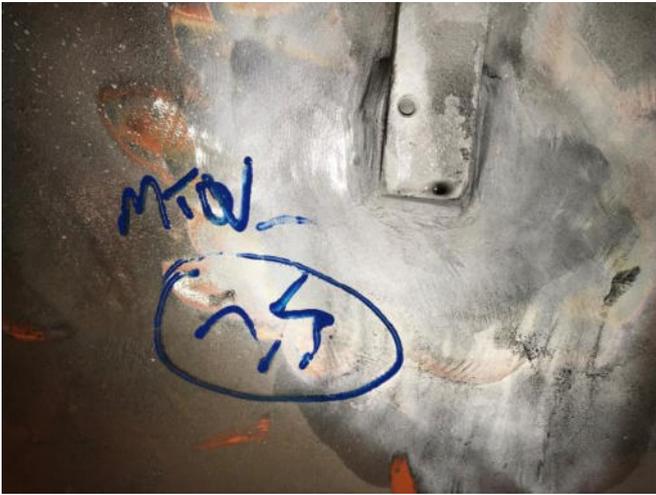
PHOTOGRAPH NO. 25 – EXTERNAL BOOM  
TYPICAL VIEW OF REPAIRED DEFECT #25

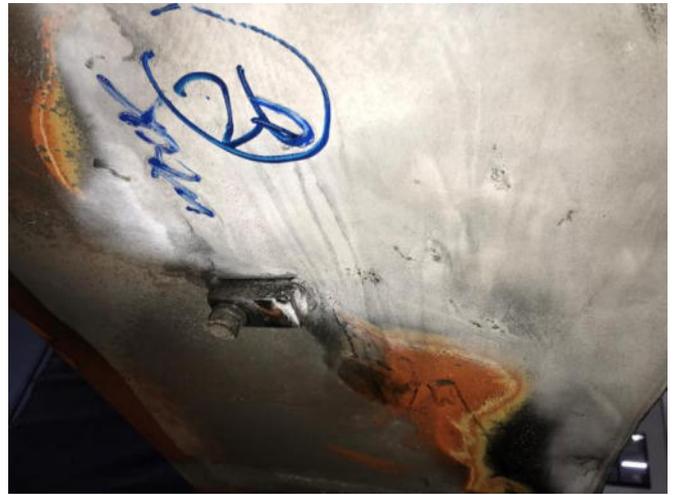
PHOTOGRAPH NO. 26 – EXTERNAL BOOM  
TYPICAL VIEW OF REPAIRED DEFECT #26

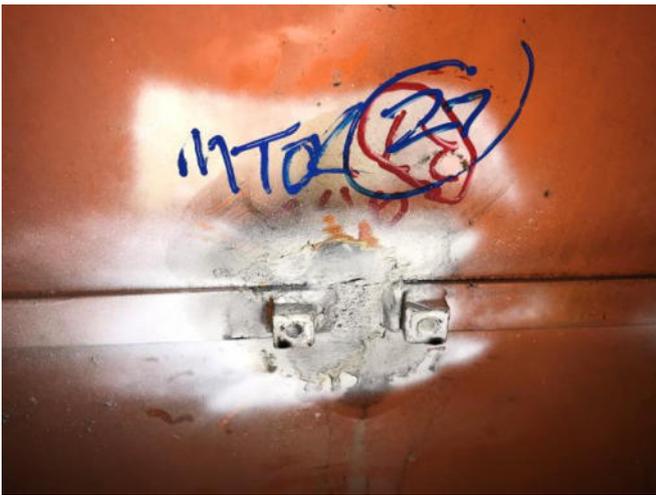
PHOTOGRAPH NO. 27 – EXTERNAL BOOM  
TYPICAL VIEW OF REPAIRED DEFECT #27

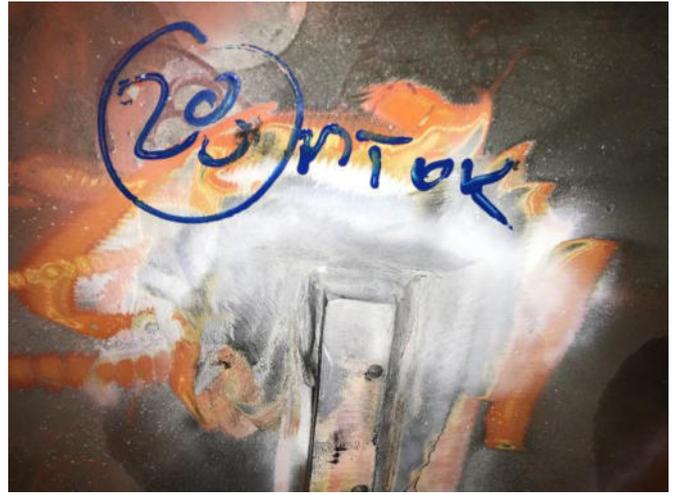
PHOTOGRAPH NO. 28 – EXTERNAL BOOM  
TYPICAL VIEW OF REPAIRED DEFECT #28

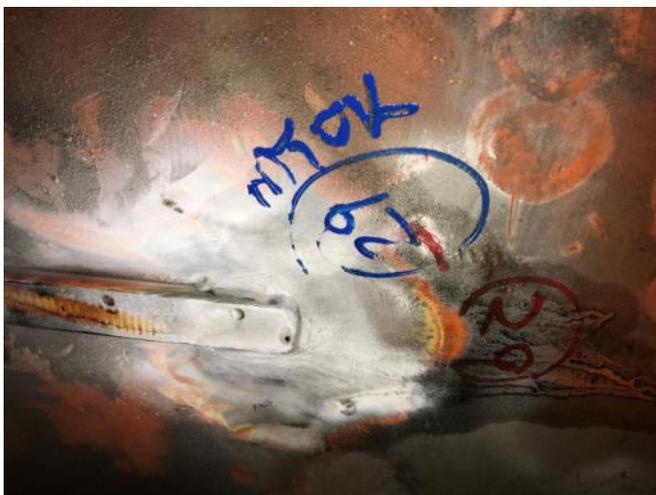
PHOTOGRAPH NO. 29 – EXTERNAL BOOM  
TYPICAL VIEW OF REPAIRED DEFECT #29

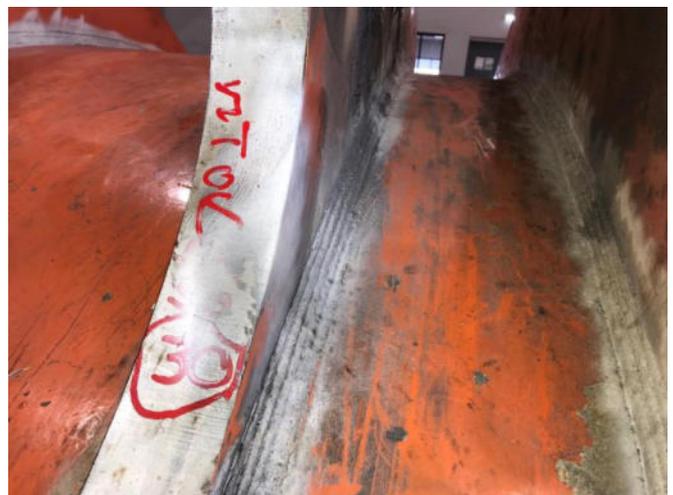
PHOTOGRAPH NO. 30 – EXTERNAL BOOM  
TYPICAL VIEW OF REPAIRED DEFECT #30

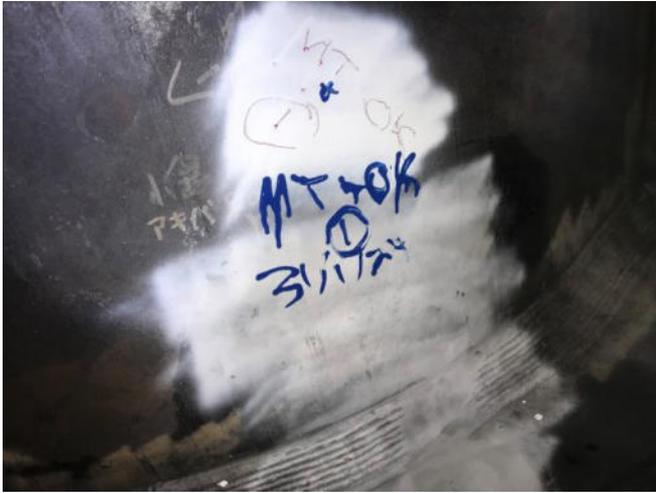
PHOTOGRAPH NO. 31 – INTERNAL BOOM BAY #1  
TYPICAL VIEW OF REPAIRED DEFECT #1

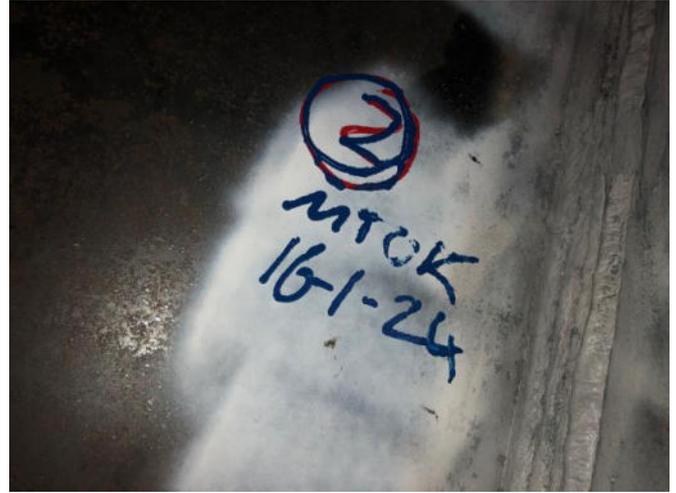
PHOTOGRAPH NO. 32 – INTERNAL BOOM BAY #1  
TYPICAL VIEW OF REPAIRED DEFECT #2

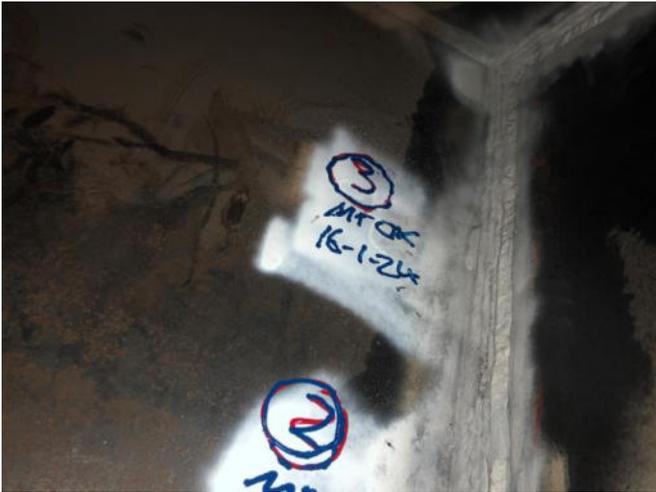
PHOTOGRAPH NO. 33 – INTERNAL BOOM BAY #1  
TYPICAL VIEW OF REPAIRED DEFECT #3

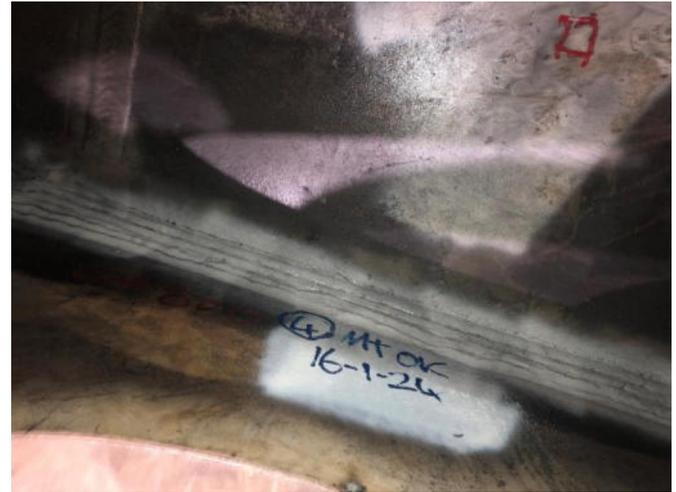
PHOTOGRAPH NO. 34 – INTERNAL BOOM BAY #1  
TYPICAL VIEW OF REPAIRED DEFECT #4

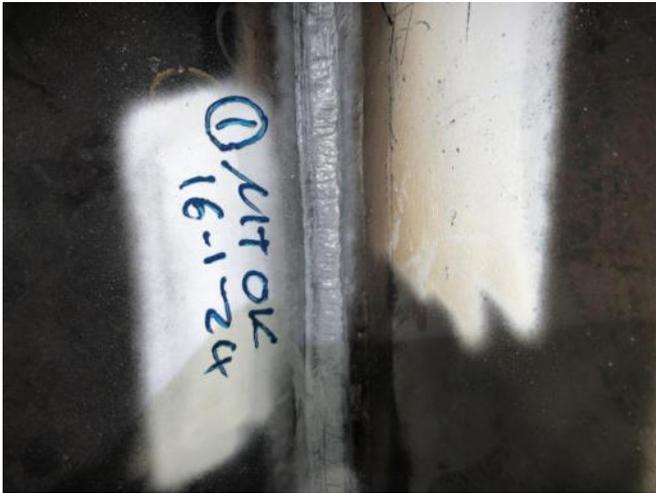
PHOTOGRAPH NO. 35 – INTERNAL BOOM BAY #2  
TYPICAL VIEW OF REPAIRED DEFECT #1

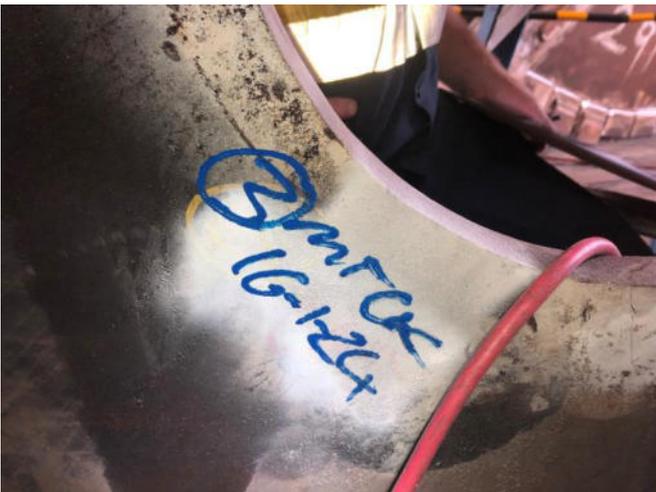
PHOTOGRAPH NO. 37 – INTERNAL BOOM BAY #2  
TYPICAL VIEW OF REPAIRED DEFECT #3

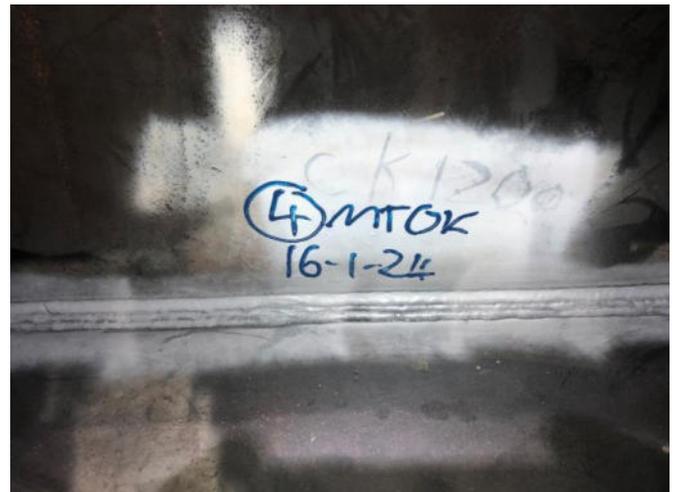
PHOTOGRAPH NO. 38 – INTERNAL BOOM BAY #2  
TYPICAL VIEW OF REPAIRED DEFECT #4

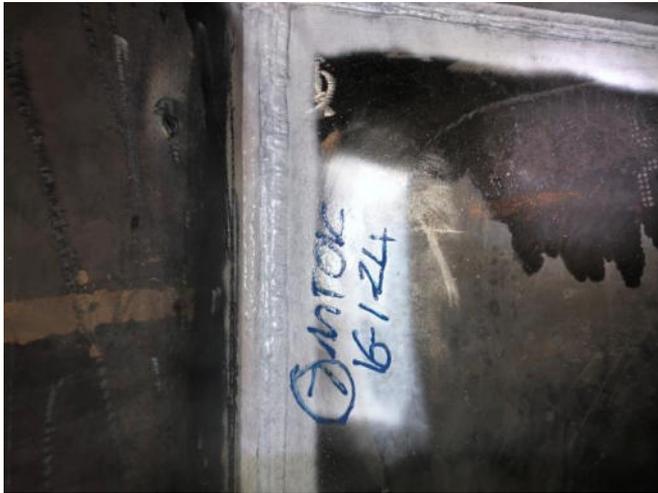
PHOTOGRAPH NO. 41 – INTERNAL BOOM BAY #2  
TYPICAL VIEW OF REPAIRED DEFECT #7

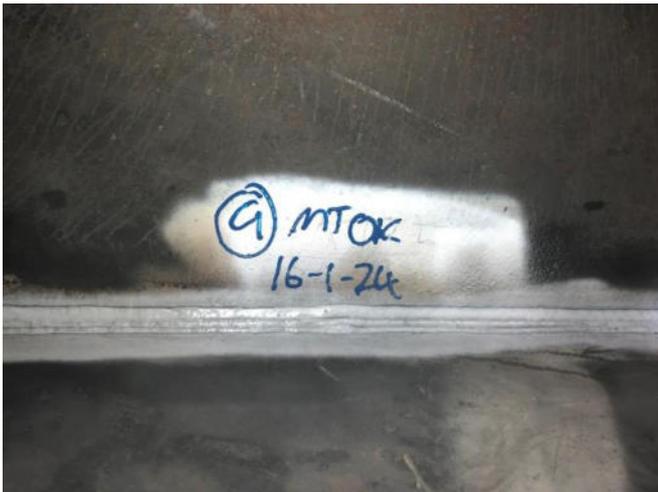
PHOTOGRAPH NO. 43 – INTERNAL BOOM BAY #2  
TYPICAL VIEW OF REPAIRED DEFECT #9

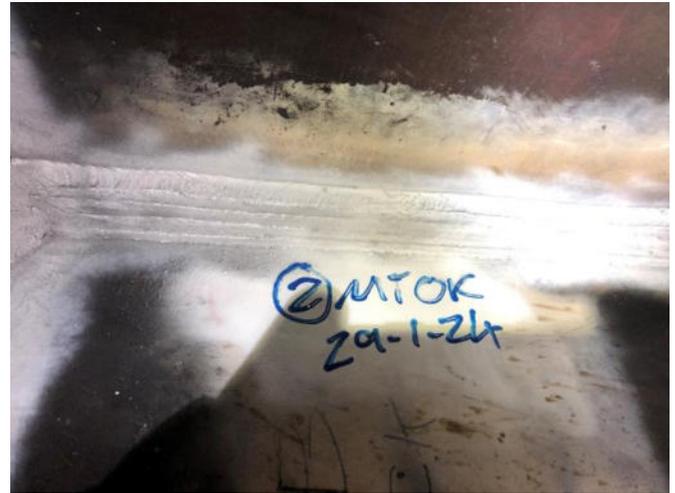
PHOTOGRAPH NO. 45 – INTERNAL BOOM BAY #3  
TYPICAL VIEW OF REPAIRED DEFECT #2

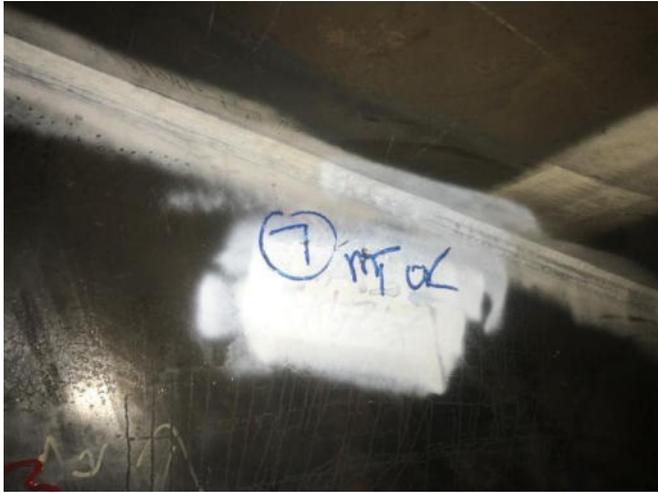
PHOTOGRAPH NO. 50 – INTERNAL BOOM BAY #3  
TYPICAL VIEW OF REPAIRED DEFECT #7
