# REPAIRER'S DATA REPORT

**JOB NUMBER: 27861**

**Description: REFURB EX5600 BOOM**

## STRUCTURAL INTEGRITY SURVEY REPORT FOR THE STRUCTURE REPORT NUMBER HMI 23-033.7

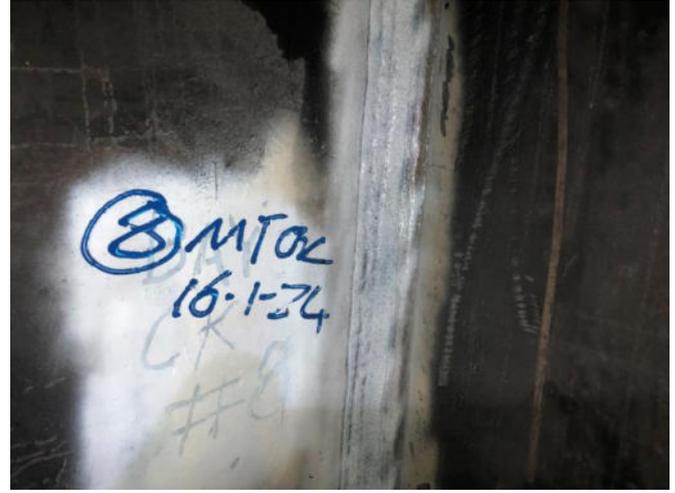
PHOTOGRAPH NO. 51 – INTERNAL BOOM BAY #3  
TYPICAL VIEW OF REPAIRED DEFECT #8

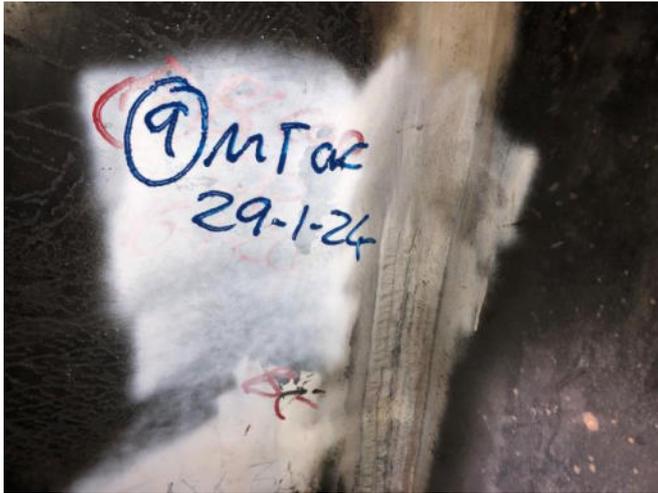
PHOTOGRAPH NO. 52 – INTERNAL BOOM BAY #3  
TYPICAL VIEW OF REPAIRED DEFECT #9

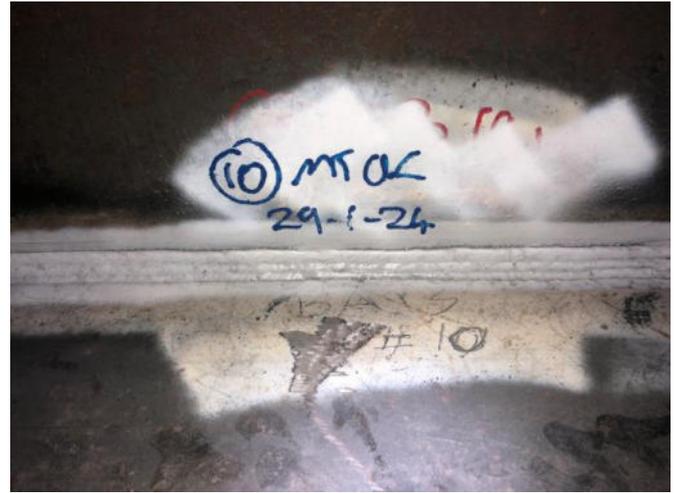
PHOTOGRAPH NO. 53 – INTERNAL BOOM BAY #3  
TYPICAL VIEW OF REPAIRED DEFECT #10

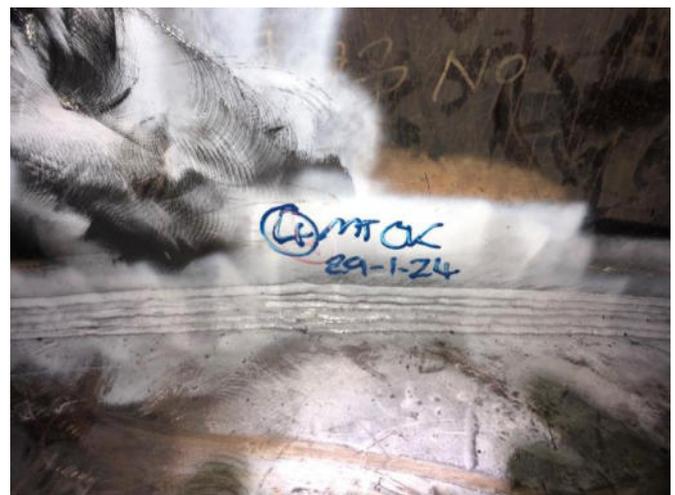
PHOTOGRAPH NO. 57 – INTERNAL BOOM BAY #4  
TYPICAL VIEW OF REPAIRED DEFECT #4

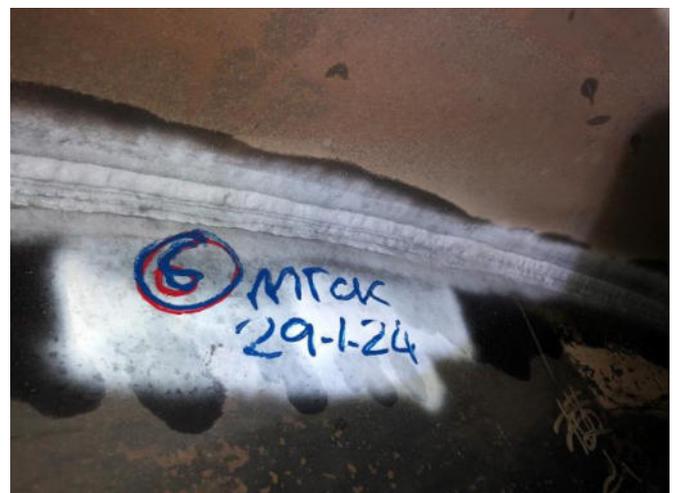
PHOTOGRAPH NO. 59 – INTERNAL BOOM BAY #4  
TYPICAL VIEW OF REPAIRED DEFECT #6

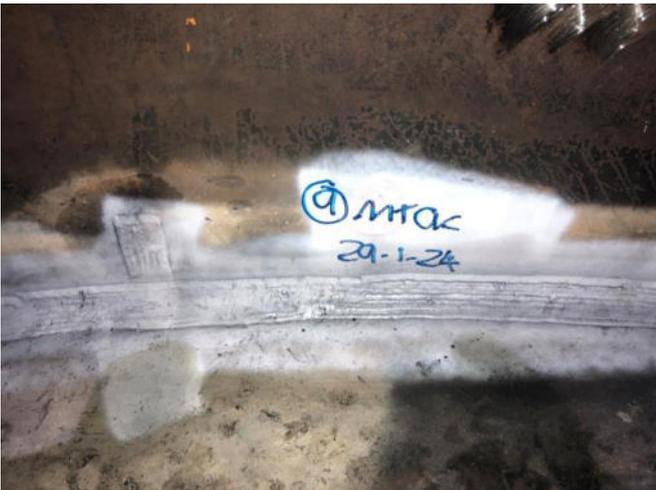
PHOTOGRAPH NO. 62 – INTERNAL BOOM BAY #4  
TYPICAL VIEW OF REPAIRED DEFECT #9

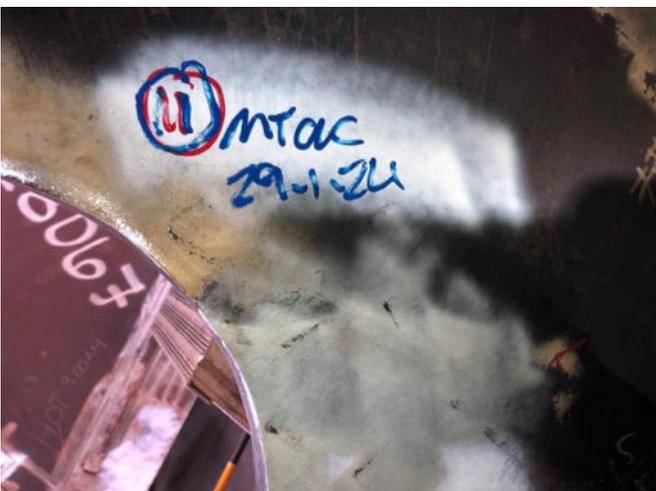
PHOTOGRAPH NO. 64 – INTERNAL BOOM BAY #4  
TYPICAL VIEW OF REPAIRED DEFECT #11

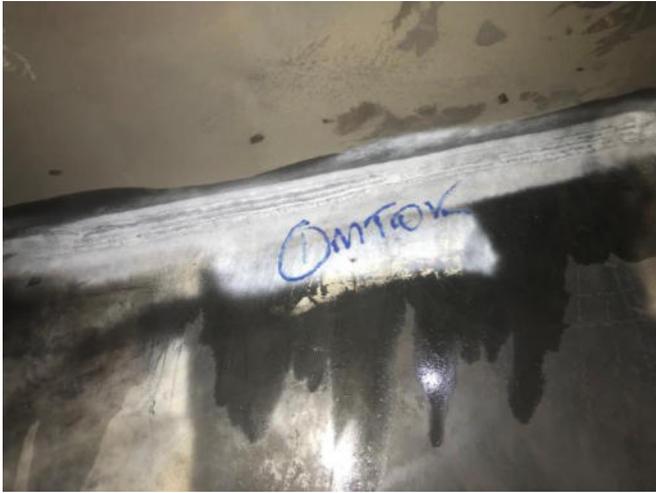
PHOTOGRAPH NO. 65 – INTERNAL BOOM BAY #5  
TYPICAL VIEW OF REPAIRED DEFECT #1

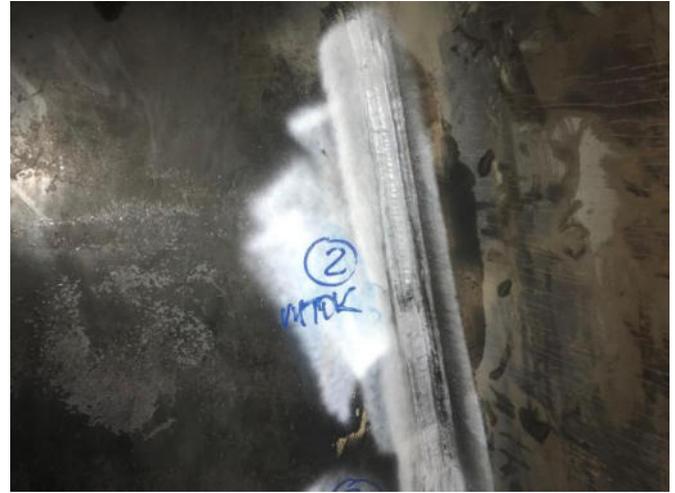
PHOTOGRAPH NO. 66 – INTERNAL BOOM BAY #5  
TYPICAL VIEW OF REPAIRED DEFECT #2

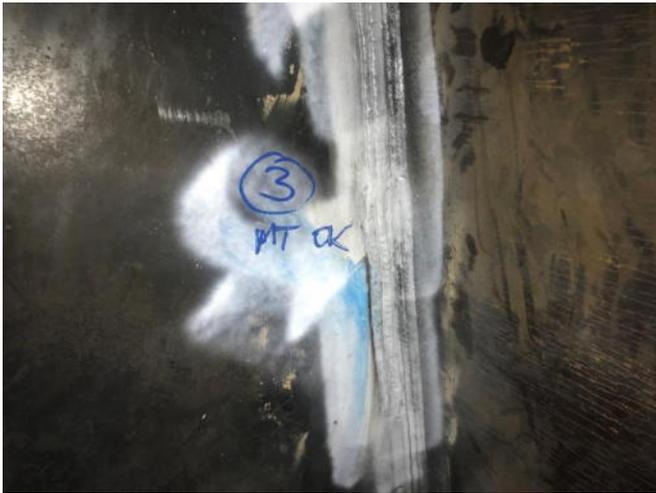
PHOTOGRAPH NO. 67 – INTERNAL BOOM BAY #5  
TYPICAL VIEW OF REPAIRED DEFECT #3

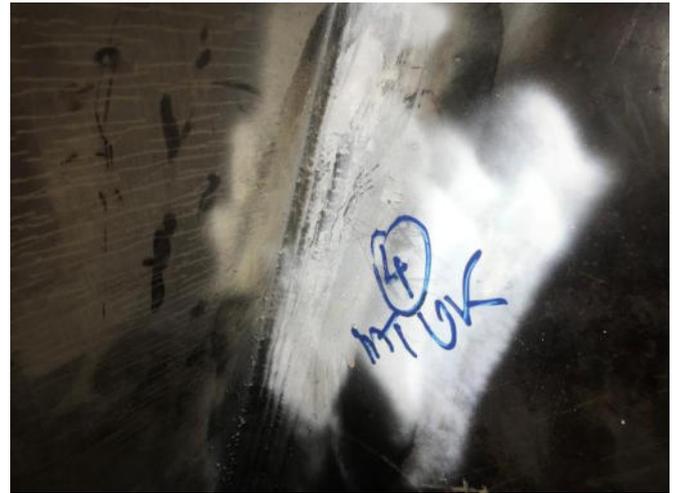
PHOTOGRAPH NO. 68 – INTERNAL BOOM BAY #5  
TYPICAL VIEW OF REPAIRED DEFECT #4

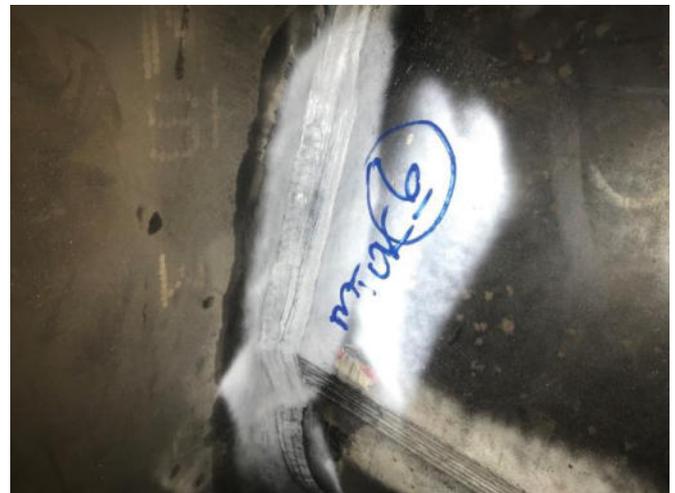
PHOTOGRAPH NO. 70 – INTERNAL BOOM BAY #5  
TYPICAL VIEW OF REPAIRED DEFECT #6

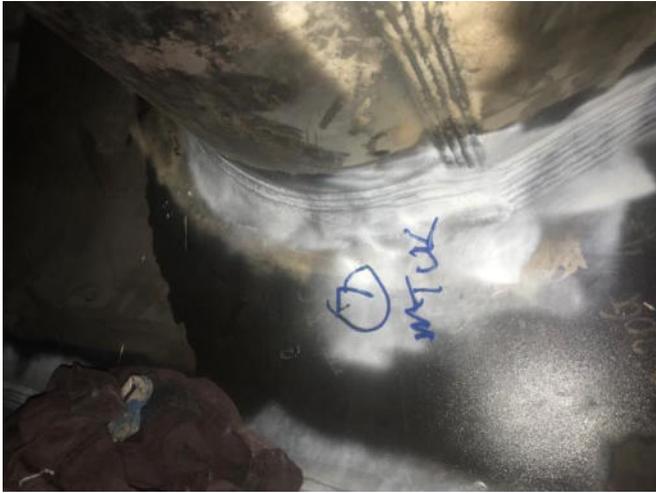
PHOTOGRAPH NO. 71 – INTERNAL BOOM BAY #5  
TYPICAL VIEW OF REPAIRED DEFECT #7

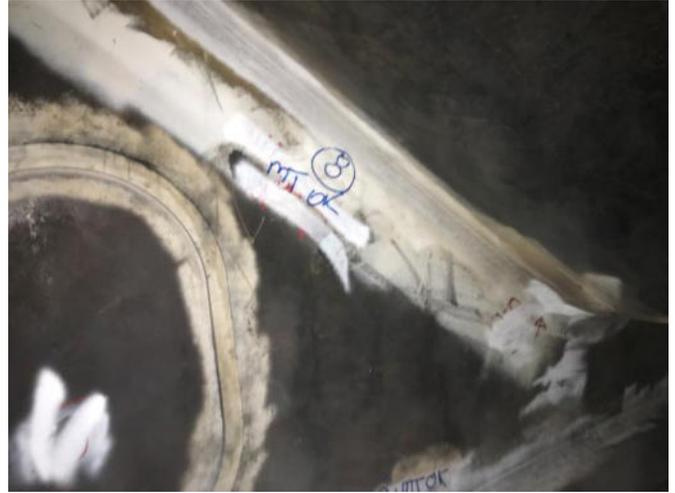
PHOTOGRAPH NO. 72 – INTERNAL BOOM BAY #5  
TYPICAL VIEW OF REPAIRED DEFECT #8

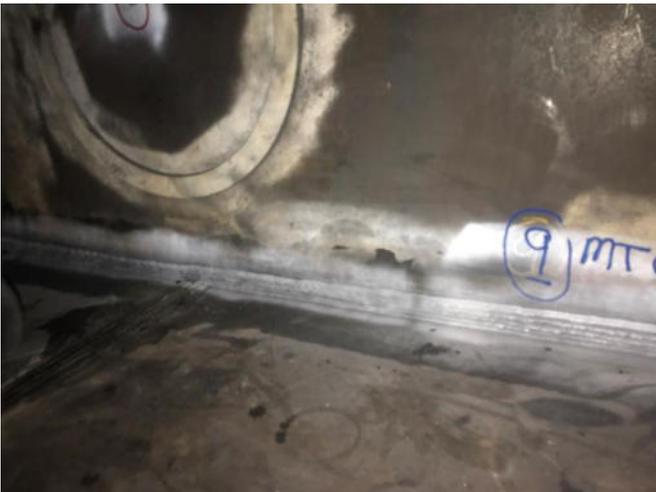
PHOTOGRAPH NO. 73 – INTERNAL BOOM BAY #5  
TYPICAL VIEW OF REPAIRED DEFECT #9

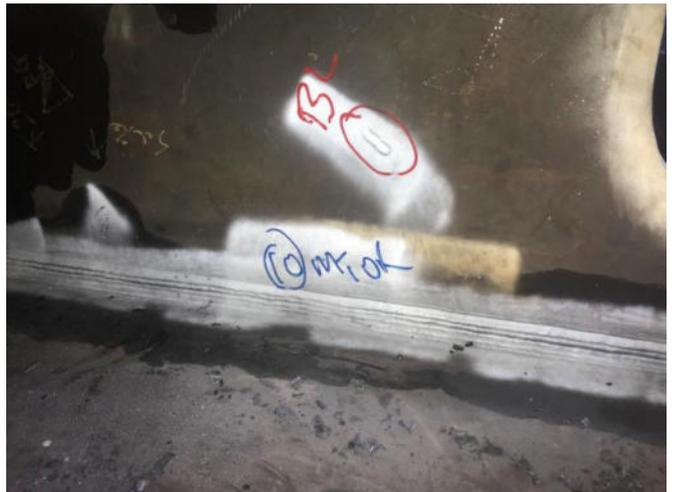
PHOTOGRAPH NO. 74 – INTERNAL BOOM BAY #5  
TYPICAL VIEW OF REPAIRED DEFECT #10

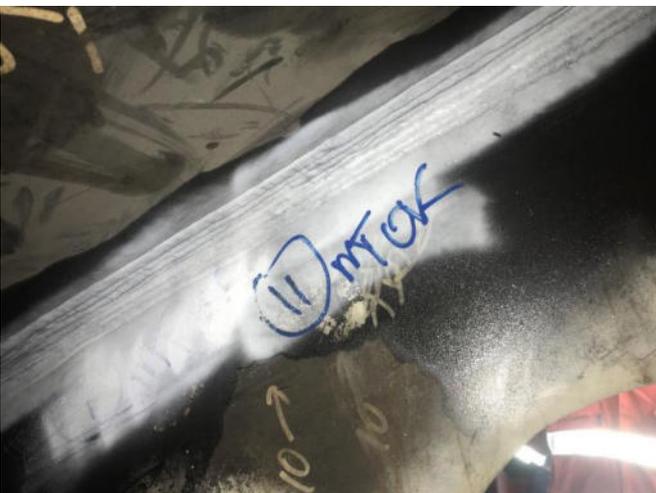
PHOTOGRAPH NO. 75 – INTERNAL BOOM BAY #5  
TYPICAL VIEW OF REPAIRED DEFECT #11

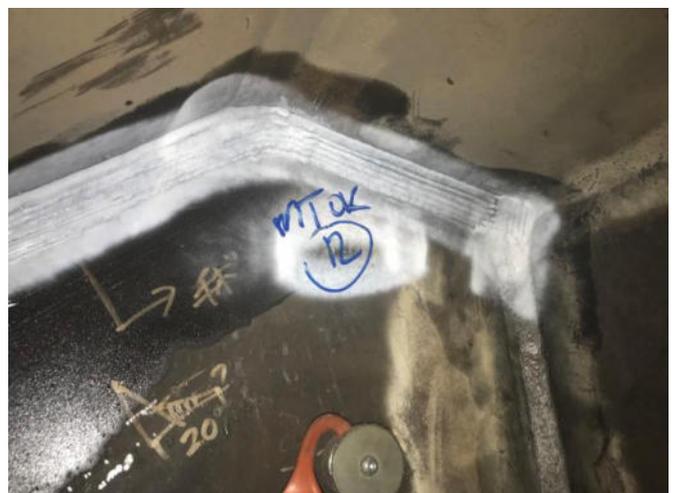
PHOTOGRAPH NO. 76 – INTERNAL BOOM BAY #5  
TYPICAL VIEW OF REPAIRED DEFECT #12

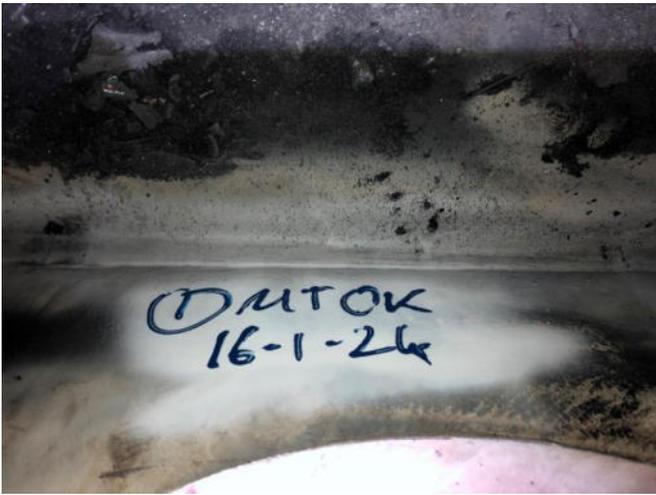
PHOTOGRAPH NO. 78 – INTERNAL BOOM BAY #6  
TYPICAL VIEW OF REPAIRED DEFECT #1

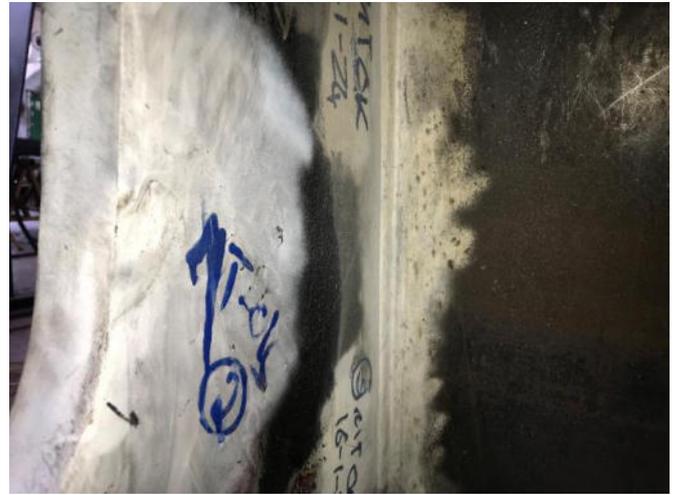
PHOTOGRAPH NO. 79 – INTERNAL BOOM BAY #6  
TYPICAL VIEW OF REPAIRED DEFECT #2

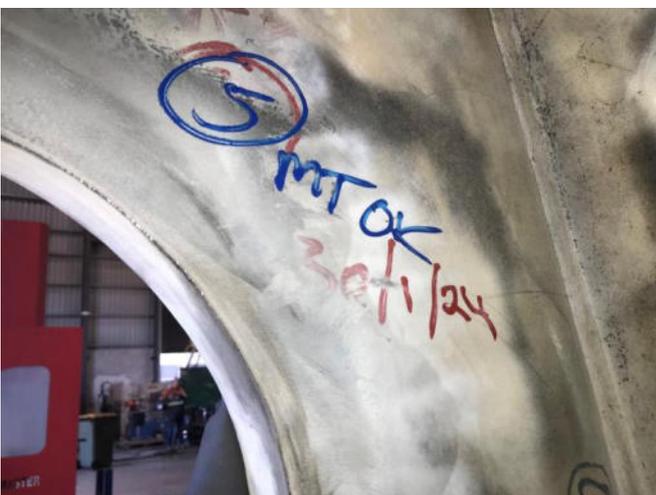
PHOTOGRAPH NO. 82 – INTERNAL BOOM BAY #6  
TYPICAL VIEW OF REPAIRED DEFECT #5

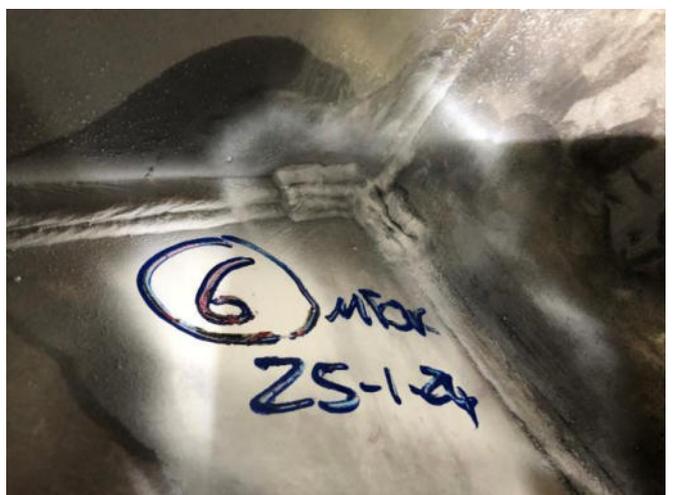
PHOTOGRAPH NO. 83 – INTERNAL BOOM BAY #6  
TYPICAL VIEW OF REPAIRED DEFECT #6

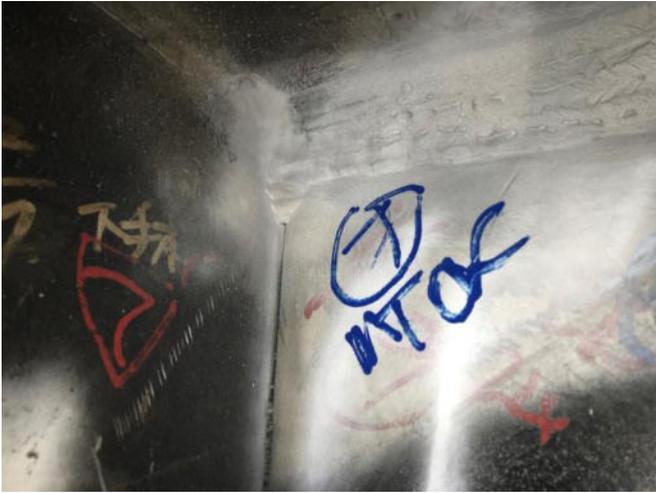
PHOTOGRAPH NO. 84 – INTERNAL BOOM BAY #6  
TYPICAL VIEW OF REPAIRED DEFECT #7

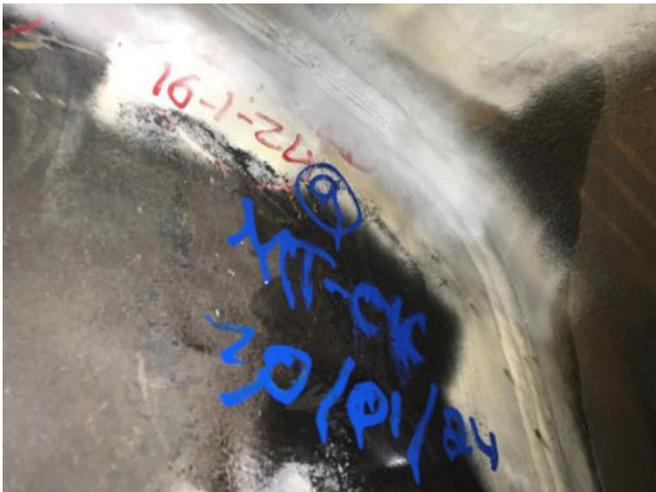
PHOTOGRAPH NO. 86 – INTERNAL BOOM BAY #6  
TYPICAL VIEW OF REPAIRED DEFECT #9

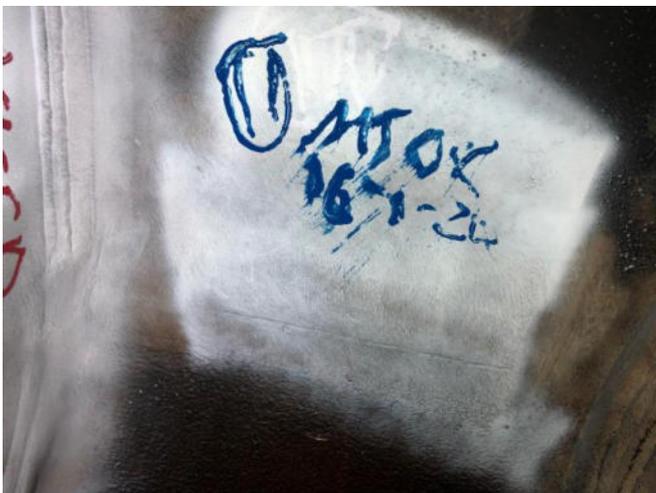
PHOTOGRAPH NO. 88 – INTERNAL BOOM BAY #6  
TYPICAL VIEW OF REPAIRED DEFECT #11

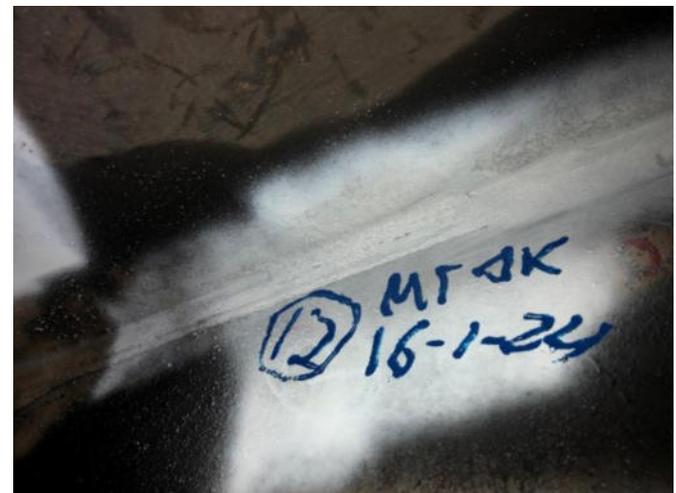
PHOTOGRAPH NO. 89 – INTERNAL BOOM BAY #6  
TYPICAL VIEW OF REPAIRED DEFECT #12

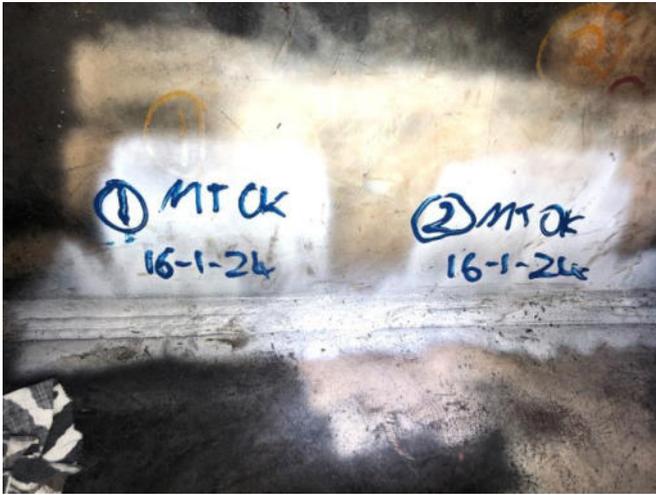
PHOTOGRAPH NO. 90 – INTERNAL BOOM BAY #7  
TYPICAL VIEW OF REPAIRED DEFECT #1 & #2

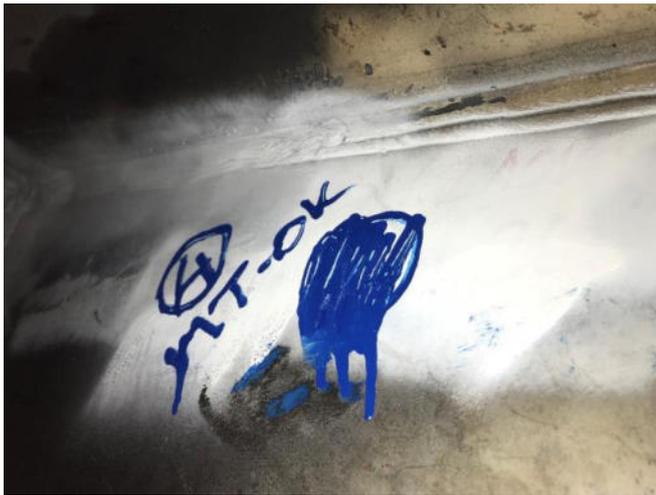
PHOTOGRAPH NO. 92 – INTERNAL BOOM BAY #7  
TYPICAL VIEW OF REPAIRED DEFECT #4

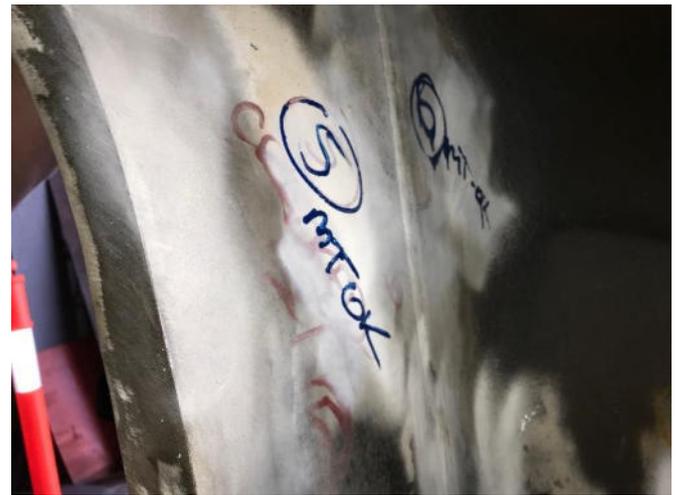
PHOTOGRAPH NO. 93 – INTERNAL BOOM BAY #7  
TYPICAL VIEW OF REPAIRED DEFECT #5

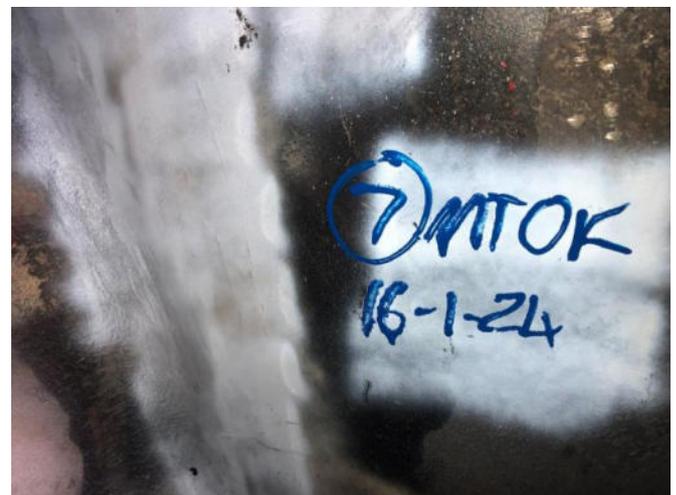
PHOTOGRAPH NO. 95 – INTERNAL BOOM BAY #7  
TYPICAL VIEW OF REPAIRED DEFECT #7

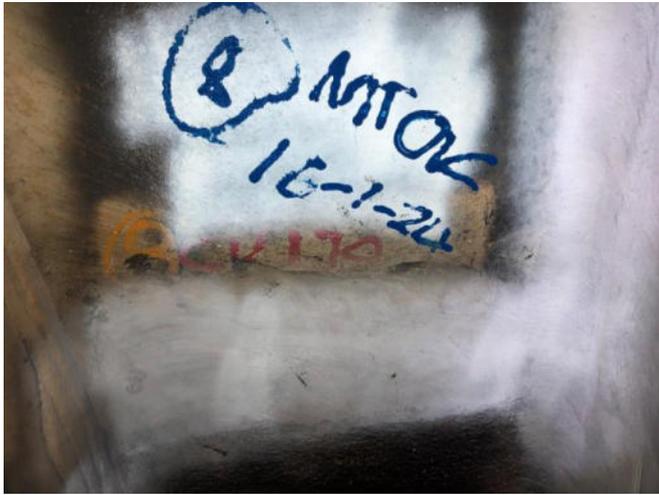
PHOTOGRAPH NO. 96 – INTERNAL BOOM BAY #7  
TYPICAL VIEW OF REPAIRED DEFECT #8

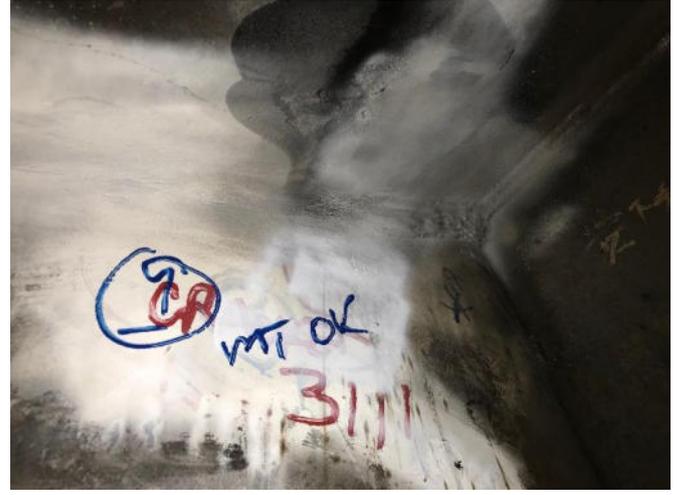
PHOTOGRAPH NO. 97 – INTERNAL BOOM BAY #7  
TYPICAL VIEW OF REPAIRED DEFECT #9

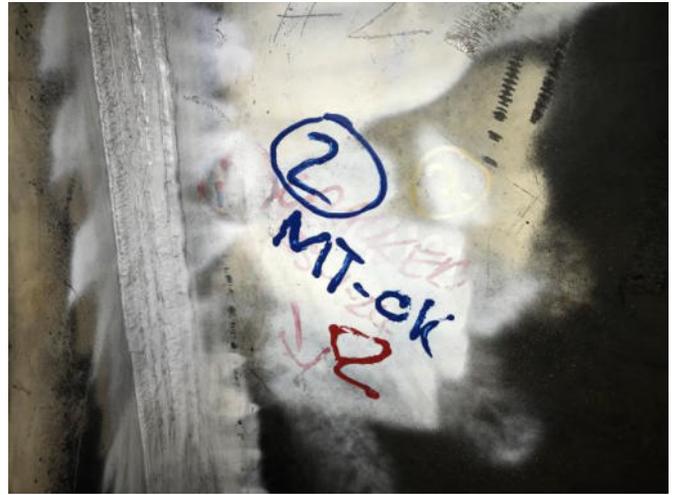
PHOTOGRAPH NO. 99 – INTERNAL BOOM BAY #8  
TYPICAL VIEW OF REPAIRED DEFECT #2

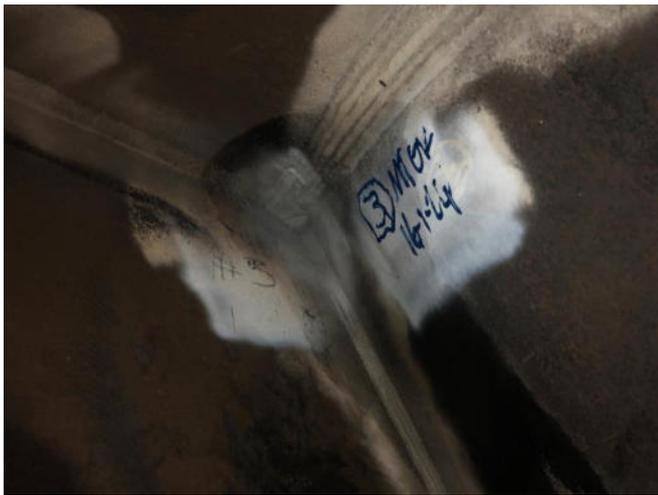
PHOTOGRAPH NO. 100 – INTERNAL BOOM BAY #8  
TYPICAL VIEW OF REPAIRED DEFECT #3

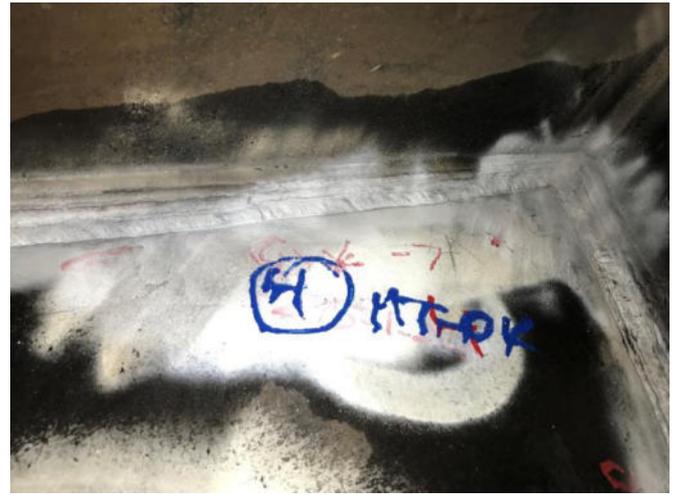
PHOTOGRAPH NO. 101 – INTERNAL BOOM BAY #8  
TYPICAL VIEW OF REPAIRED DEFECT #4

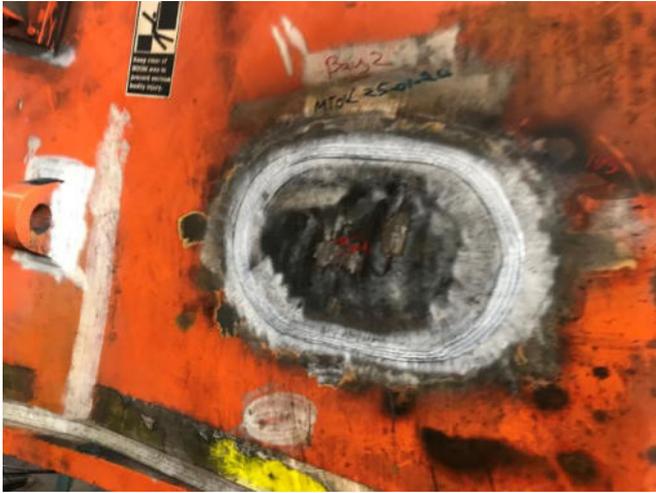
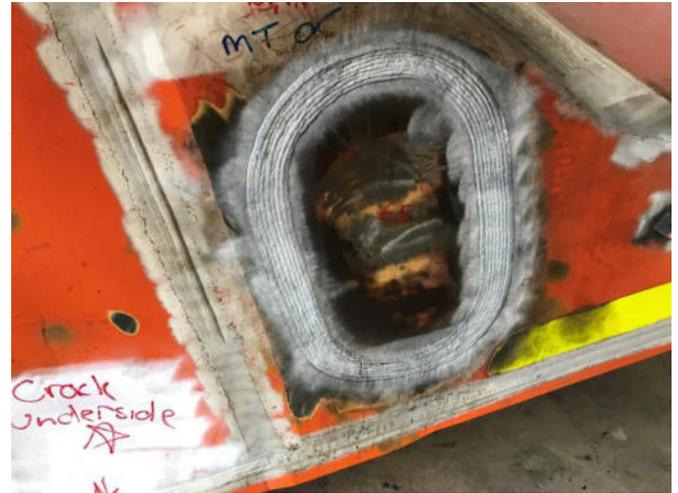
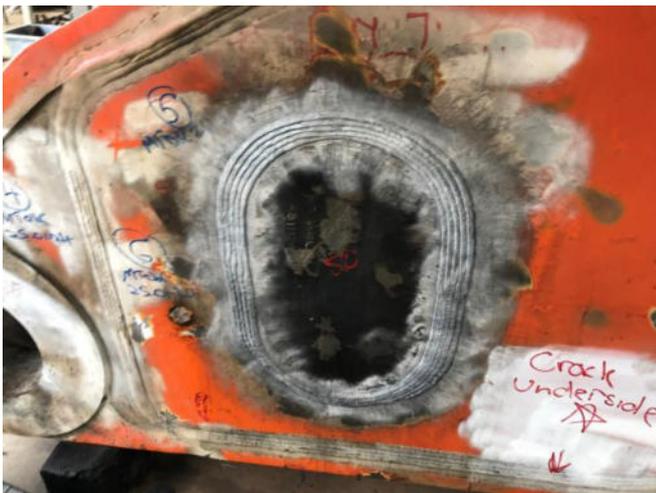
PHOTOGRAPH NO. 102 – GENERAL VIEW OF NEW MAN HOLE COVER

PHOTOGRAPH NO. 103 – GENERAL VIEW OF NEW MAN HOLE COVER

PHOTOGRAPH NO. 104 – GENERAL VIEW OF NEW MAN HOLE COVER
